**Hotel**  
**, LLC)**

----- **Way**  
----- **Alabama**-----

**Inspection #8**

Inspection Date: -----

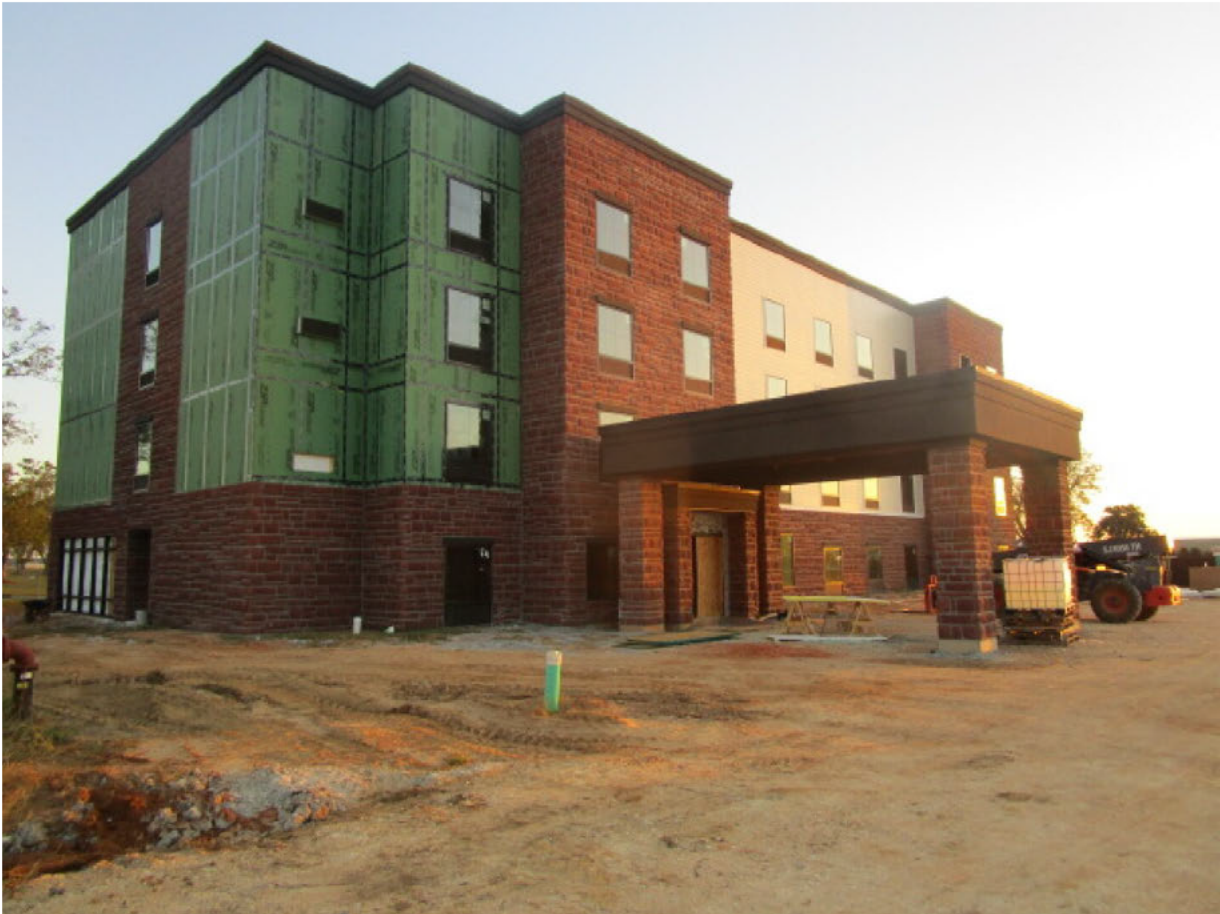
For the overall building exterior, the exterior stone work was now approaching completion and estimated at 97% complete. Exterior windows and doors are installed, except those left out for material delivery into the building. Exterior siding installations are in progress with material stored on site. Exterior Insulation Finish System (EIFS) work is complete at the porte cochere and trim band at the main building.

1. Exterior veneer progress noted on main elevation.

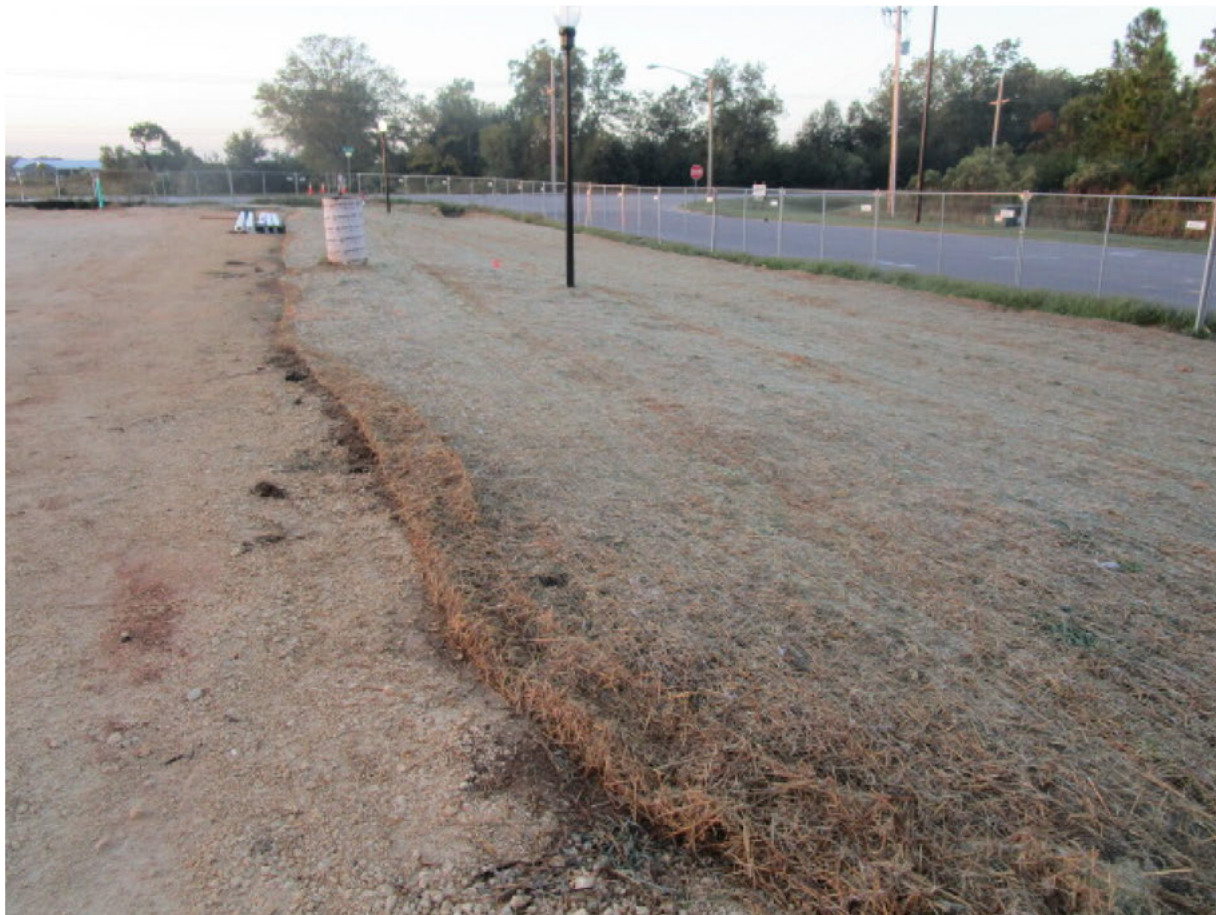
Since our last site visit, we noted stabilization work in progress including some straw matting. Several pallets of sod were also on site yet not installed.

3. Matting added for site stabilization.

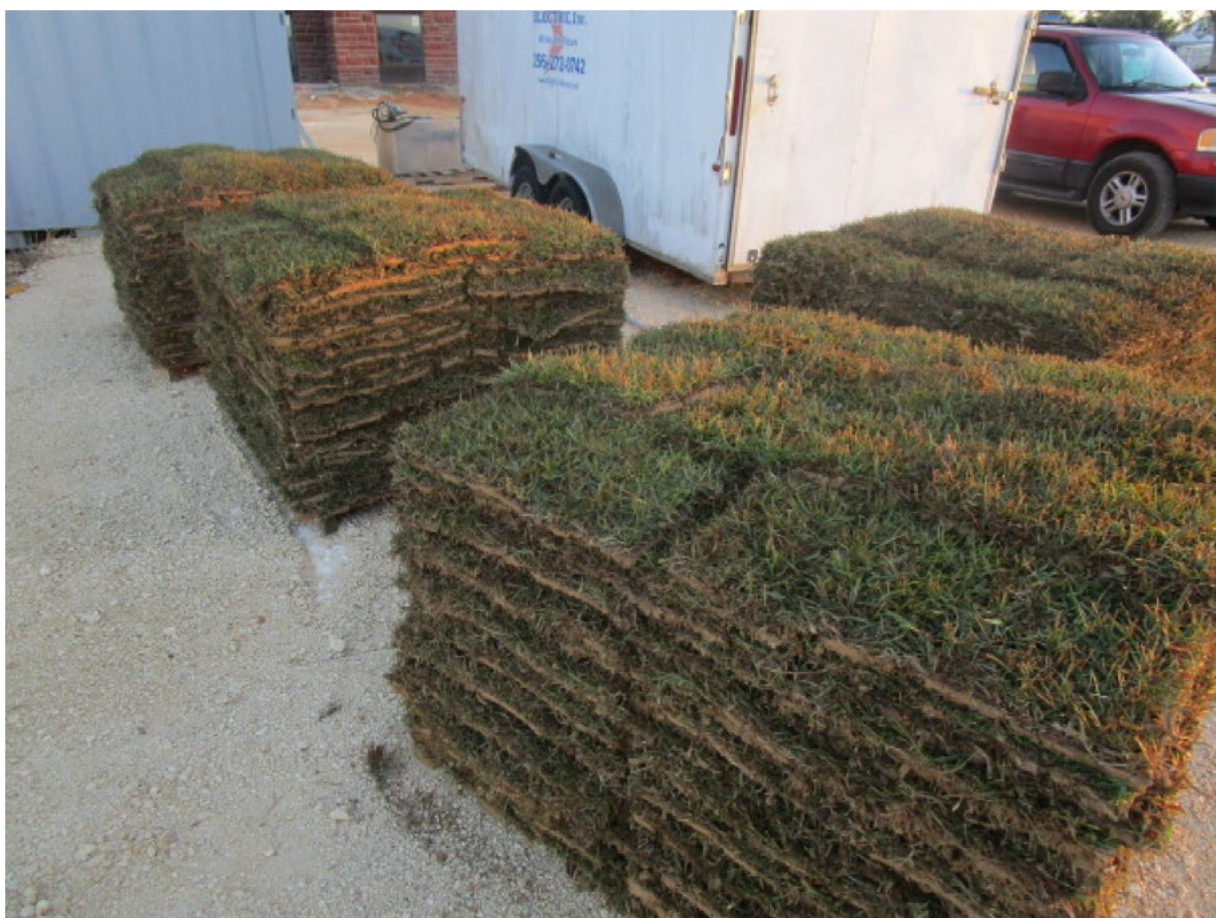
4. Sod stored on site.

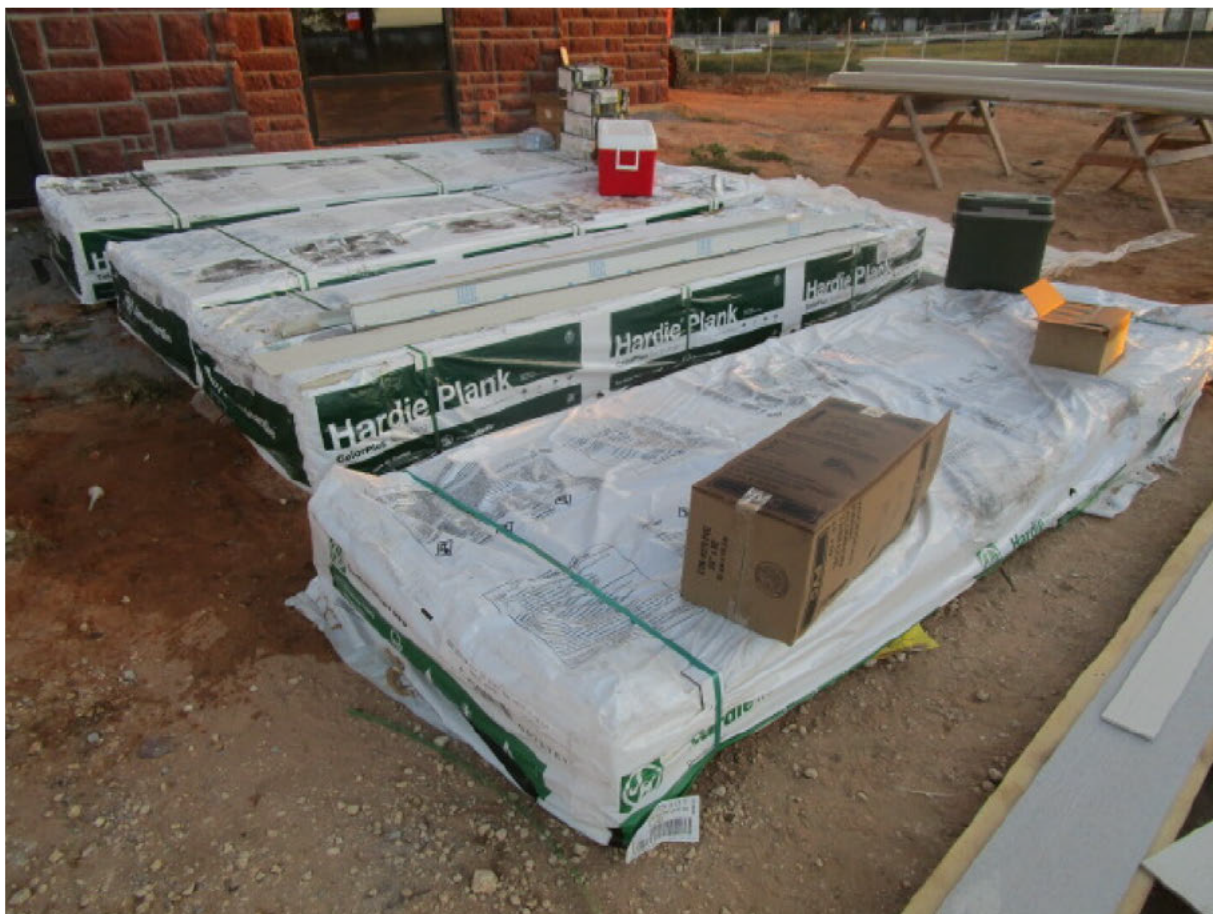
5. Siding stored on site for ongoing installations.

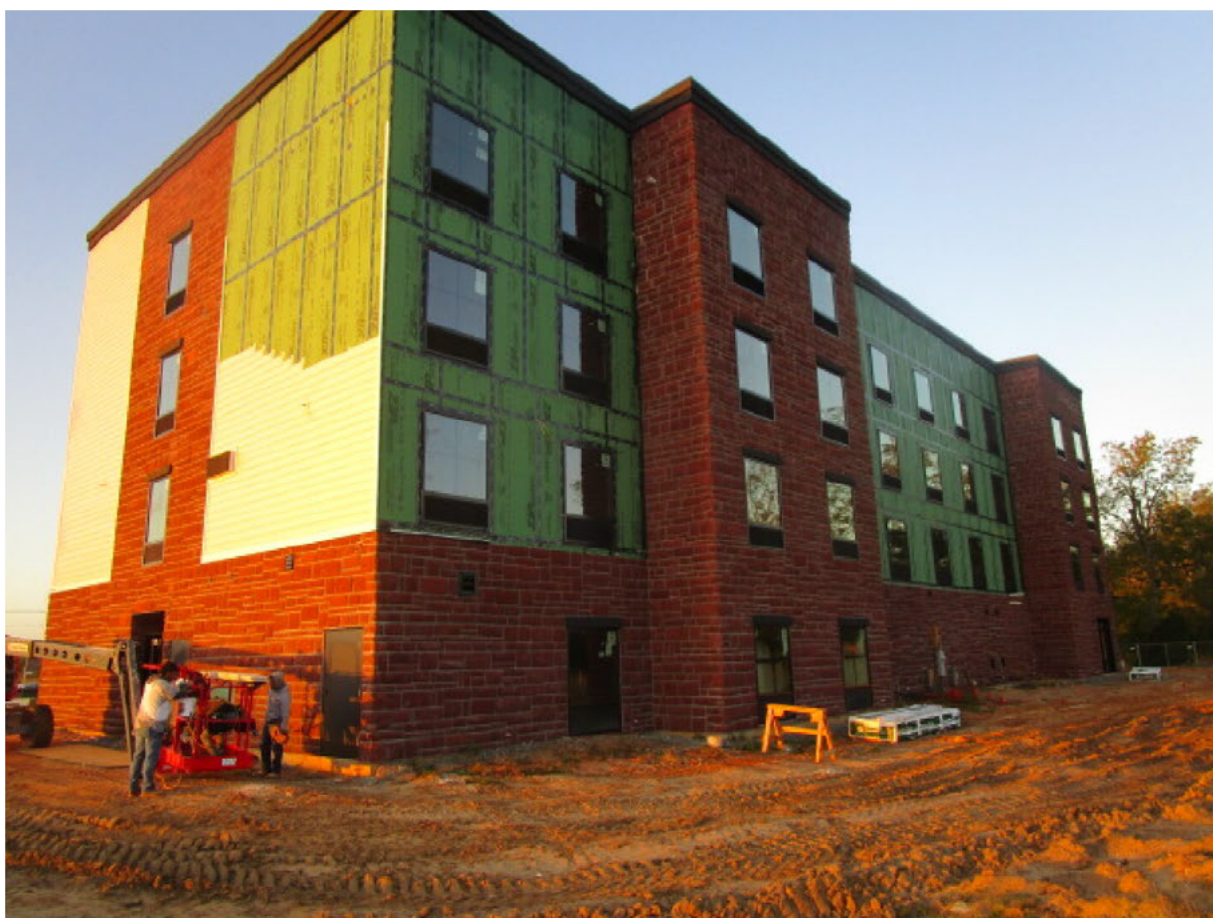
6. Rear elevation noting exterior veneer progress.

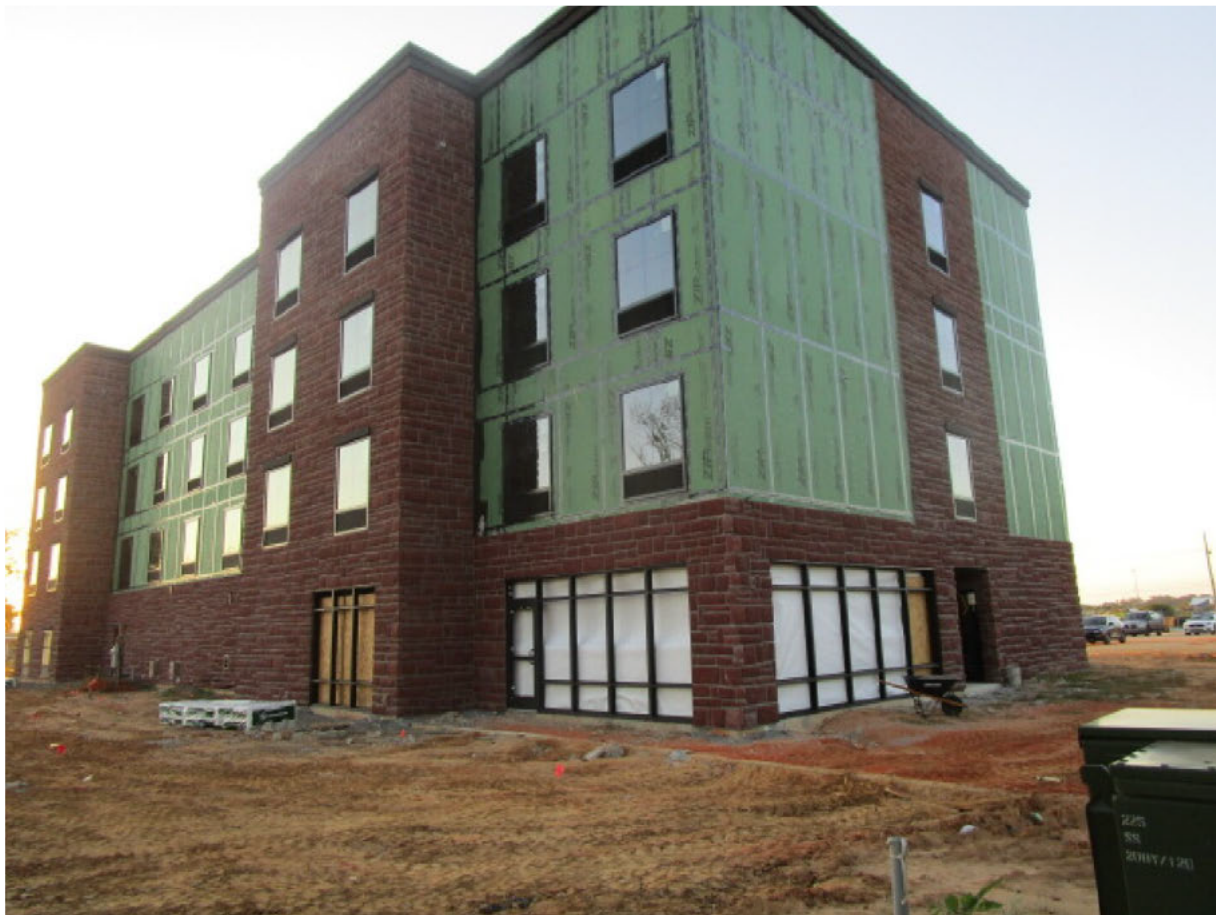
7. Exterior doors and windows generally installed, except for some leave outs for material delivery and glazing inserts at storefront.

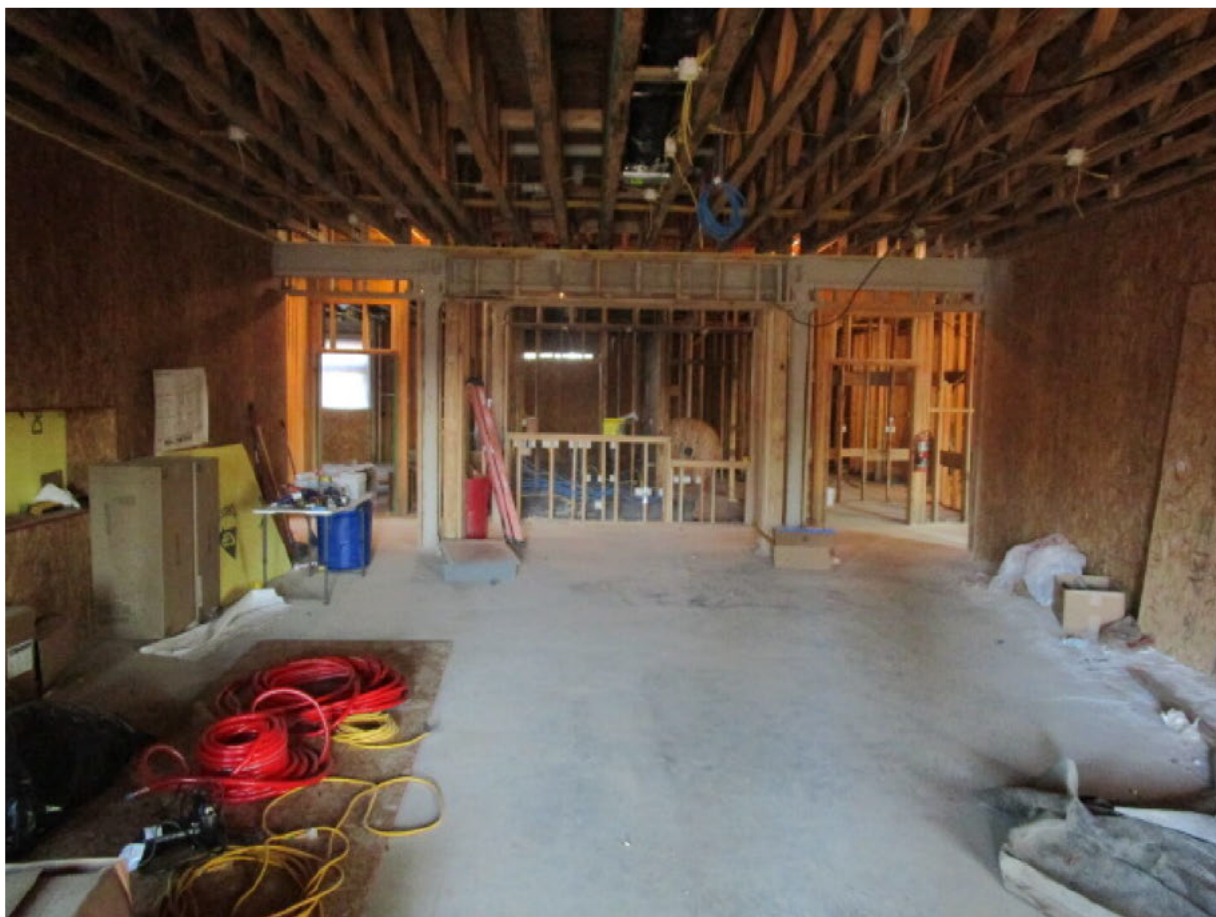
8. Main entry noting framing and rough-ins.

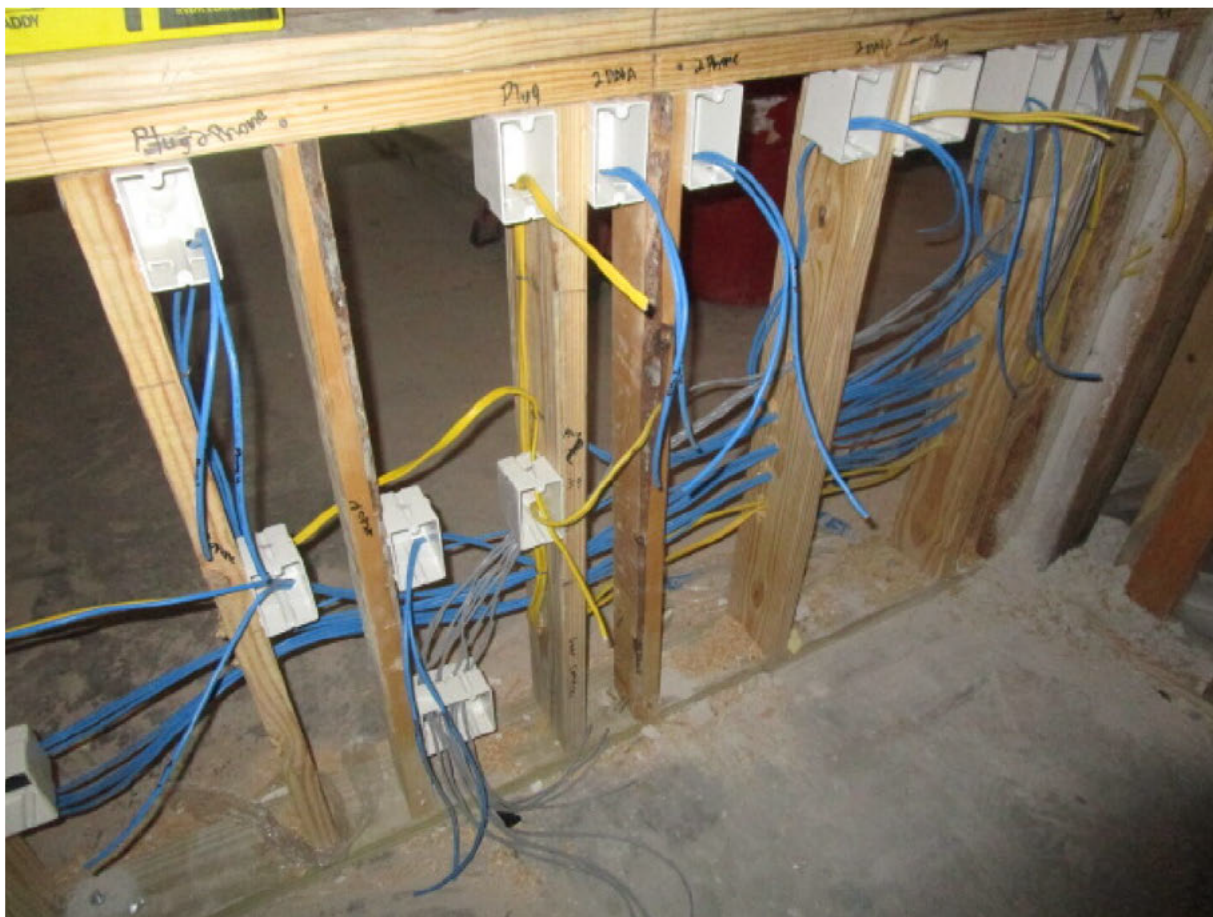
9. Electrical and low voltage wiring observed at first floor.

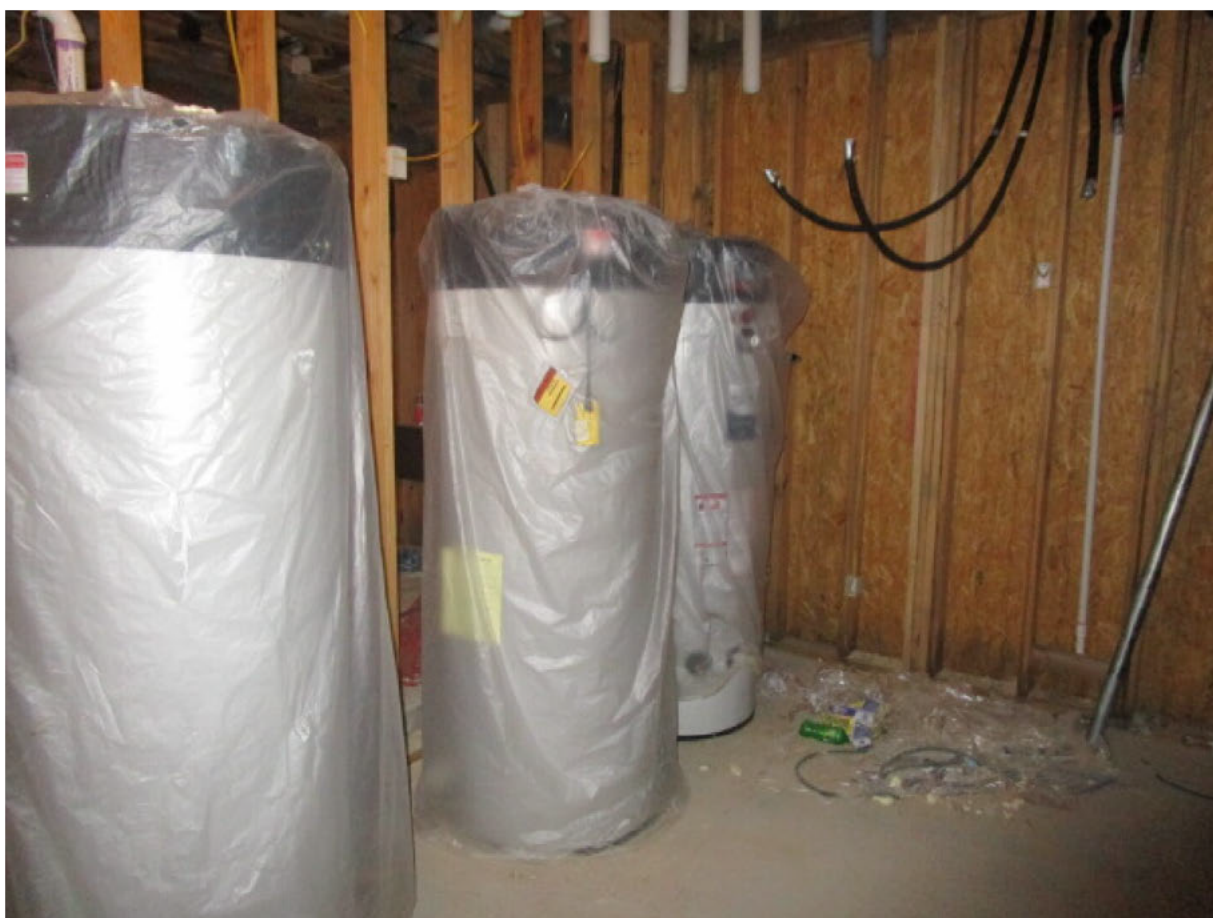
At the interior of the building, MEP work remains in progress. Rough plumbing, electrical, HVAC duct work/exhaust fans, and fire sprinkler work were generally noted on all floors. The water heaters and the main electrical gear remain to be installed in the first floor mechanical area. No wall insulation or sheetrock work have commenced.

10. Shared water heaters remain to be installed at first floor.

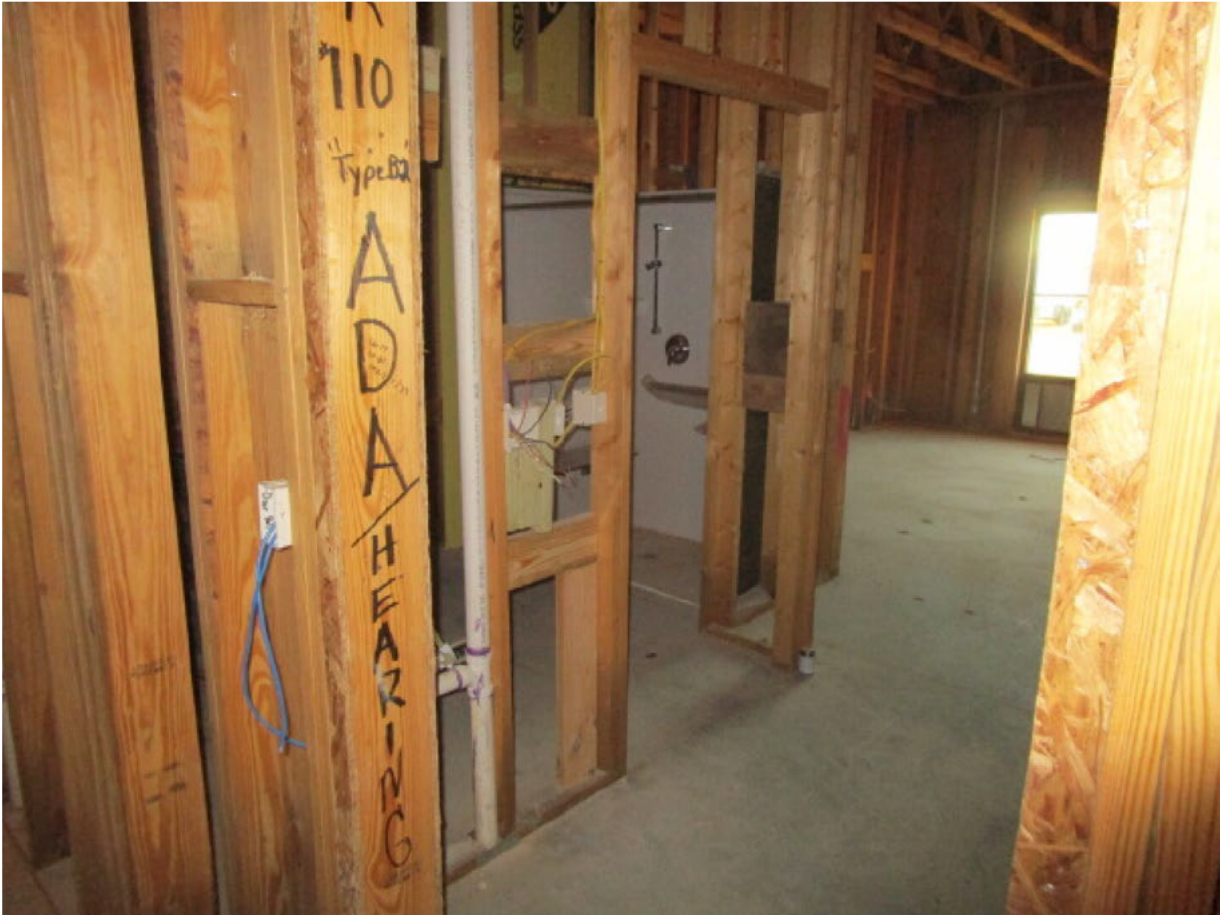
11. Typical first floor framing and rough-in progress observed.

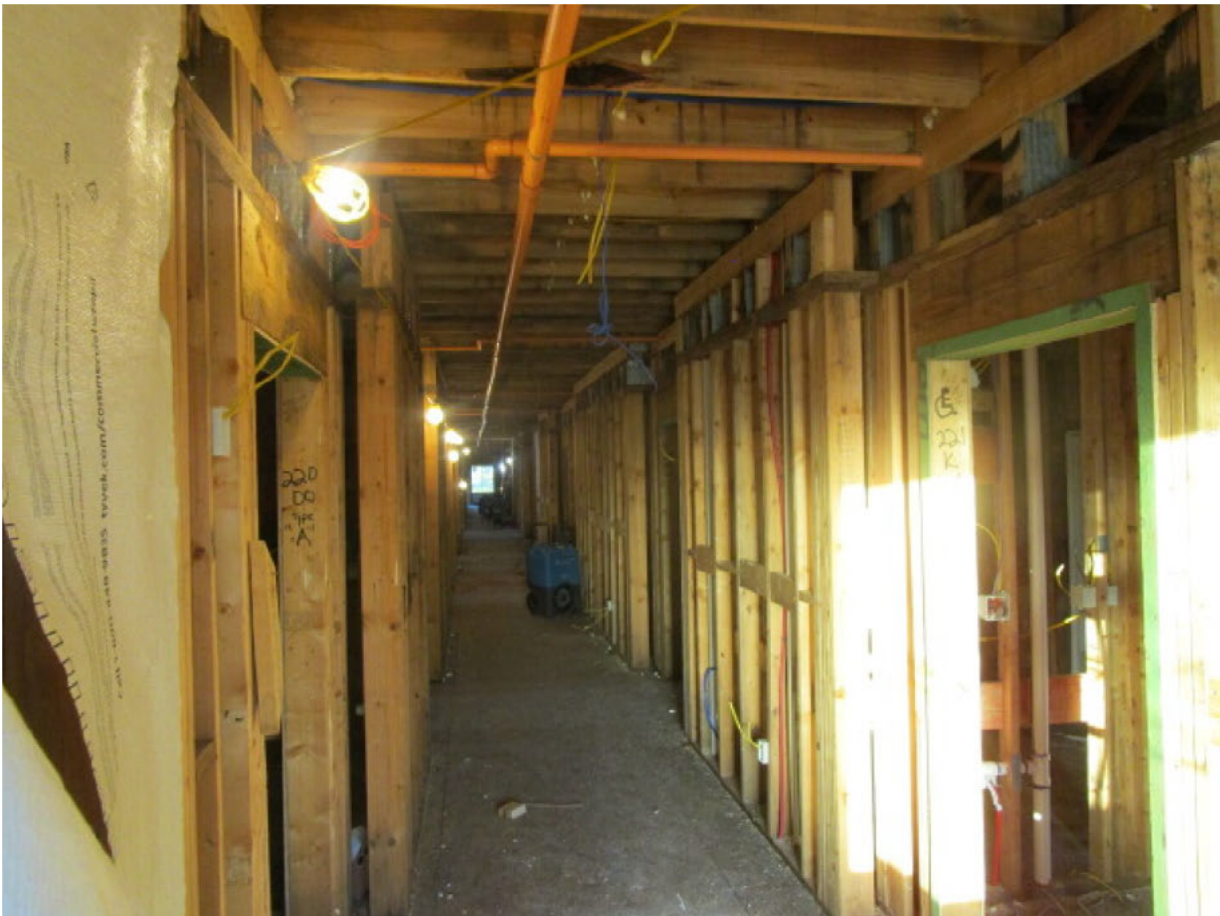
12. View along second floor corridor.

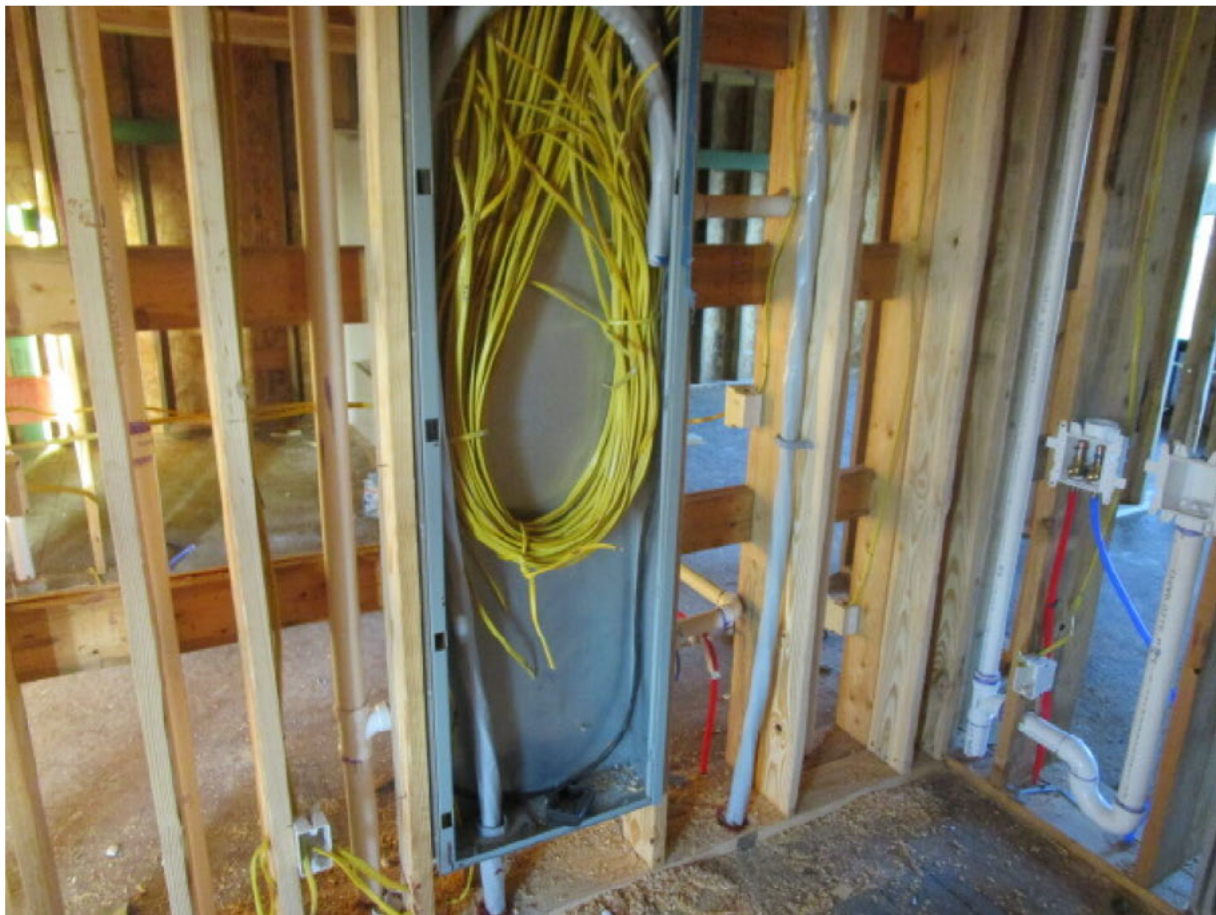
13. Rough-ins observed at second floor.

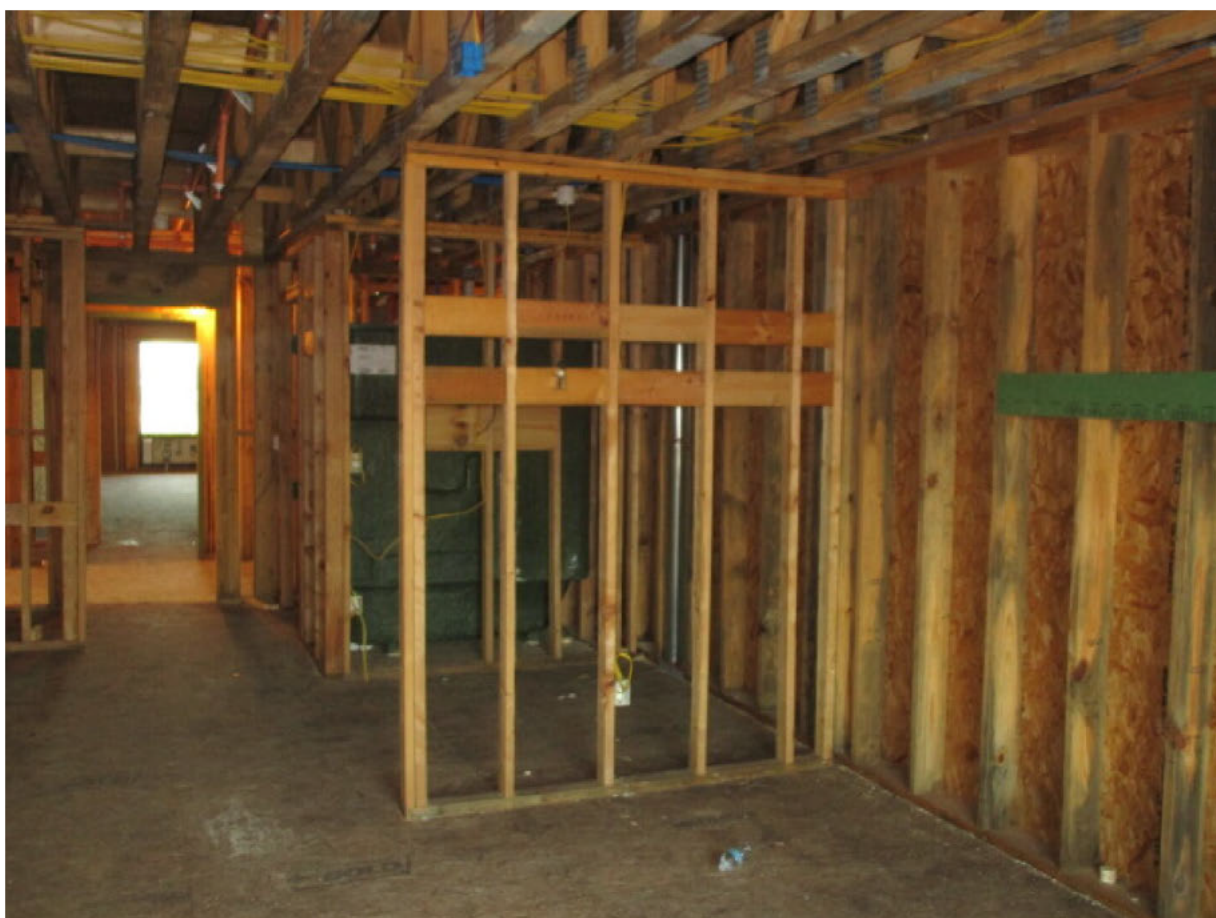
14. Typical guestroom observed with rough-in work noted.

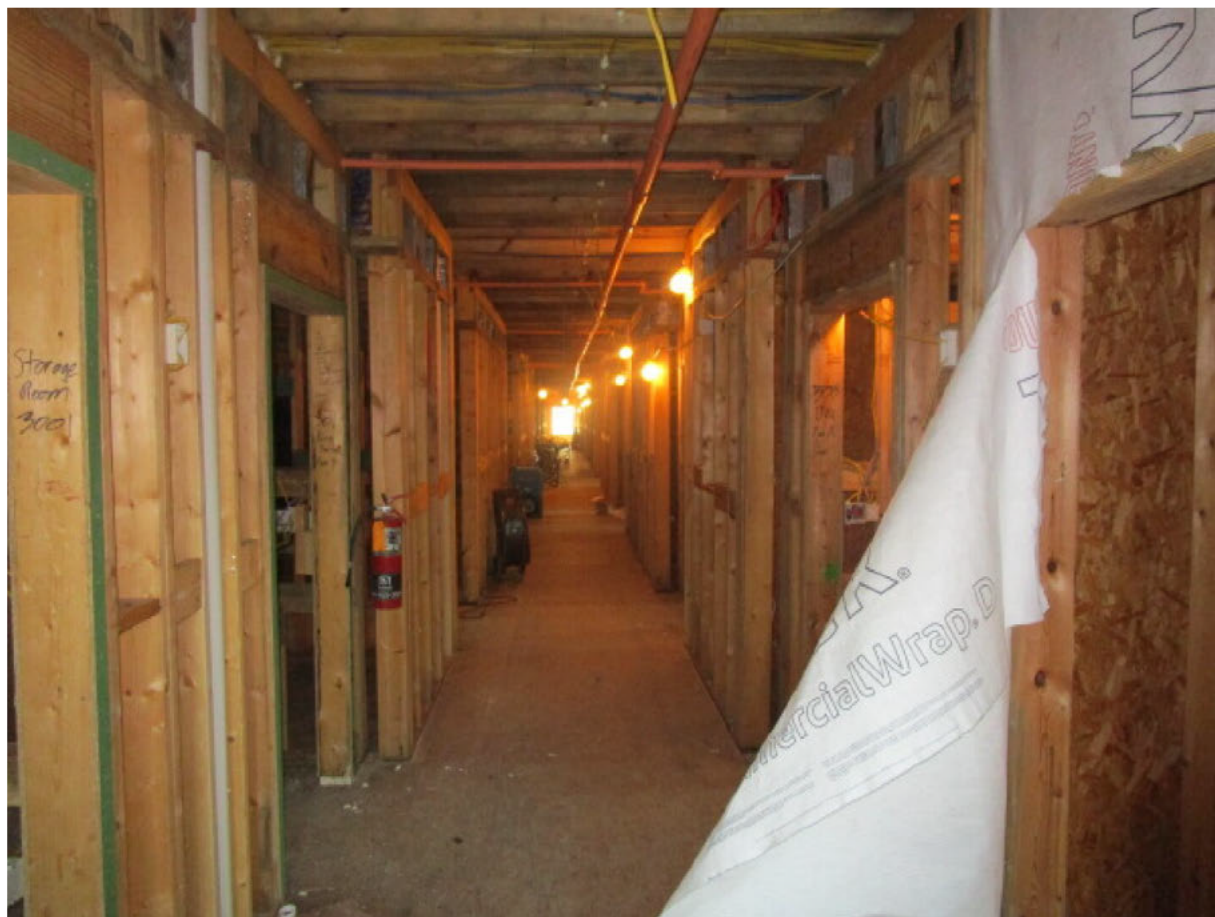
15. Third floor corridor.

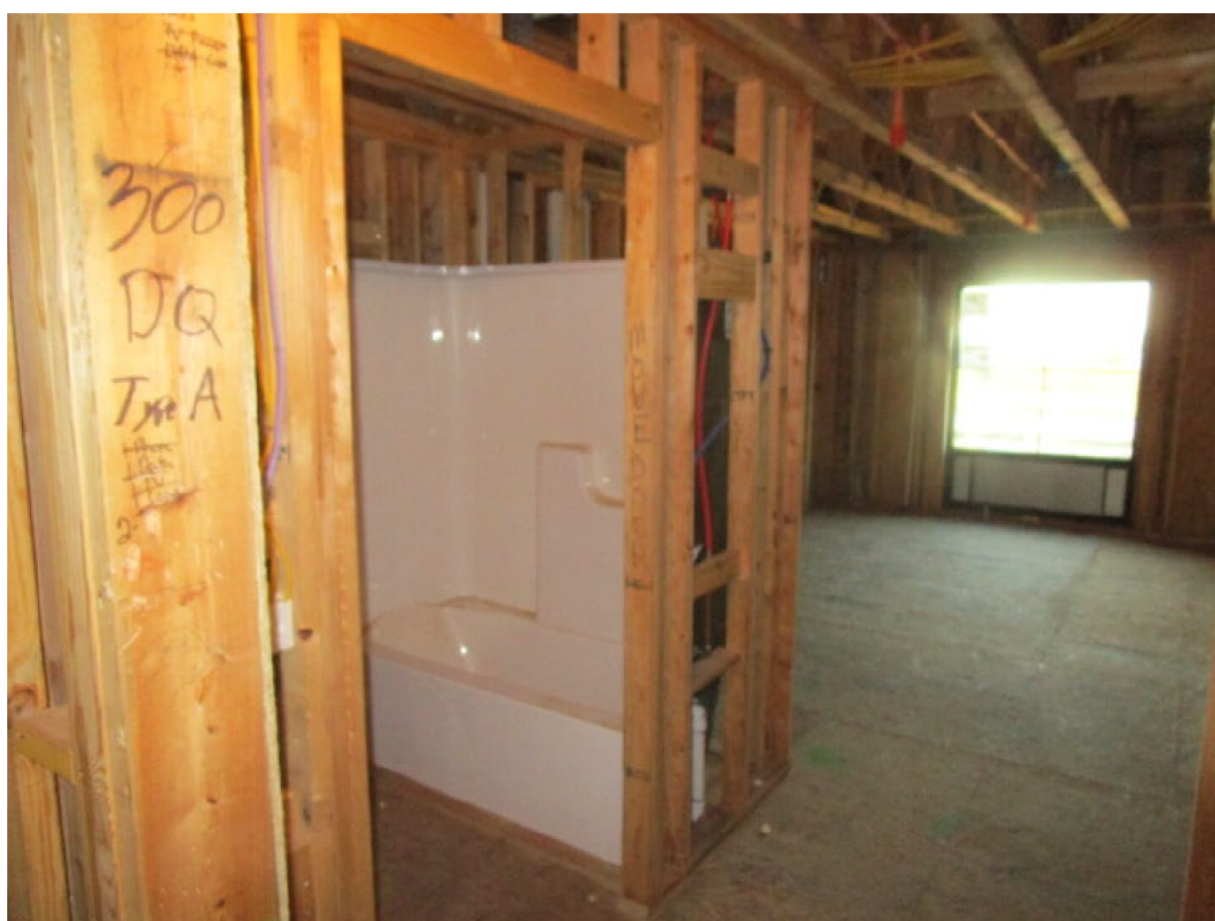
16. Typical third floor guestroom level of completion.

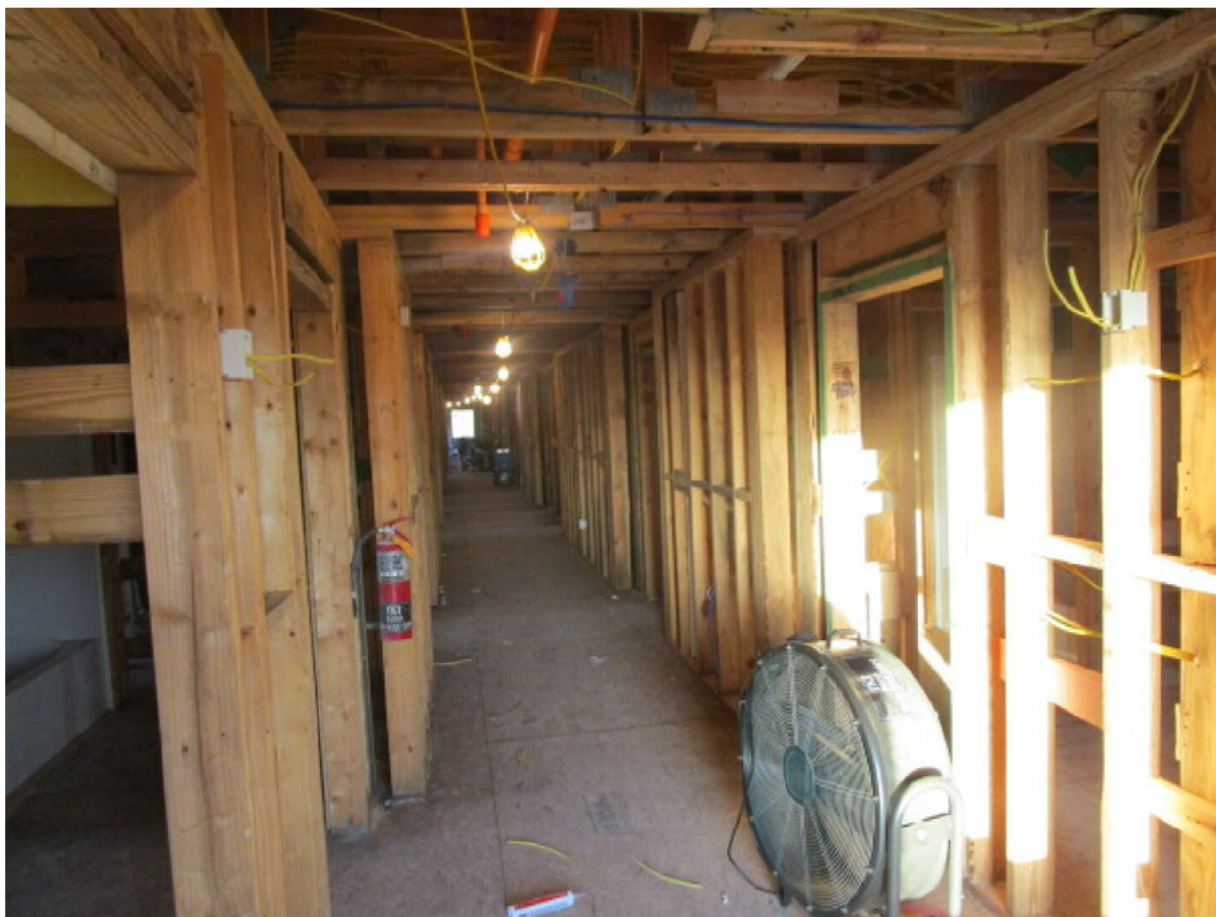
17. Fourth floor corridor.

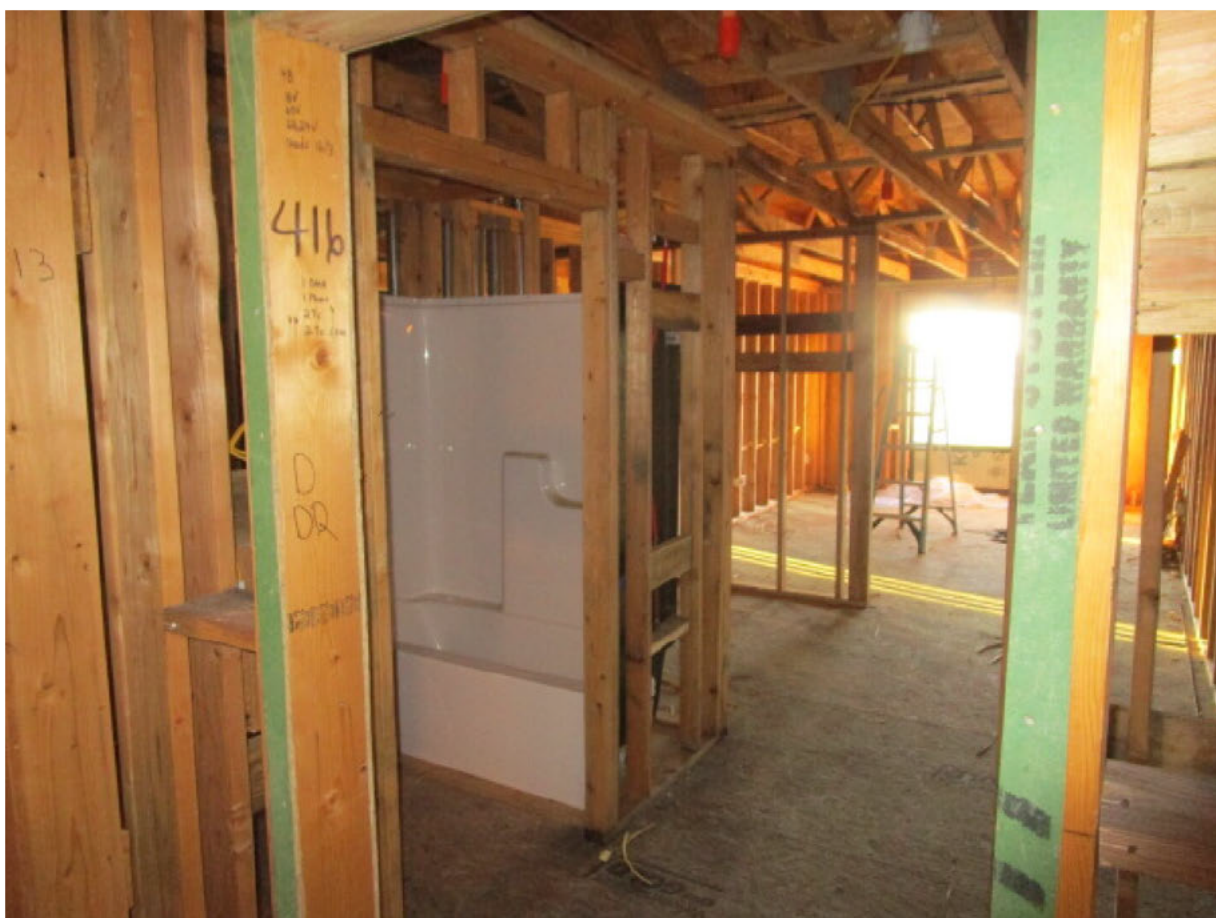
18. Typical fourth floor guestroom noting rough-ins.

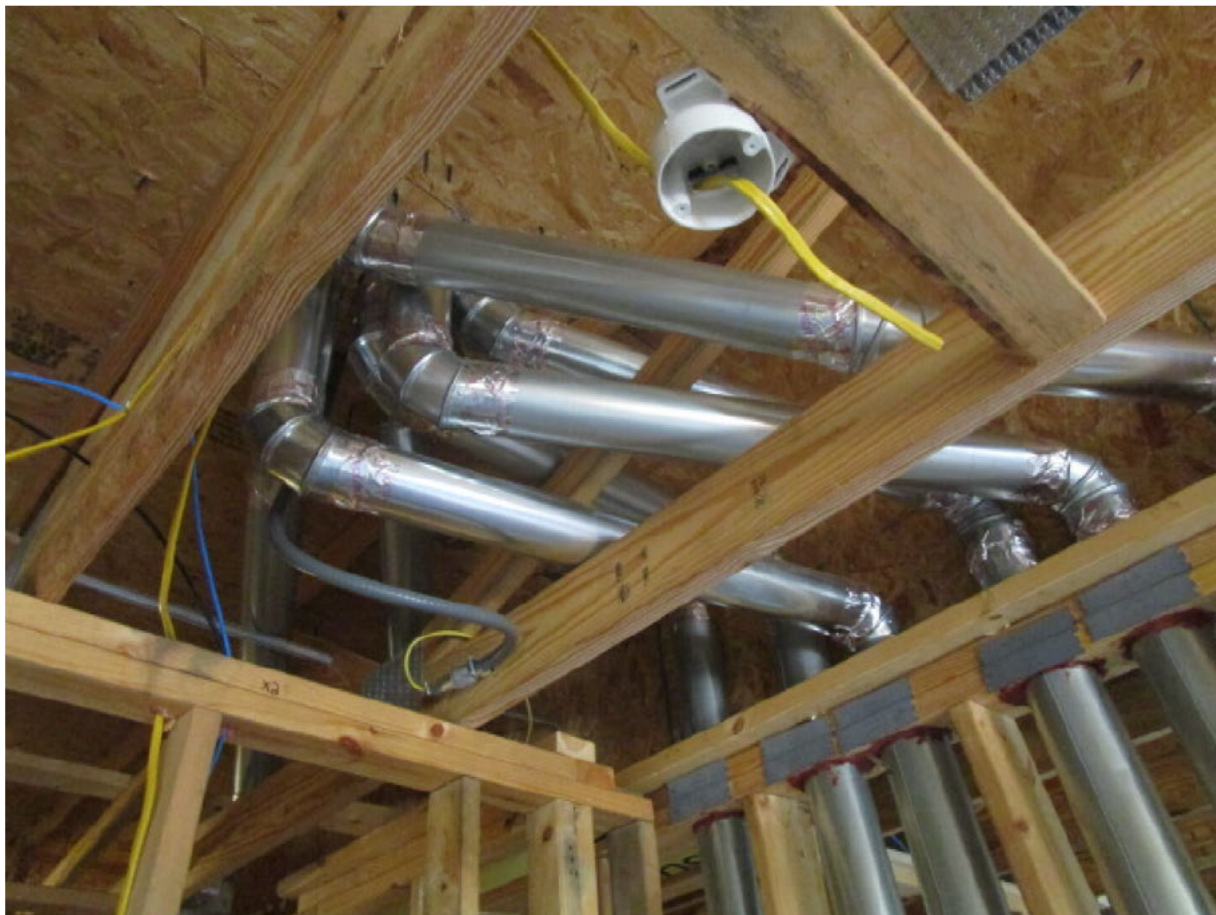
19. Bathroom vent fans and duct work observed.

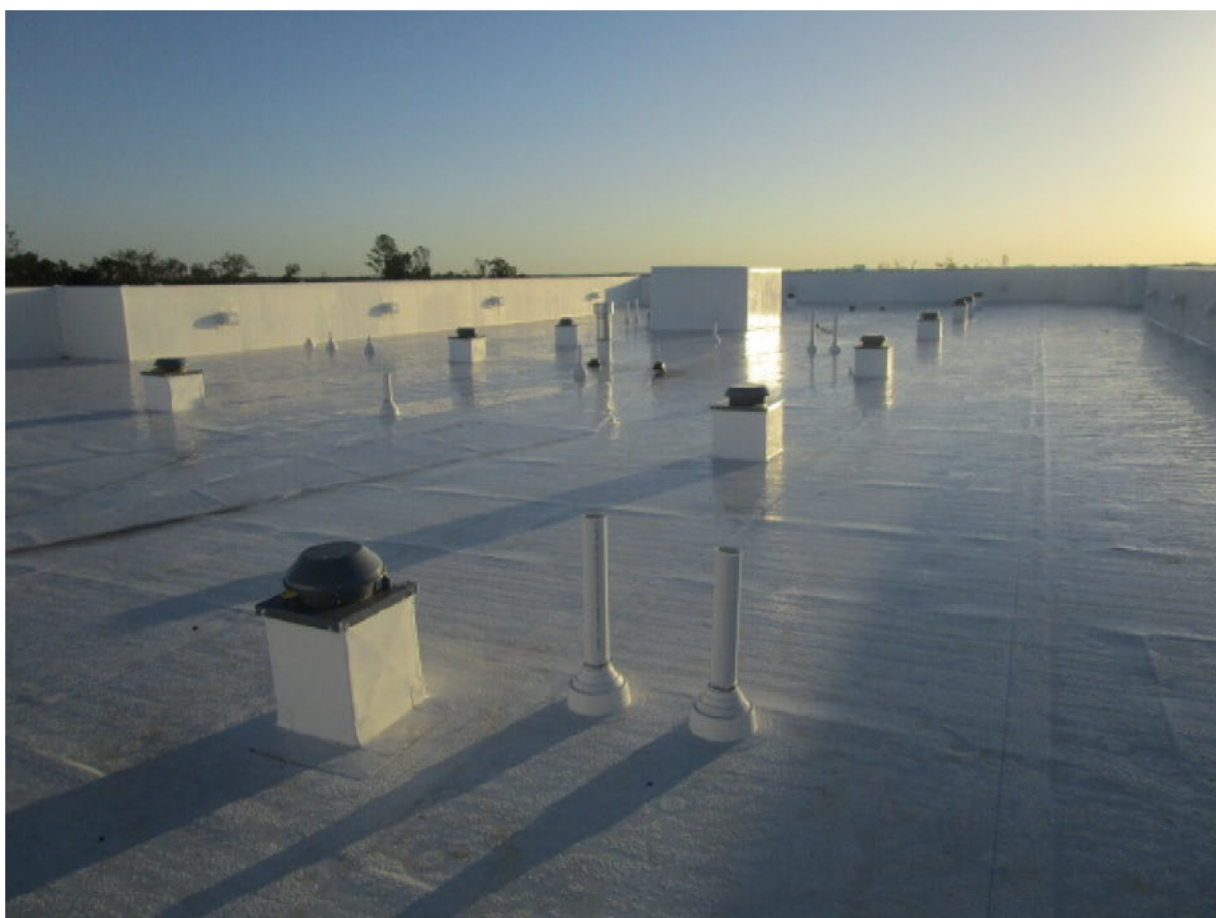
20. Roof level noting ventilation fans installed and parapet wall coping.
