# Restaurant Tenant Building

**XXX Street – Suite 4**  
XXX, XX

**Limited Property Condition Assessment**

Report Date: March 12, 2025

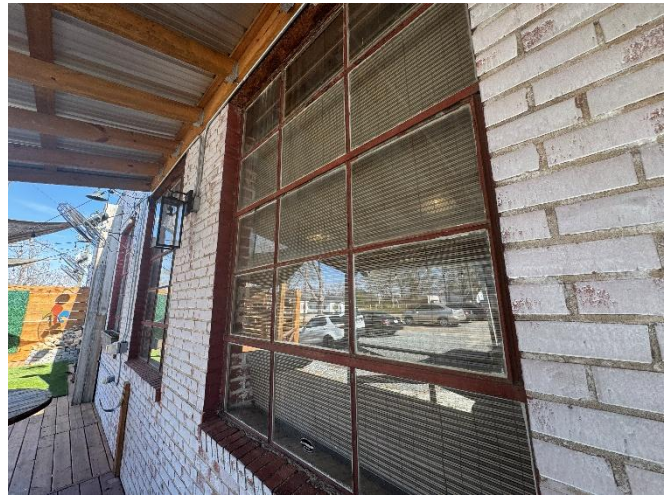
Picture 4: Closeup of the front elevation windows.

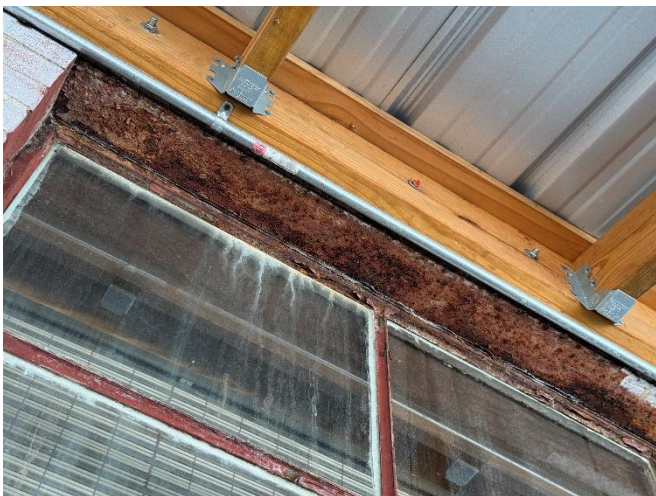
Picture 5: Closeup of rusted window lintels.

- The storefront systems appeared to be in fair to good condition. No visible broken seals were observed; however, we have included pricing with the Exterior Opening allowance to re-caulk the storefront openings.
- The metal windows were in fair to poor condition. Faded paint, exposed metal surfaces, failed caulking, failed window seals, and rusted window lintels were observed. Pricing has been included within the Exterior Opening Allowance to repaint, re-caulk, and reseal the window openings.

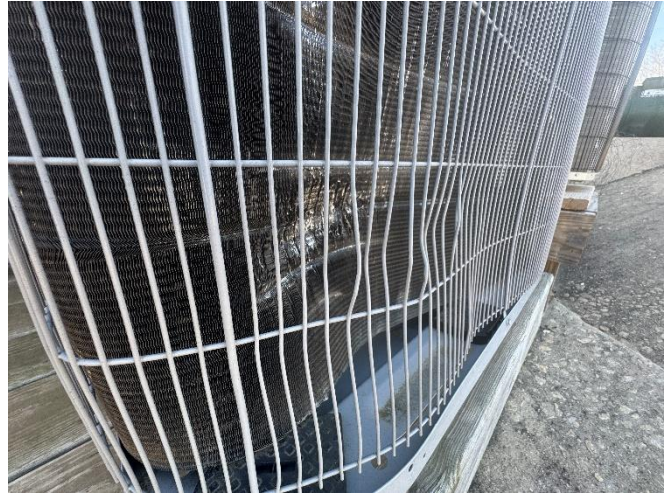
Picture 20: Closeup of minor damage to an exterior condensing unit.

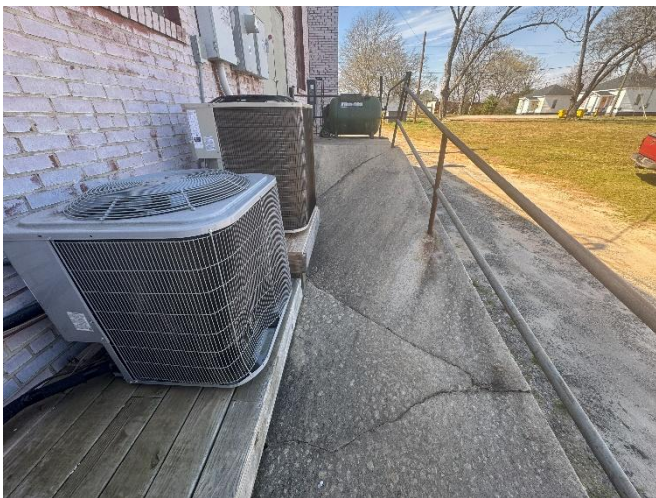
- The wooden porch components appeared to be properly sealed and in good condition. Pricing has not been included for this item.
- The concrete ramp appeared to be in poor condition. Significant surface cracking and settlement issues were observed. Three exterior condensing units are mounted on wooden platforms on top of the concrete ramp. To avoid potential damage to the condensing units and to allow proper access for deliveries, we have included pricing within the Short-Term Repair Section of this report to repair the concrete ramp and to install protective fencing around the condensing units.

Picture 21: View of the surface cracking at the concrete ramp.

| <b>Item</b> | <b>Quantity</b> | <b>Unit</b> | <b>Unit Cost</b> | <b>Budget \$ Immediate</b> | <b>Budget \$ Short Term</b> |
|---|---|---|---|---|---|
| Concrete Ramp Repairs/HVAC enclosure | 1 | EA | \$5,000 | \$0 | \$5,000 |

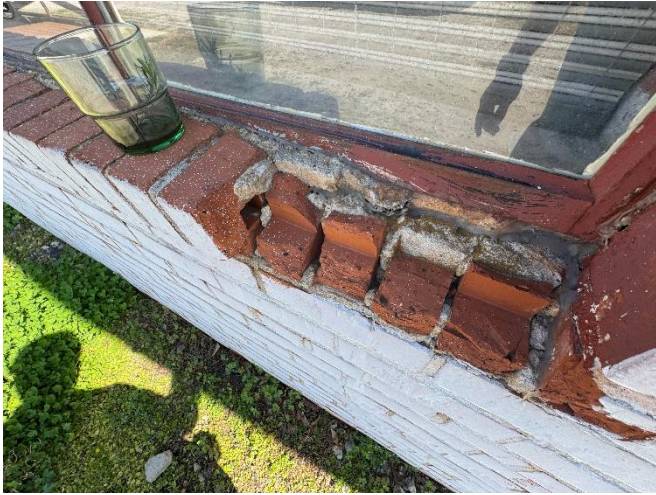
Picture 37: Closeup of minor windowsill damage.

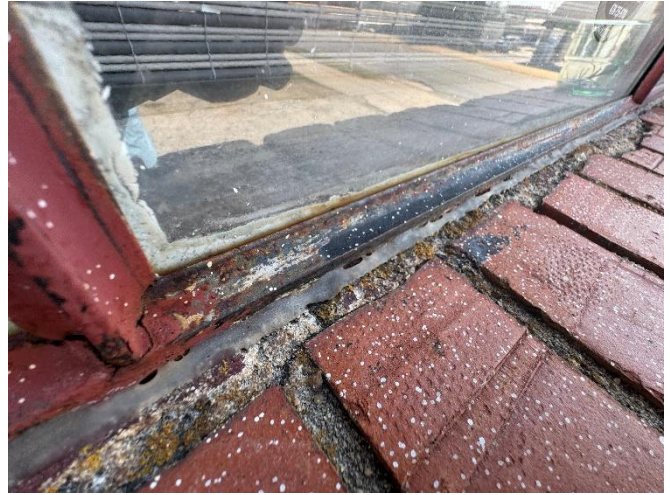
- The hollow metal and steel framed door systems were observed to be in fair condition. Faded paint, exposed metal surfaces, and cracked caulking were observed.
- We have included an Exterior Opening Allowance within the Short-Term Repair Section of this report to re-caulk, reseal, and repaint the hollow metal and steel door systems.

Picture 38: Closeup of failed caulking.

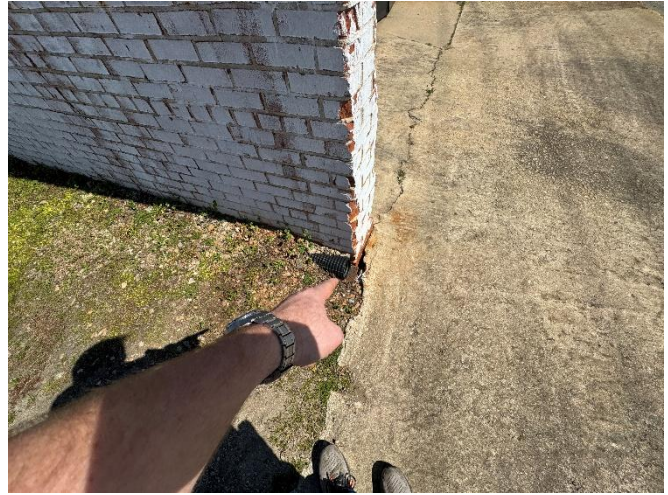
- The roof scupper did not appear to be properly attached to the building. The discharge location of the below grade corrugated piping serving the scupper downspout has caused minor erosion issues between the concrete sidewalk and southwest corner of the building. Pricing for these minor repairs fall below the \$5,000 threshold for inclusion within this report.

Picture 44: Closeup of improper rain leader draining.

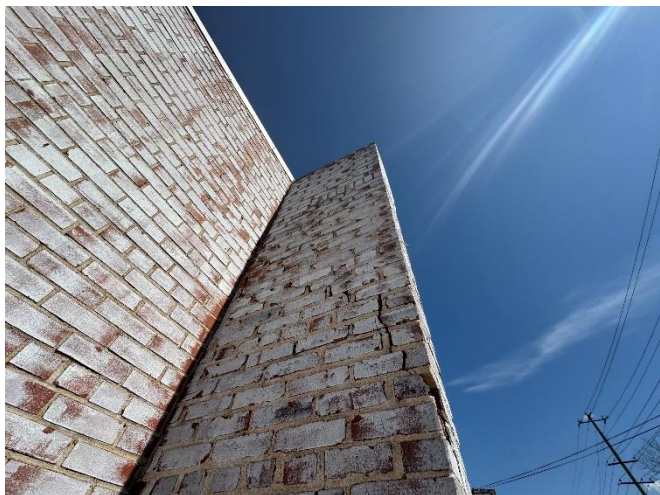
- The exterior brick appeared to be in fair condition. We observed minor brick damage at the south elevation of the building and an area of step cracking within the grout joint at the demising wall between the tenant spaces. We do not anticipate these repairs to exceed the \$5,000 threshold for inclusion within this report.

*Picture 49: Closeup of step cracking at an exterior wing wall.*

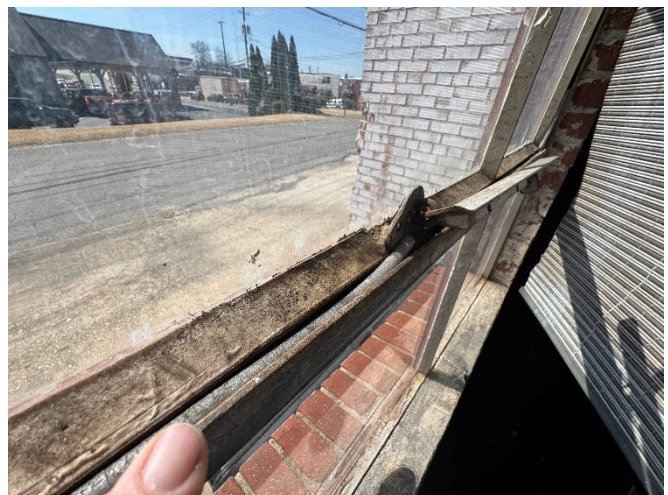
*Picture 56: Closeup of rusting at the side elevation window.*

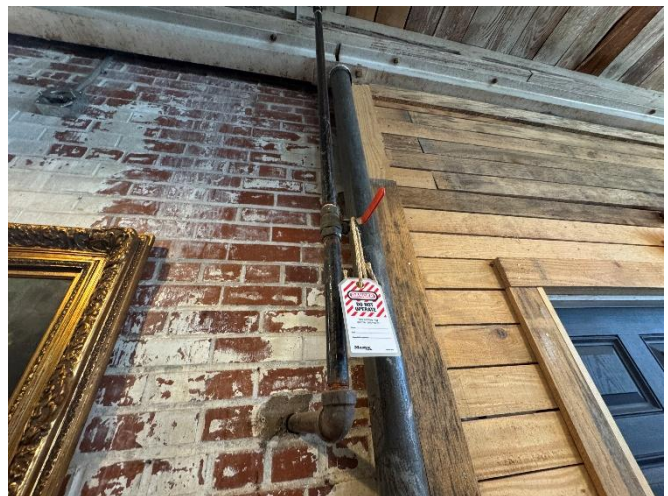
Picture 60: View of a red inspection tag on a fire riser pipe.

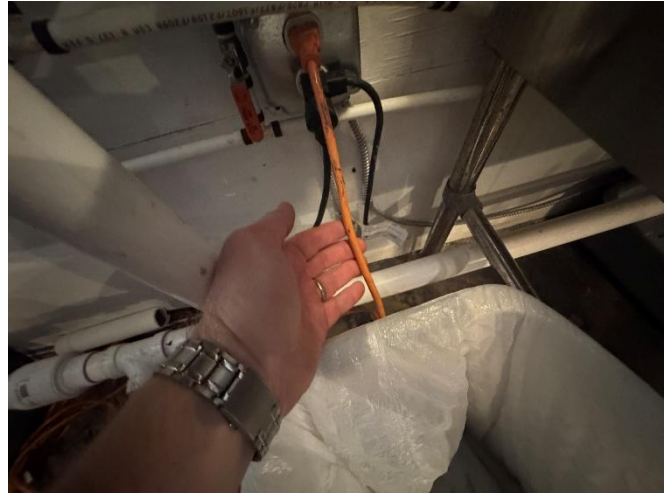
Picture 70: View of a non-GFCI outlet at the bar area.

- The electrical sub panels appeared to be in good condition. We did not observe evidence of any tripped, hot or arcing breakers, missing breaker labels, or outdated panel directories.
- The light fixtures appeared to be in good working order with the exception of a few fixtures needing bulb replacements.
- Based on random testing of outlets, we did not observe any outlets without power or with open ground wiring.
- GFCI protection was noted in the restrooms; however, the electrical outlet located within the bar area is not GFCI protected. This is a building code violation; thus, pricing has been included within the Immediate Repair Section of this report to install a GFCI protected outlet.

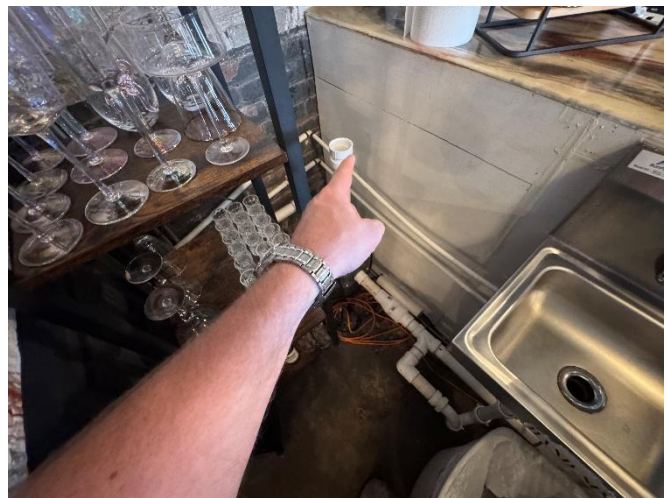
- The drain piping serving the sinks at the bar area is equipped with a drain pump. The drain pump vent piping is not equipped with an air admittance valve (AAV) cover. This is a building code violation; thus, pricing has been included within the Immediate Repair Section of this report to install an AAV.

Picture 72: View of the missing AAV.

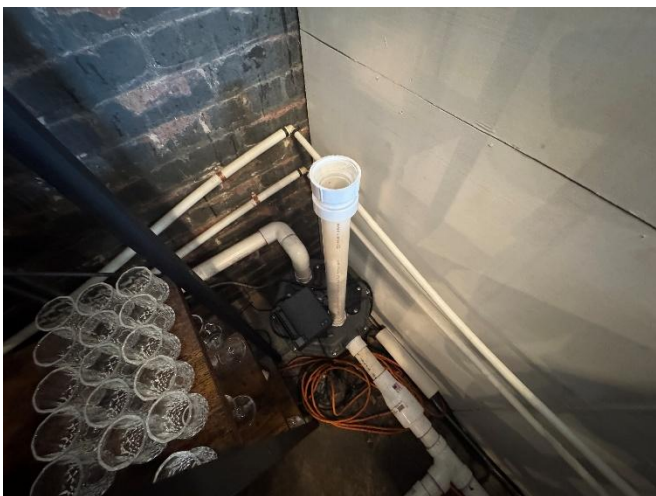
Picture 73: View of the missing AAV.

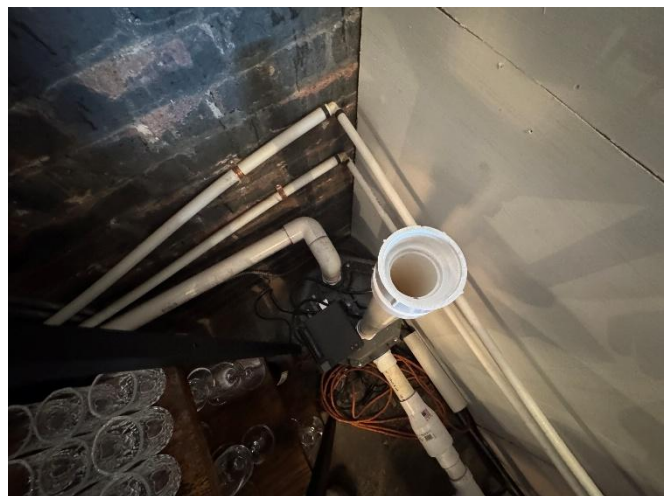
Picture 74: View of the missing AAV.

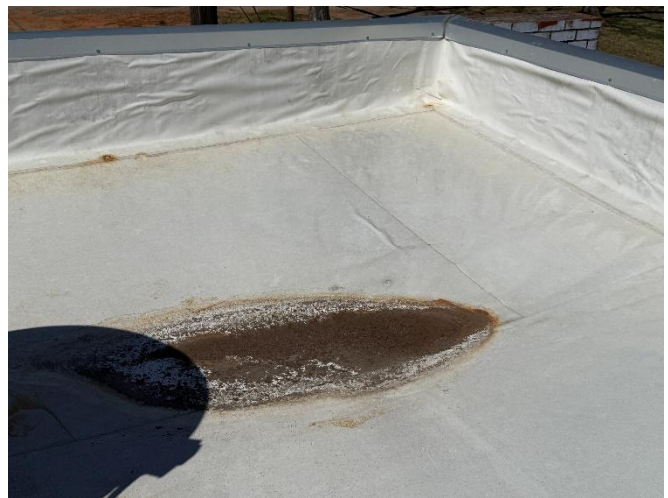
Picture 104: Ponding water area

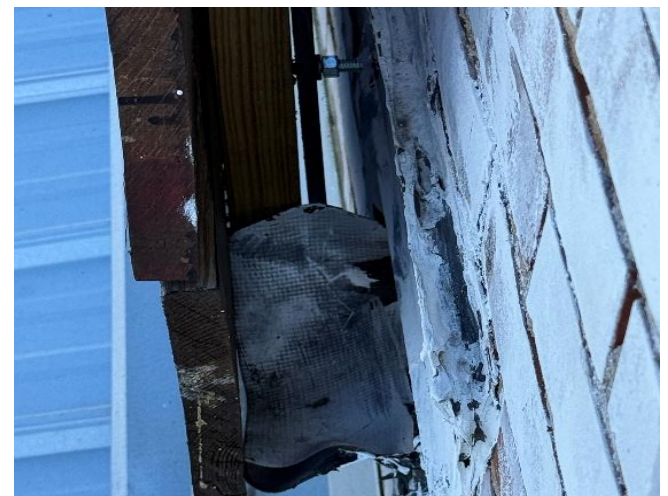
Picture 106: Scupper with impeded water flow
