## XXX Shopping Center

### XXX Crossing

**Abbreviated Property Condition Assessment**

Report Date: May 20, 2025

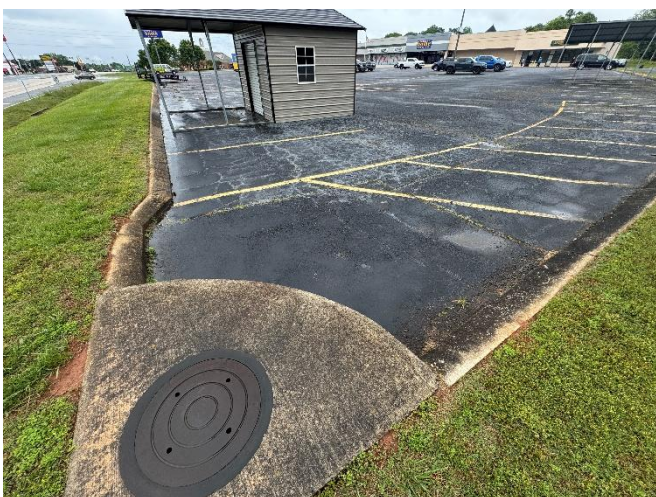
***Recommendations: The asphalt parking and drive area was noted to have significant alligator cracking, yet we did not notice areas of significant subgrade failure which typically results in differential settlement, significant asphalt failures, and potholes. Given the conditions observed, we recommend an asphalt crack sealer and topcoat application throughout the parking and drive area as well as restriping. While no significant structural damage was noted in the parking/drive areas at the time of inspection, leaving the cracks unaddressed will create significant future repair costs. We have included an estimate to remedy these issues in our Immediate Repair Estimates section below.***

*Picture 4: Typical asphalt conditions – cracking observed throughout.*

*Note, the above recommendation is to prolong the life of the existing asphalt pavement, yet a more permanent long-term repair would be to mill and overlay the entire parking lot. This includes removing the top layer of asphalt and installing a new wear layer which will last longer than crack treatment and top coating recommended above. The cost to mill and overlay the estimated 90,000 square feet of asphalt surface would be approximately \$445,500 (90,000 sf X \$4.95/SF).*

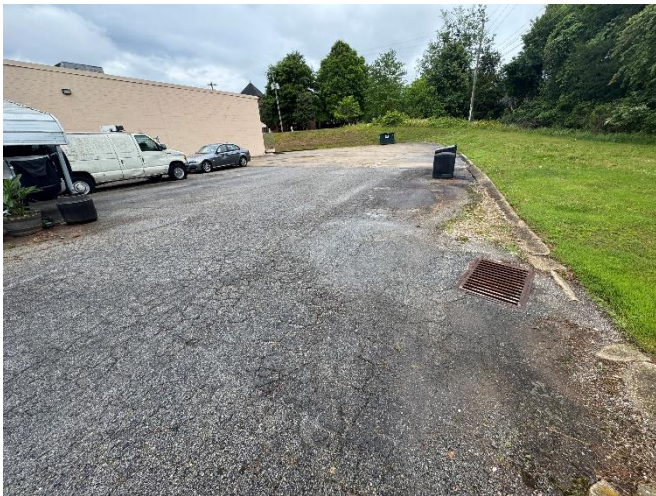
*Picture 8: Asphalt parking area conditions observed.*

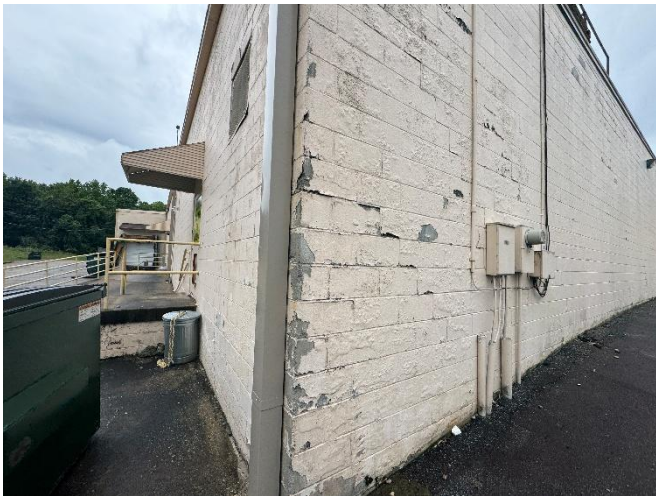
The CMU block exterior wall systems have water damage observed to the paint, which suggests that water has entered the CMU block and water pressure has caused bubbling and cracking/peeling of the exterior paint coating. Some areas of CMU block damage from water are evident as well, and the entirety of the CMU wall surfaces are in need of repair and repainting after the roof and gutter systems are corrected to prevent water damage to the rear CMU wall.

Picture 14: Water damage noted at rear CMU wall.

***Recommendations: Given that active roof leaks were not observed onsite during our site visit, we have not recommended a full roof replacement, as this report is to recommend Immediate Repair Concerns only. We have included a repair allowance to correct water ponding at the rear roof of the building, as well as replacement of gutter and downspouts to properly shed water away from the rear CMU walls and prevent further water damage. Additionally, we have included an allowance to repair and repaint all exterior CMU and EIFS veneer areas based on the conditions observed onsite.***

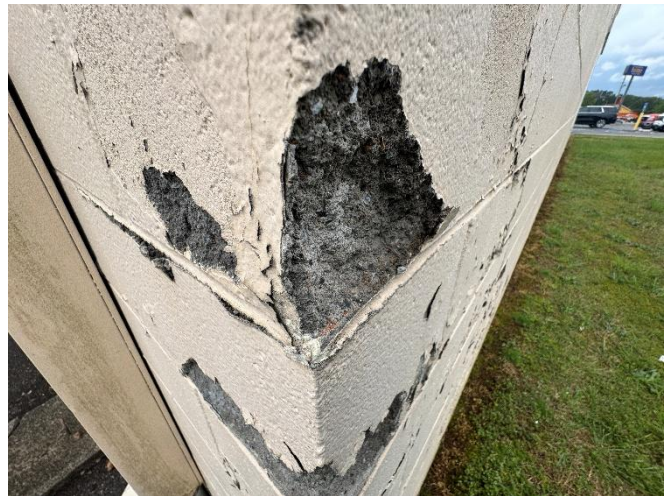
Picture 15: Additional water damage observed at rear CMU wall.

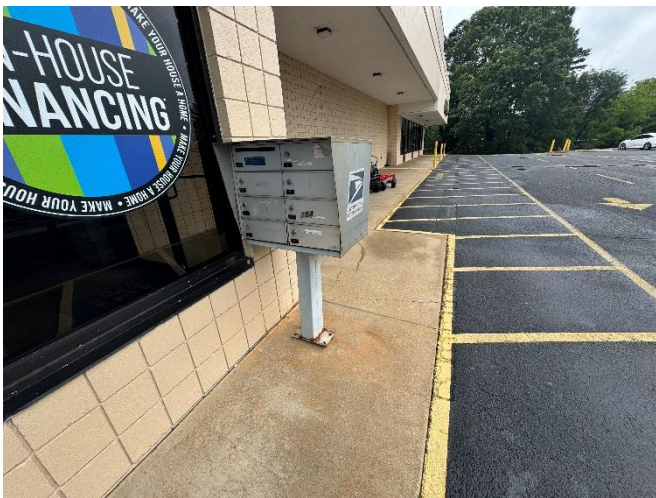
The front EIFS canopy veneer appeared to be in fair condition. Minor repairs and repainting are recommended to coincide with the rear CMU wall repairs and repainting. Aluminum storefront door and window systems, as well as the metal segmented roll-up door at the rear of the building appeared to be functional and in fair to good condition. No immediate repair concerns were noted.

Picture 20: Minor soffit damage noted at front elevation.

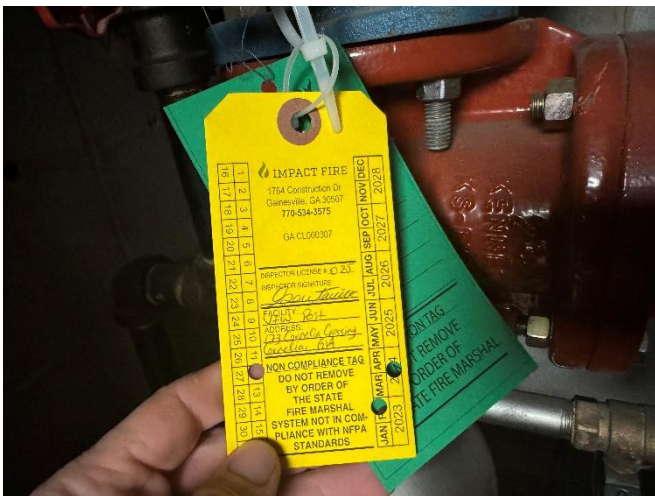
***Fire extinguishers were observed to have current annual inspections in the XXX Furniture space, yet other spaces had expired extinguishers. These are likely tenant responsibilities, yet current annual inspections and fire extinguisher updates should be completed at tenant spaces with expired annual inspections.***

Picture 40: Fire Extinguisher annual service tag – needs inspection.

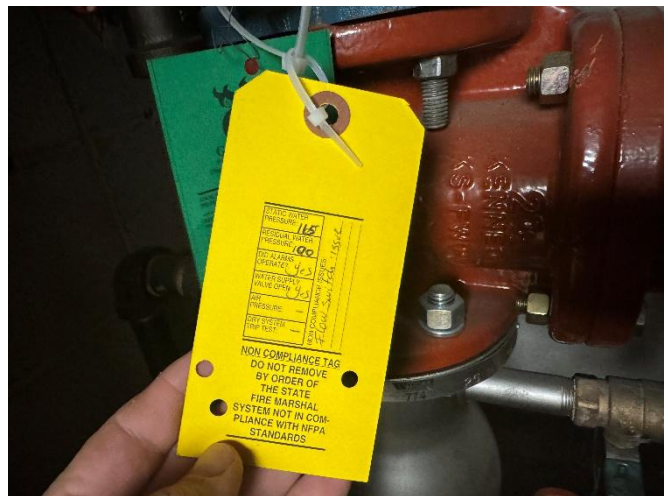
***Recommendations: The fire riser was observed to have a “yellow tag” indicating non-compliance as of the most recent annual inspection that occurred on February 12, 2024. The annual compliance inspection was noted to be non-compliant due to a “flow switch issue” which needs to be corrected. We recommend that a current annual inspection be completed, and any issues be resolved to bring the sprinkler system into compliance with the National Fire Protection Association (NFPA) standards.***

Picture 41: Fire Riser Tag – Non-Compliance “Yellow Tag”.

***We have included an allowance for the current Fire Sprinkler System annual inspection as well as fire extinguisher annual inspections, yet we have not included funds for significant fire sprinkler system updates. Findings of the annual inspection may require additional flow switches or other system updates to become compliant with NFPA standards.***

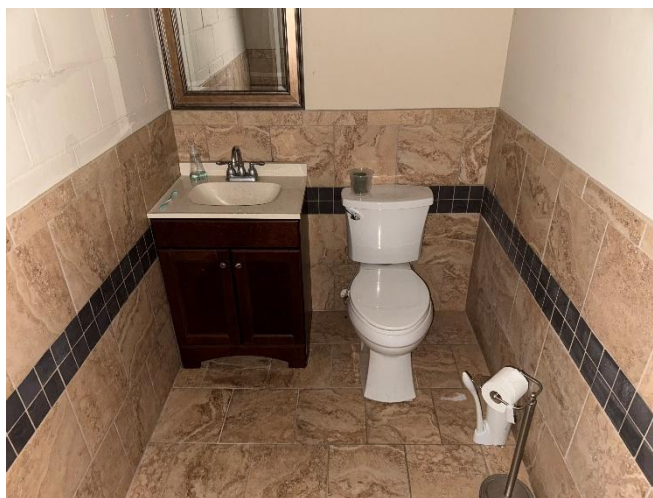
Picture 66: Bathroom at Suite 154 – grab bars needed.

***Recommendations: Based on our observed parking space count (224 spaces), the site needs to have 3 additional ADA spaces added for a total of 7 spaces. For this count, 2 of the ADA spaces need to be Van Accessible, which includes a larger access aisle and proper signage. We have included an allowance to provide 2 additional ADA "Van Accessible" parking spaces, as well as 1 additional standard ADA space for the site, which is required based on the number of observed parking spaces. Additionally, we have included an allowance to add levered door and bath fixtures where not provided at areas of public accommodation to be considered "reasonable accommodations" for ADA accessibility.***
