# Commercial Building

**Full ASTM Property Condition Assessment**

Report Date: March 19, 2025

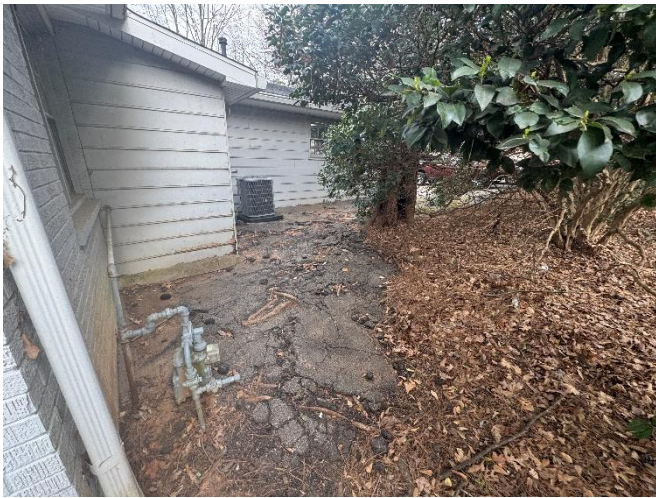
- The asphalt paved parking lot was in poor condition. Several areas of alligator cracking and paving damage were observed throughout the paved surfaces due to root damage and other subsurface issues. The extent of the pavement damage affects the usability and surface drainage capabilities of the surface.
- Pricing has been included within the Short-Term Repair Section of this report to mill & overlay the entire parking lot, which will result in a smooth, new wearing surface of asphalt. We have also included pricing for installing new parking lot striping.
- We have also reflected pricing within the 10-Year Replacement Reserve Table to reseal and re-stripe the parking lot every 5 years.
- The concrete curbing appeared to be in good condition. Pricing has not been included for this item.
- ADA parking issues will be discussed within the ADA Section of this report.

*Picture 15: View of the cracked paving at the northeastern elevation.*

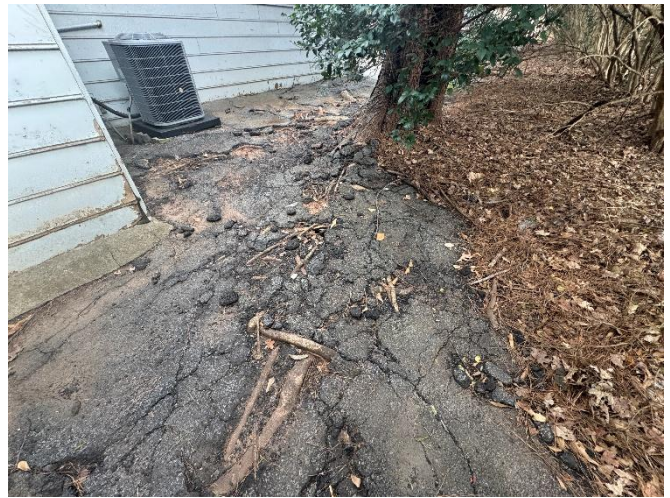
*Picture 16: Closeup of the cracked paving.*

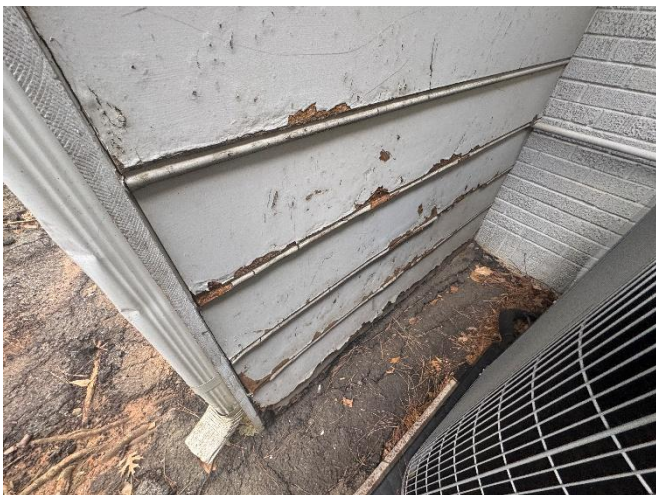
- The lap siding appeared to be in fair to poor condition. Siding damage was observed along the bottom perimeter and in other isolated areas, and faded paint was observed in multiple locations. The siding appears to have moisture damage in multiple locations.

*Picture 17: View of minor siding damage.*

- An Exterior Repair Allowance has been included within the Short-Term Repair section of this report to remove damaged siding and replace with new cementitious lap siding. We have included a general allowance for repairs and not a full replacement, yet we note that full replacement of the exterior siding may be best for uniform appearance and proper waterproofing of the veneer. Upon removal of damaged areas, it may be found that sheathing or framing members have water damage and additional repairs may be necessary.

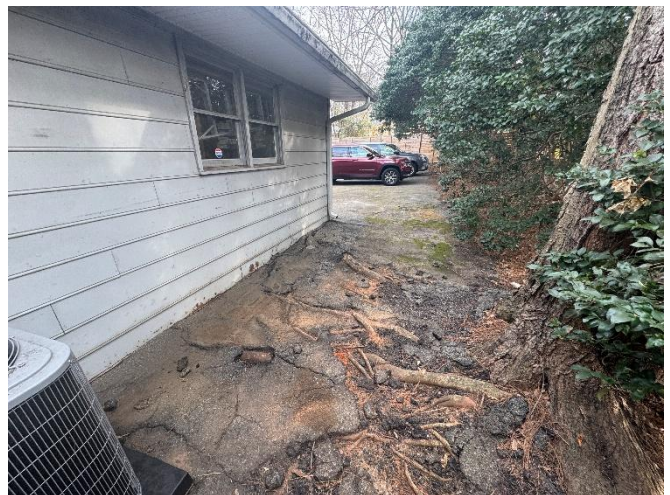
- A hardwood tree is located at the rear of the building near the A/C compressor units. The area between the tree and the building has asphalt pavement which is severely damaged due to tree roots. Removal of the tree is recommended as the roots are approaching the building foundation and future damage to the foundation could occur. An allowance for removal of this tree and additional tree trimming (See Section 3.1.7.2 below) is included in the Short-Term Repair Estimate in Section 4 of this report.
- The landscaping appeared to be in fair condition. Landscaping upgrades are not considered within this report; thus, pricing has not been included for this section.

*Picture 18: View of the damaged paving from tree roots.*

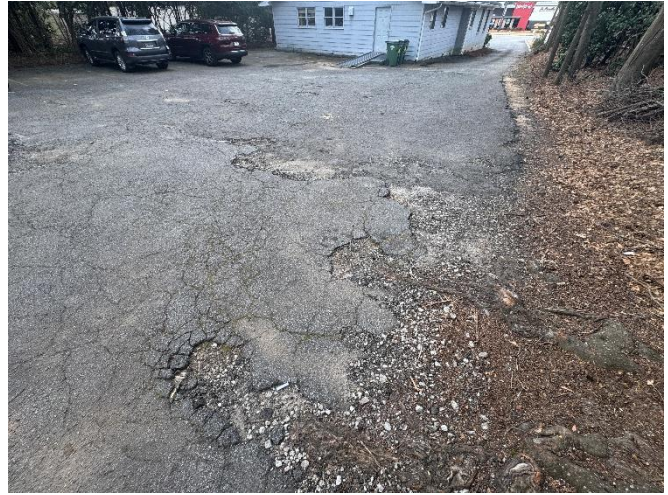
*Picture 26: Closeup of alligator cracking.*

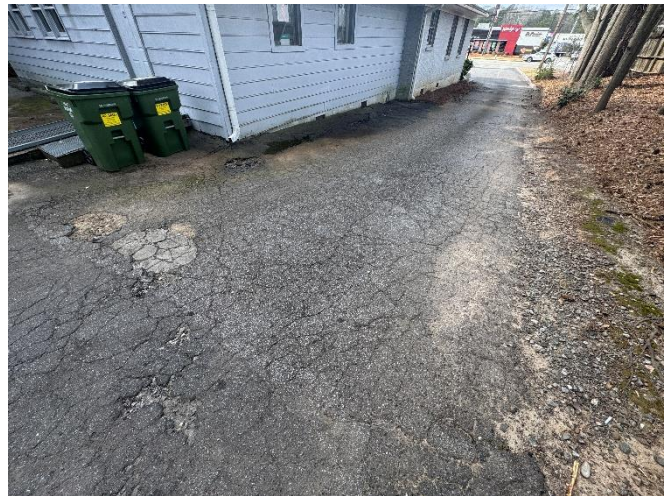
*Picture 28: View of the alligator cracking along the internal drive.*

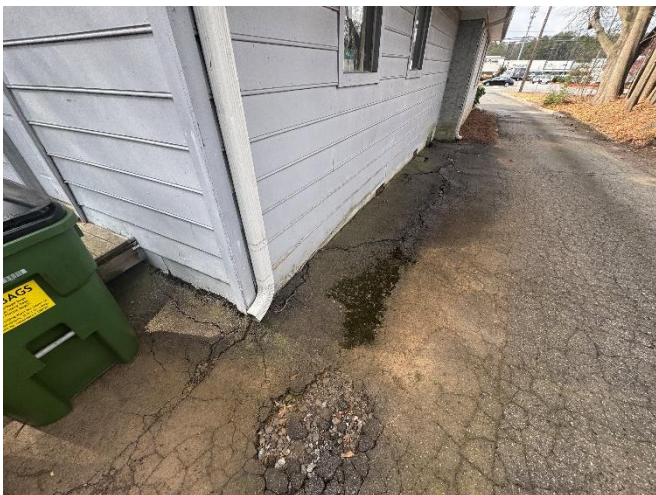
*Picture 29: Closeup of alligator cracking adjacent to the building.*

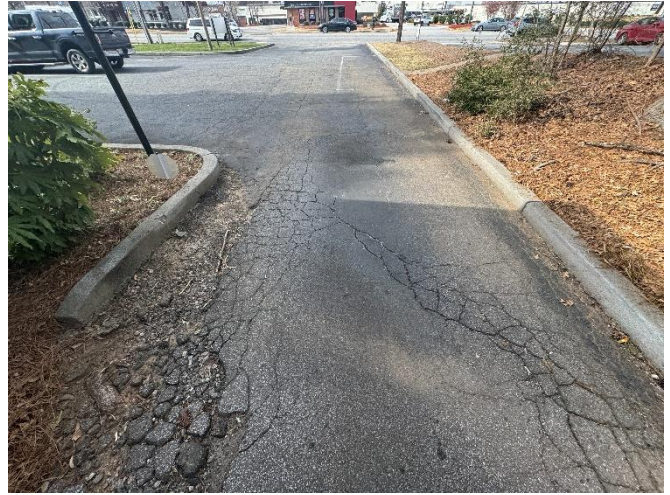
Picture 32: View of the curbing and additional alligator cracking.

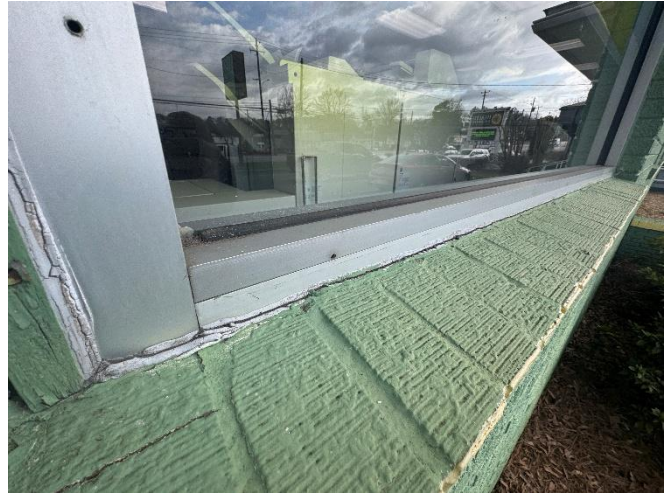
- The wooden window systems at the original building appeared to be in poor condition. Faded paint, exposed wood surfaces, failed caulking, and failed window seals were observed. Pricing has been included within the Short-Term Repair Section of this report to replace all the wood window systems in the original building.
- Repainting, re-caulking, and resealing the window openings located within the building addition and at the front storefront window openings are included in the Exterior Repair Allowance noted in Section 4.

Picture 38: Closeup of cracked window caulking.

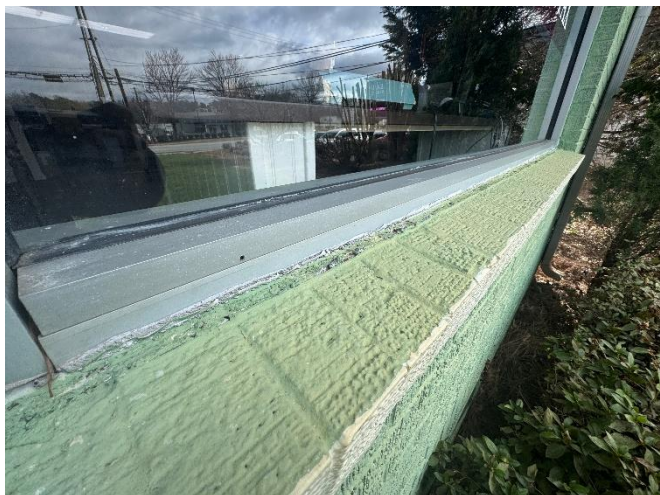
Picture 43: Closeup of cracked window caulking.

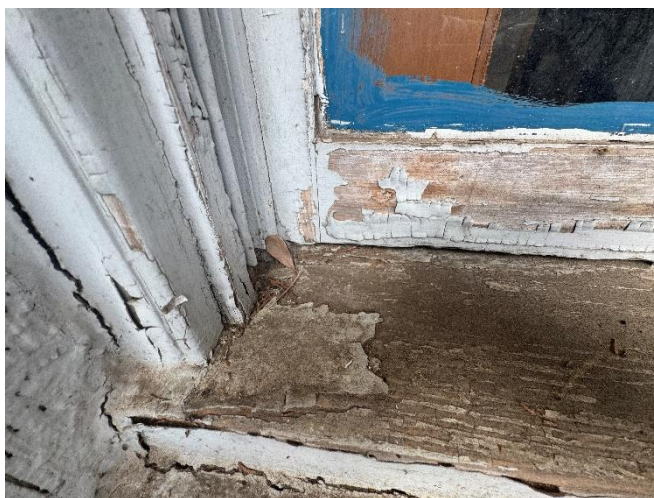
Picture 46: Closeup of window damage.

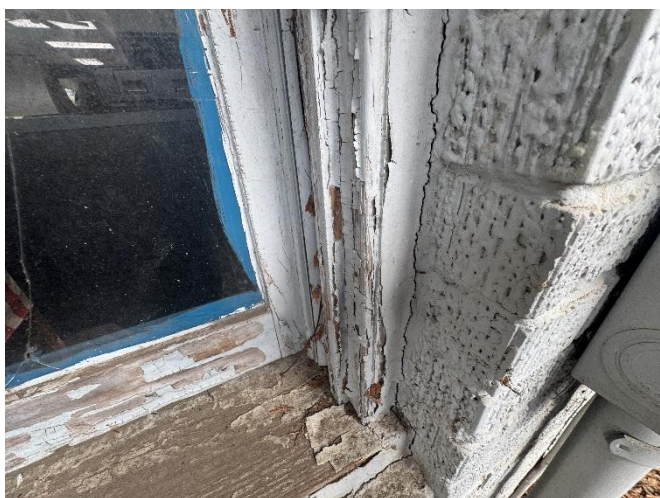
Picture 47: Additional closeup of window damage.

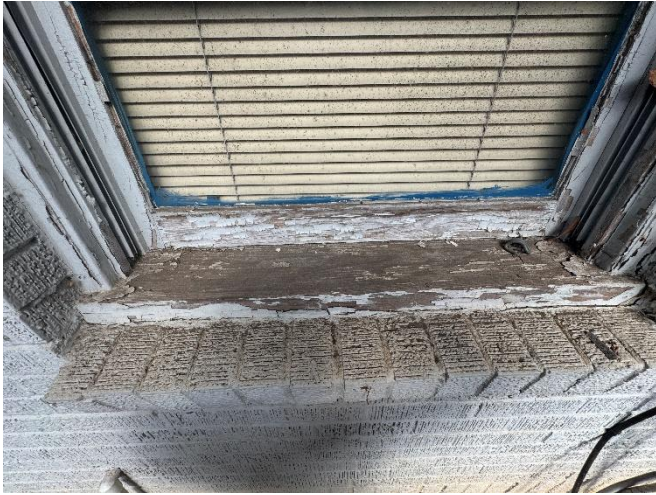
*Picture 49: Closeup of additional window damage.*

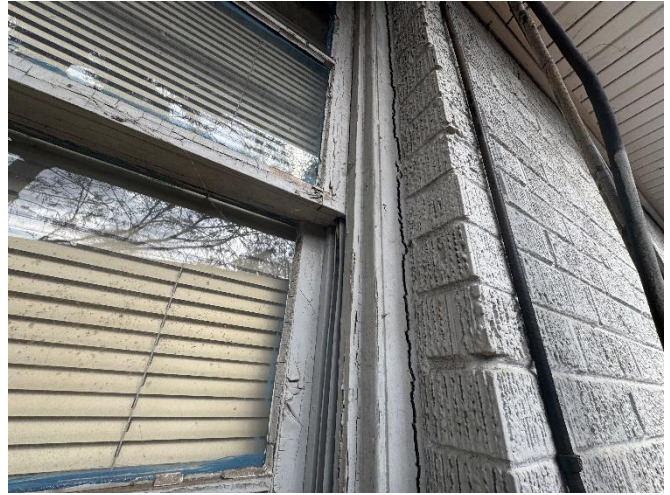
*Picture 50: Closeup of failed caulking.*

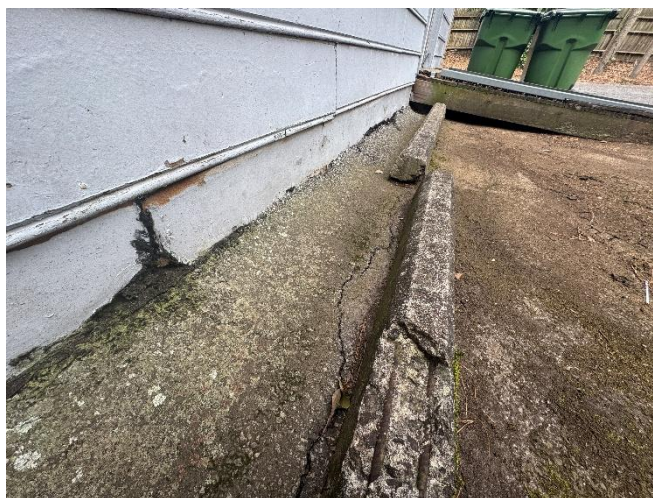
Picture 58: View of minor siding damage.

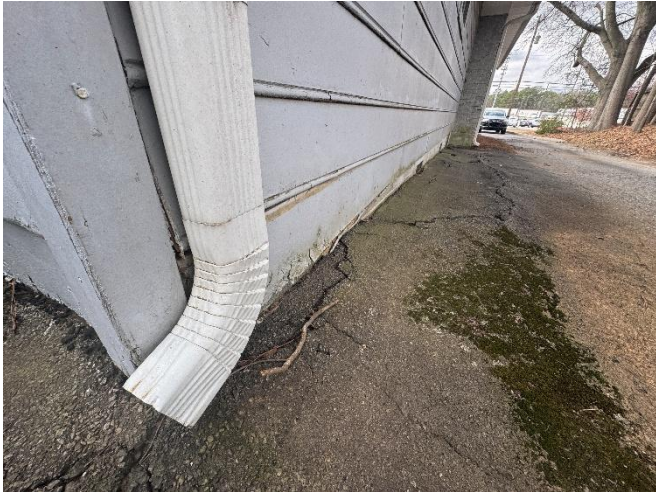
- The stormwater drainage system is in fair condition. The gutter downspouts discharge directly at the base of the building. In some instances, there is minimal to negative slope at the discharge points, and paved surfaces should be modified to allow for positive drainage at least 5 feet away from the base of the building. Pricing to remedy this issue will be discussed within the paving section below as it can be addressed during the recommended pavement repair work.

*Picture 61: Closeup of missing downspout extensions.*

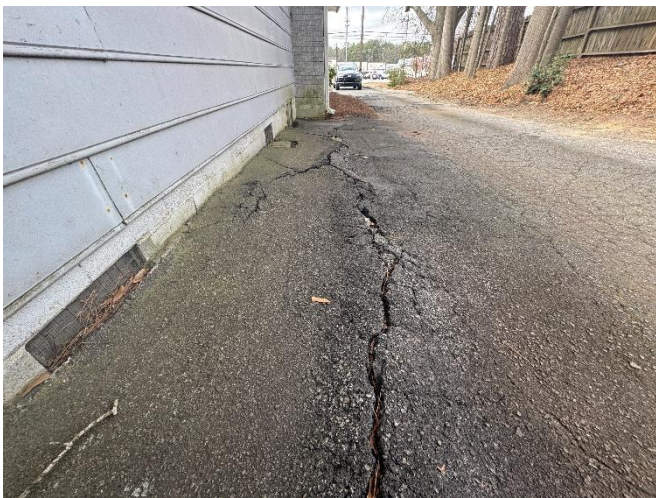
*Picture 63: Closeup of pavement cracking.*

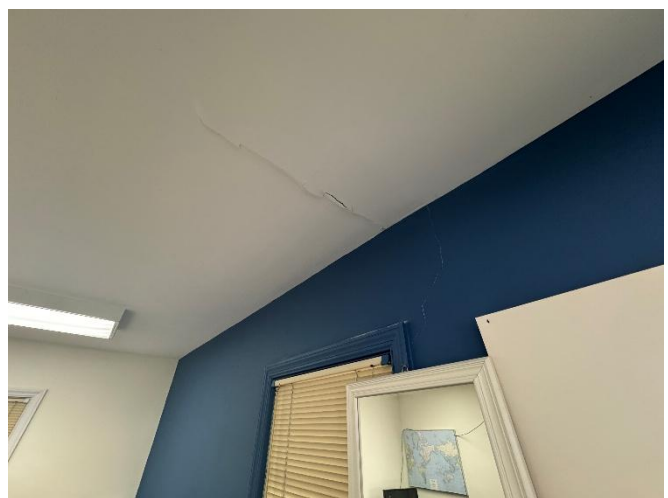
Picture 88: Closeup of ceiling cracking.

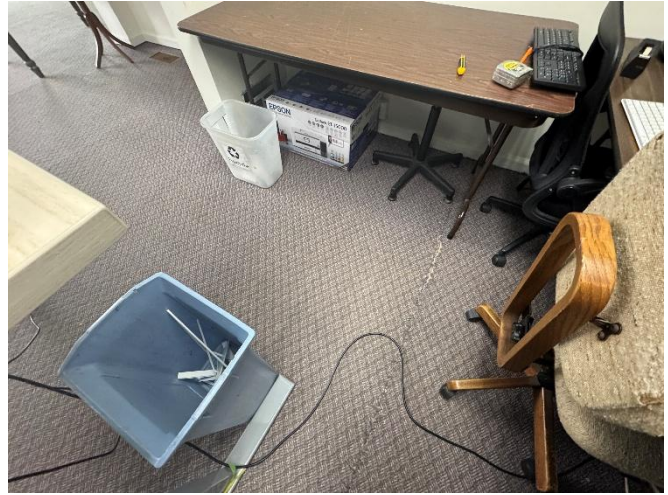
- The interior finishes are outdated and appeared to be in poor to fair condition. We observed several areas of ceiling staining from a presumed pre-existing roof leak. Typical wear and tear damage was observed on the wall coverings throughout the building. We observed several areas of staining and damage to the rolled carpeting. We also observed areas of exposed subflooring where flooring has been removed.

Picture 90: View of damaged carpeting.

- Pricing has been included within the Immediate Repair Section of this report to replace all of the flooring finishes.
- We have included an Interior Repair Allowance within the Short-Term Repair Section of this report for ceiling tile replacements, wallpaper removal, and interior painting of the gypsum board and interior trim.

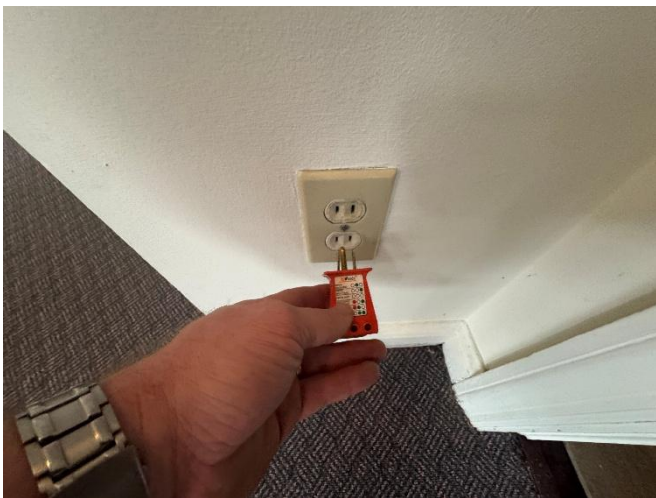
- The electrical system appeared to be in fair to poor condition. We observed original wiring (60+ years old), unshielded commercial wiring, exposed and damaged wiring within the attic space, missing breaker labels and outdated panel directories at the MDP and sub panel.
- The light fixtures appeared to be in good working order with the exception of a few fixtures needing bulb replacements.
- Based on random testing of outlets, we did not observe any outlets without power; however, we did observe several open ground outlets, non-grounding-type receptacles, and the absence of GCFI protection in the bathrooms.
- We have included an Electrical Upgrade/Modernization and Repair Allowance within the Immediate Repair Section of this report for the noted electrical issues mentioned above.

Picture 91: View of a non-grounded outlet.

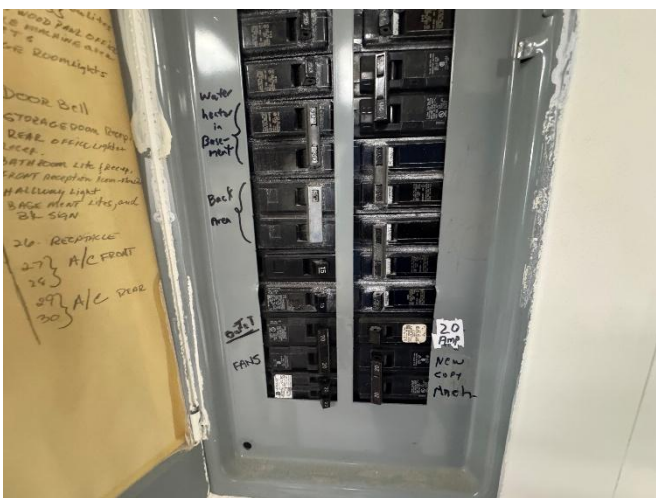
Picture 93: Closeup of the missing breaker labels and outdated panel directory.

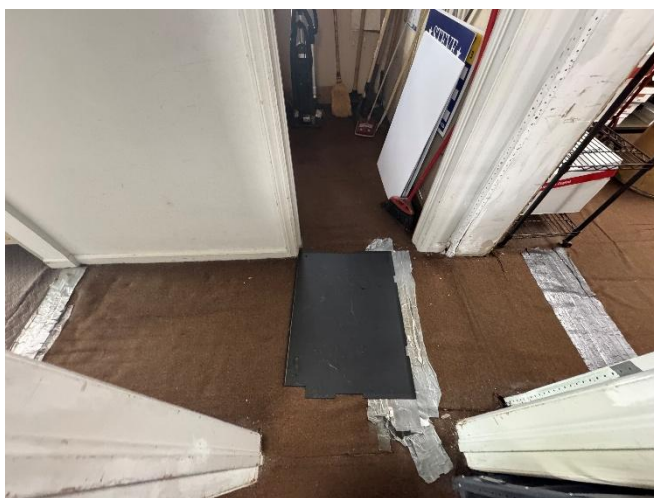
Picture 106: Closeup of damaged carpeting.

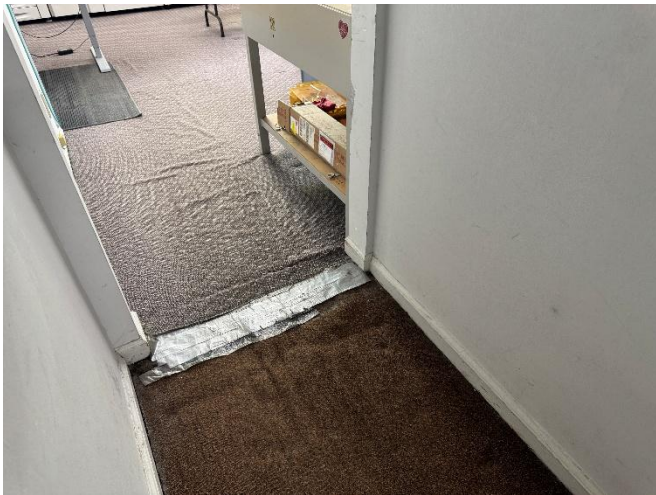
Picture 107: View of a missing threshold.

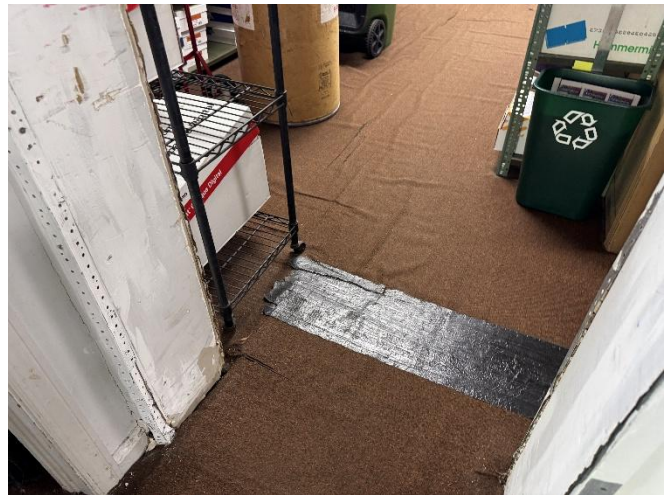
Picture 108: Closeup of damage carpeting.

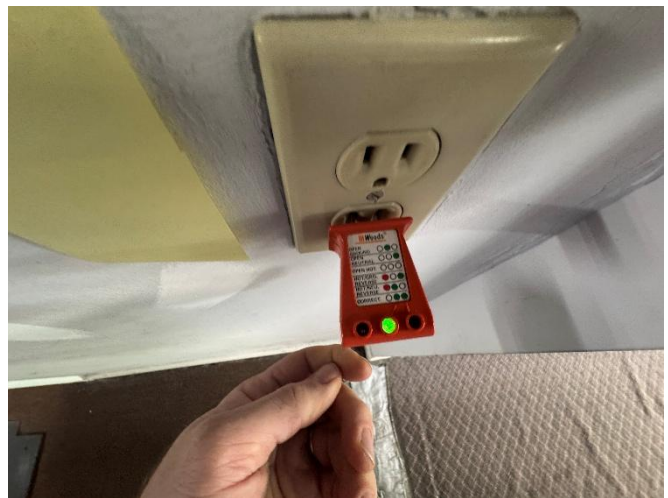
Picture 110: View of an outlet with an open ground.

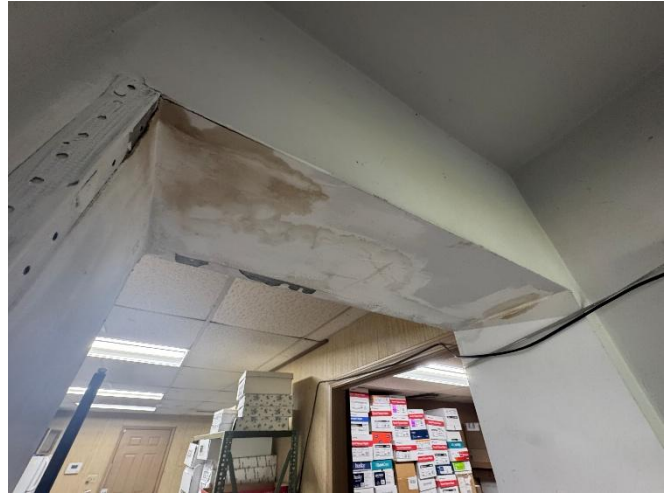
Picture 114: Closeup of drywall damage.

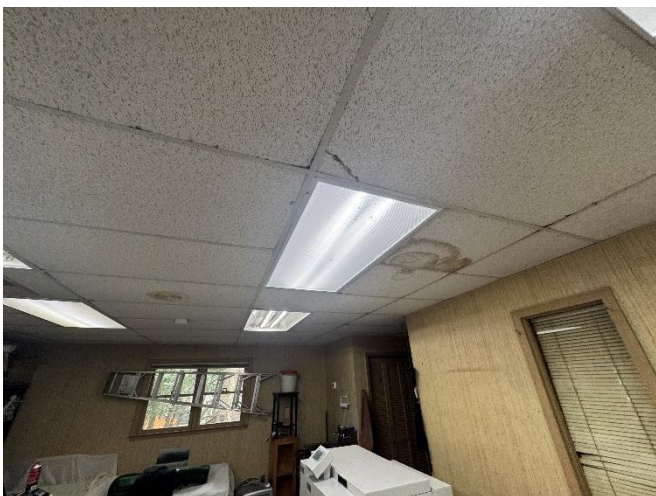
Picture 117: View of stained ceiling tiles.

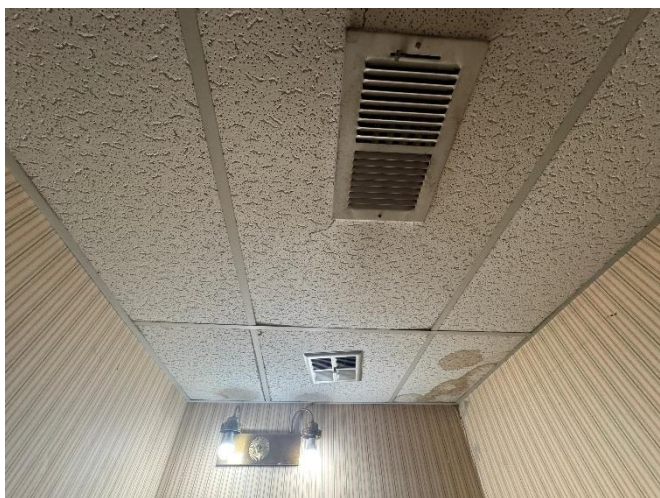
*Picture 121: View of ceiling tile staining at the restroom.*

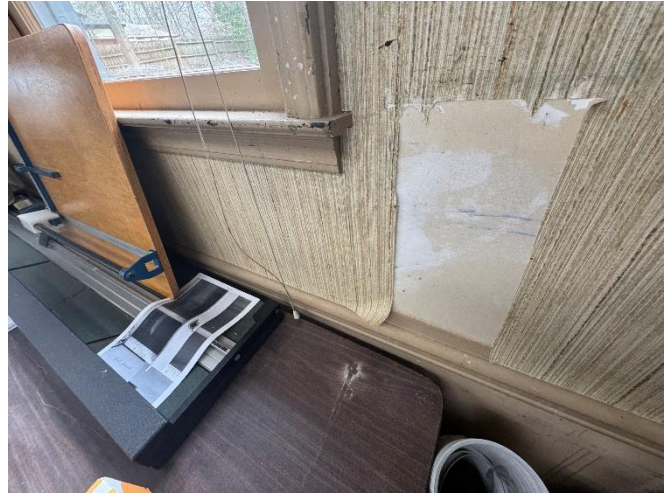
Picture 126: View of wallpaper damage.

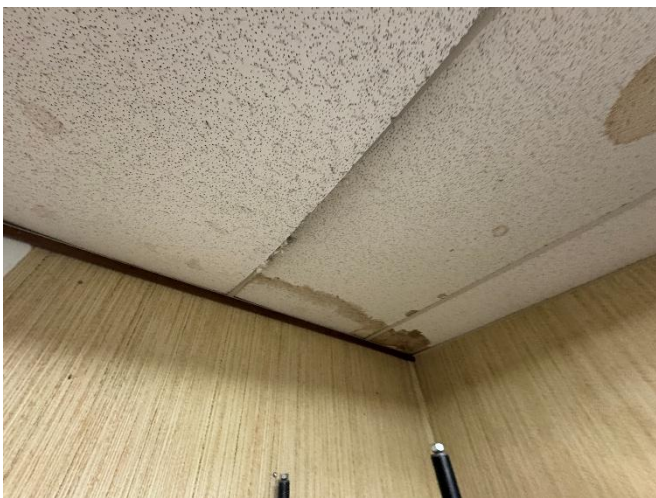
Picture 129: Closeup of additional ceiling tile staining.

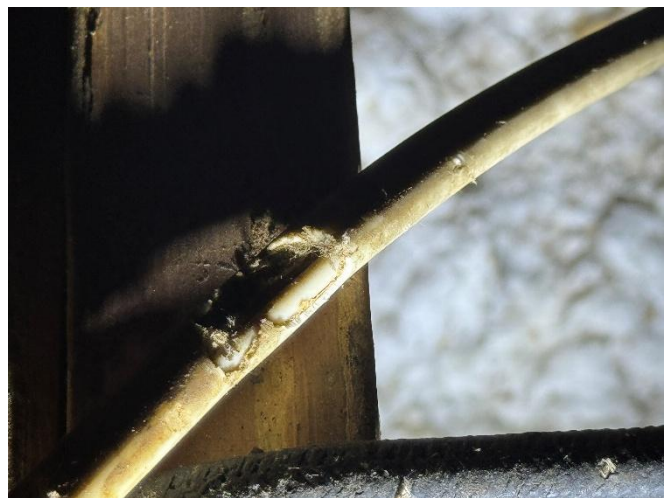
Picture 130: Closeup of damaged electrical wiring.

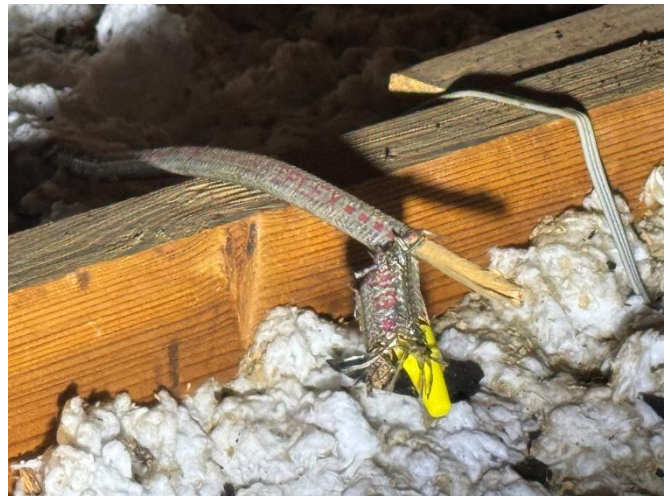
*Picture 134: Closeup of damaged electrical wiring.*
