# Restaurant Tenant Building

**XXX Street – Suite 4**  
XXX, XX

**Limited Property Condition Assessment**

Report Date: March 12, 2025

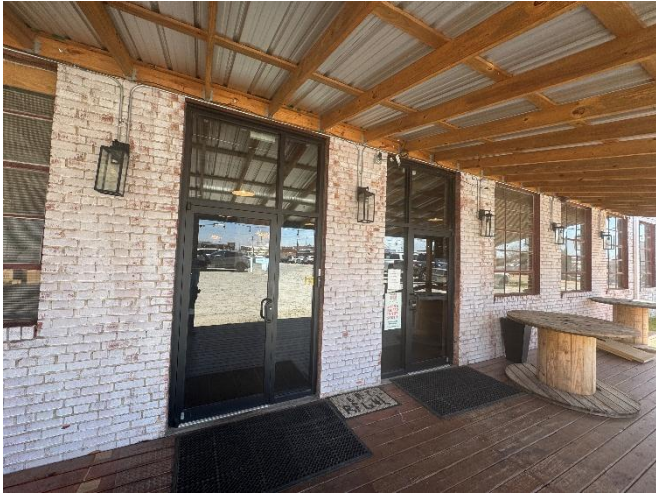
Picture 1: View of the main entry doors.

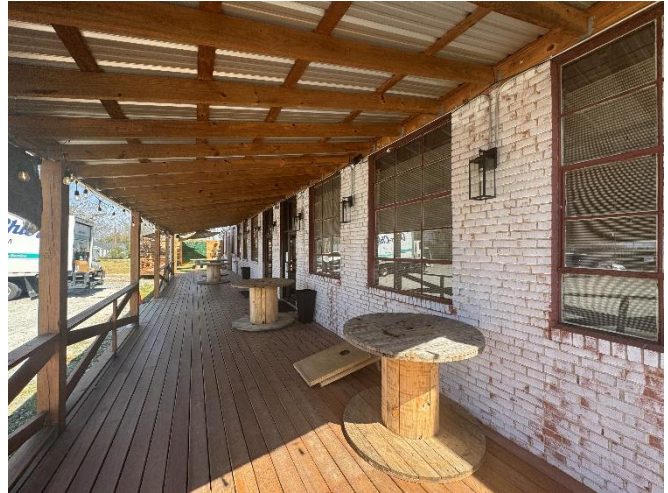
Picture 2: View of the front porch.

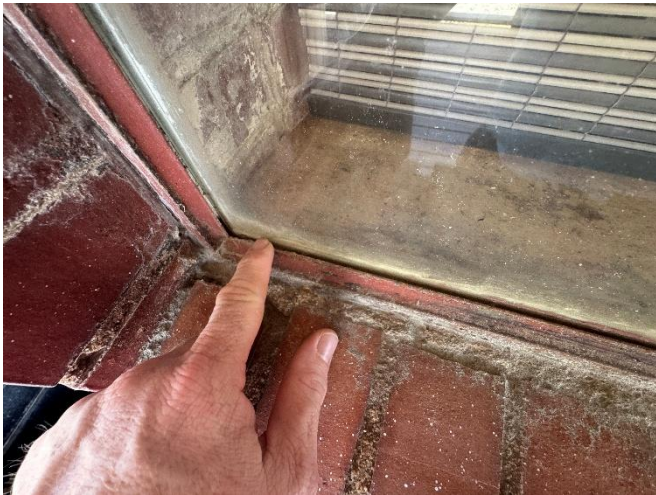
Picture 3: Closeup of window fogging.

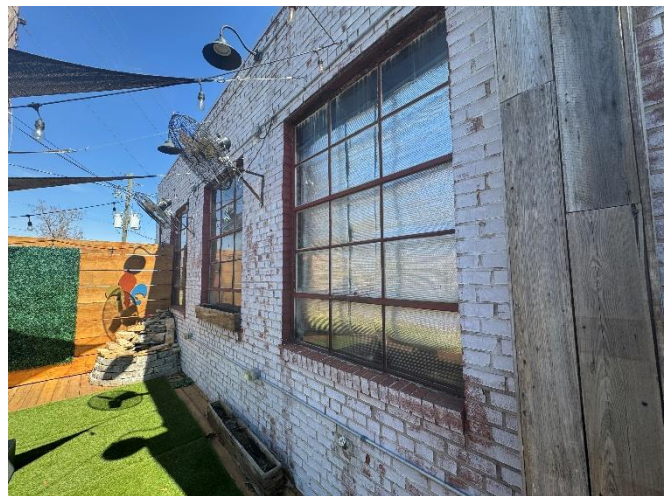
Picture 6: Overview of the front elevation windows.

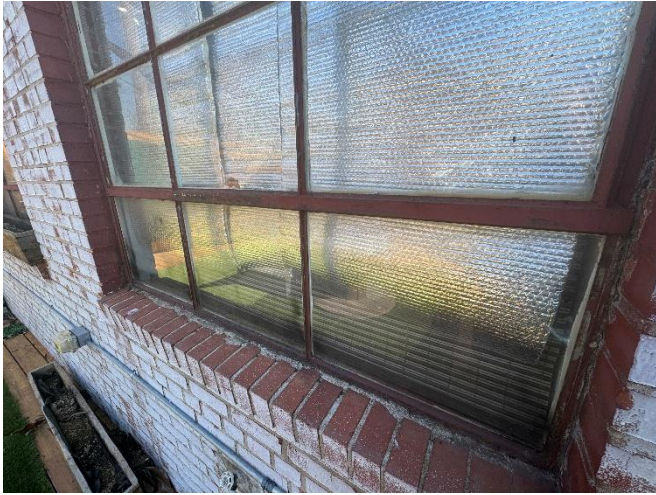
Picture 7: Closeup of a front elevation window.

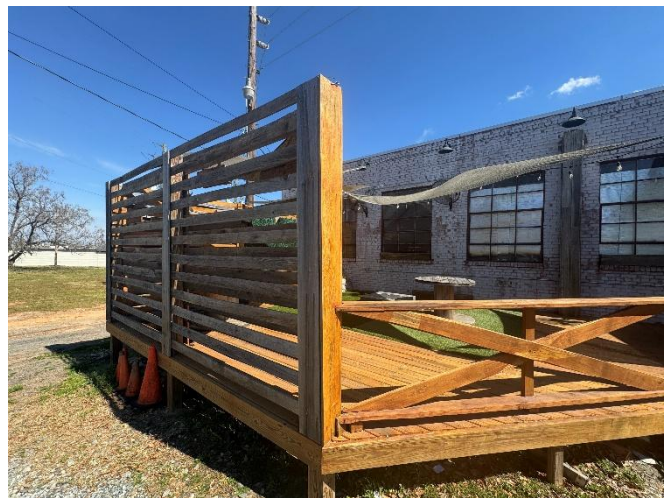
Picture 10: View of the front porch decking.

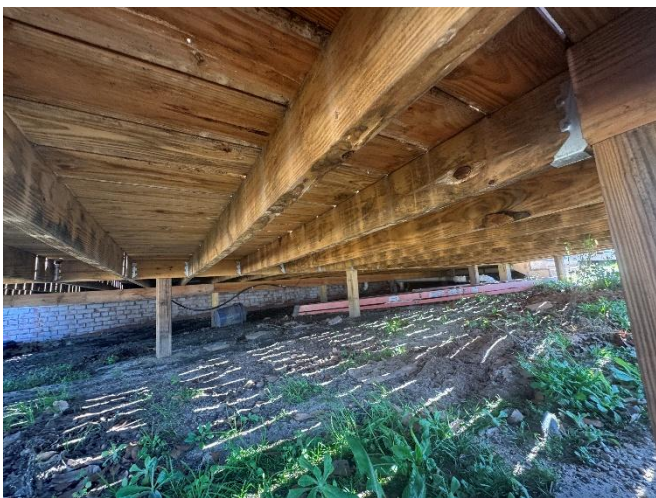
Picture 11: View of the porch decking.

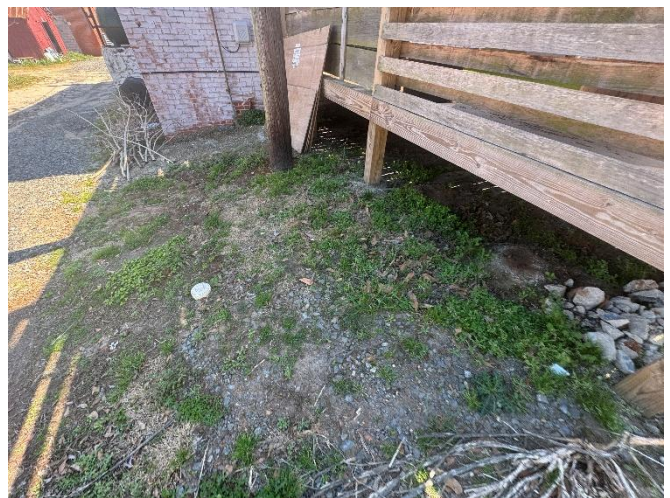
Picture 12: View of a sewer cleanout.

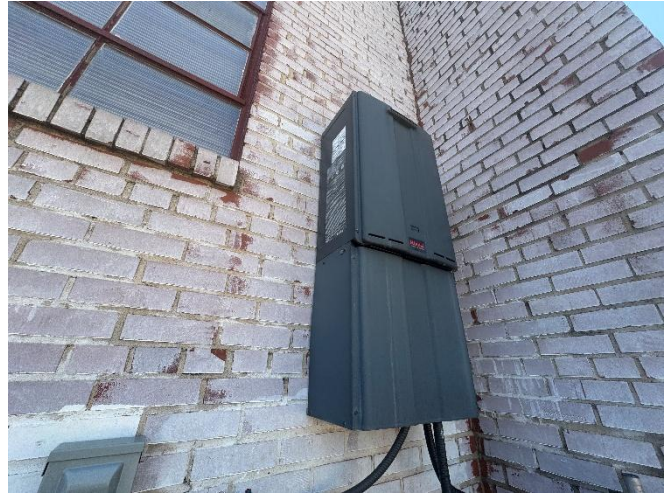
Picture 14: Closeup of a tankless water heater.

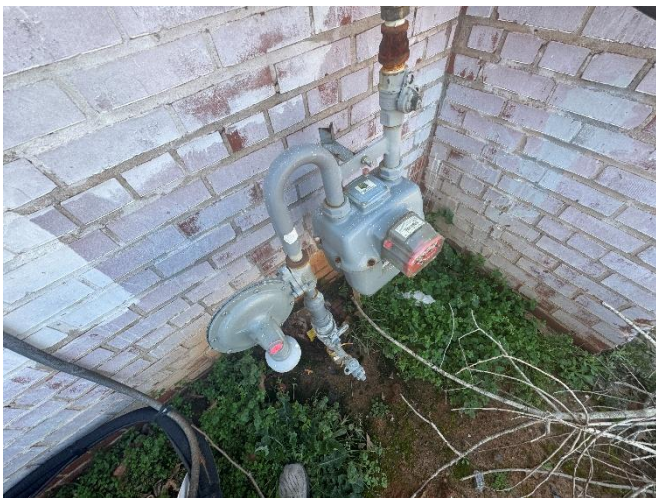
We observed a single meter service and main shut-off valve located at the north elevation of the building.

Picture 15: View of the gas meter.

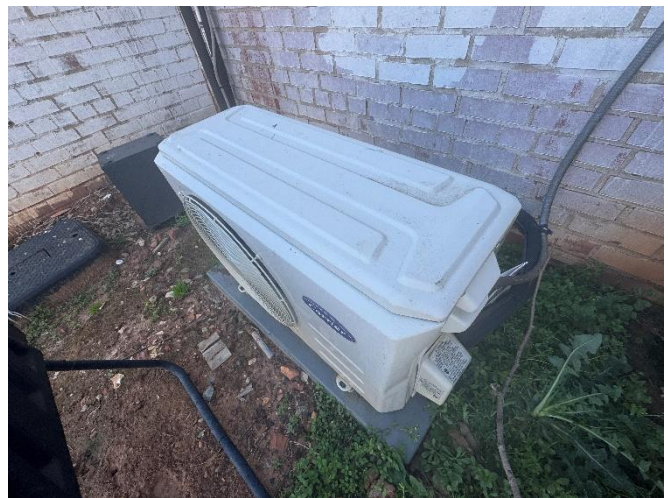
Picture 16: View of a heat pump.

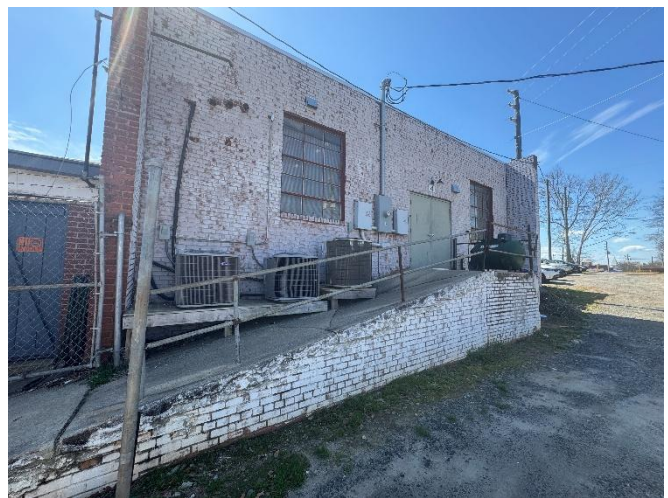
Picture 18: View of the concrete ramp at the north elevation.

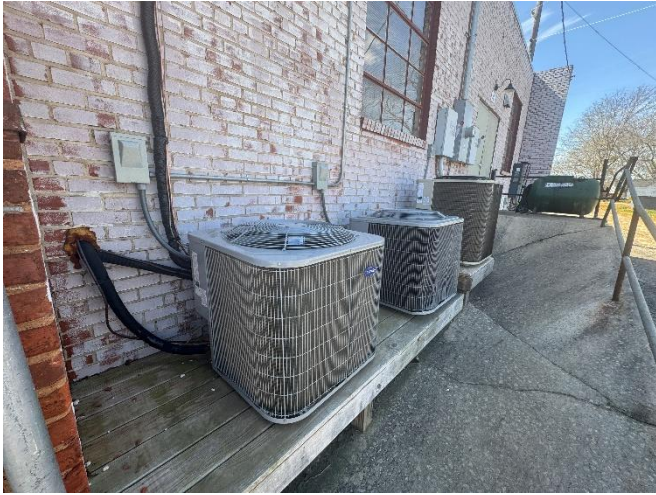
Picture 19: View of the exterior condensing units.

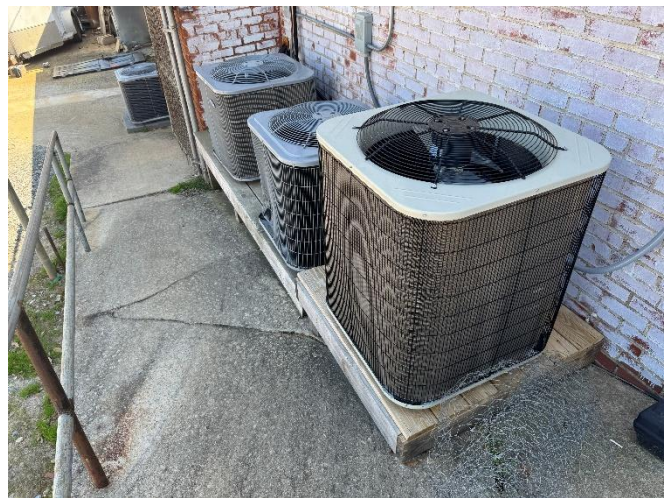
Picture 22: View of the wooden platforms serving the condensing units.

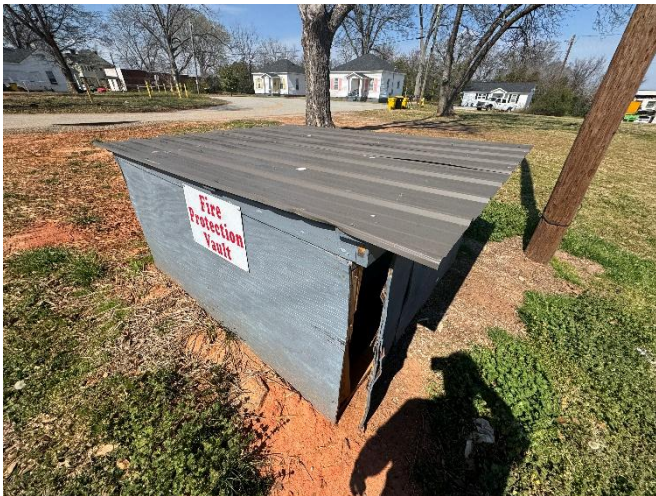
Picture 27: View of the fire protection vault.

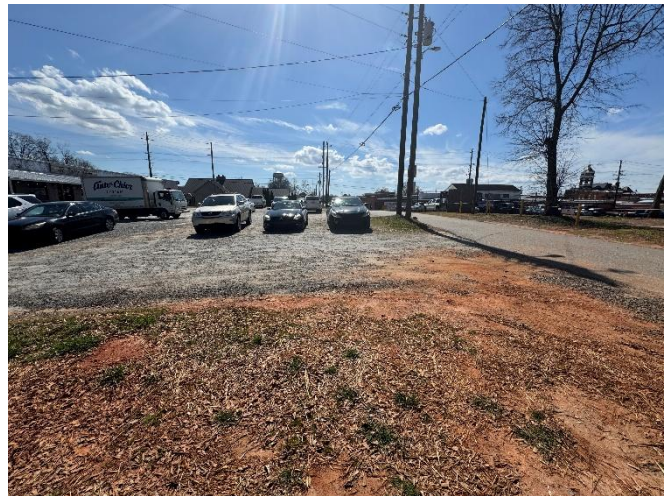
Picture 28: View of the gravelled parking areas.

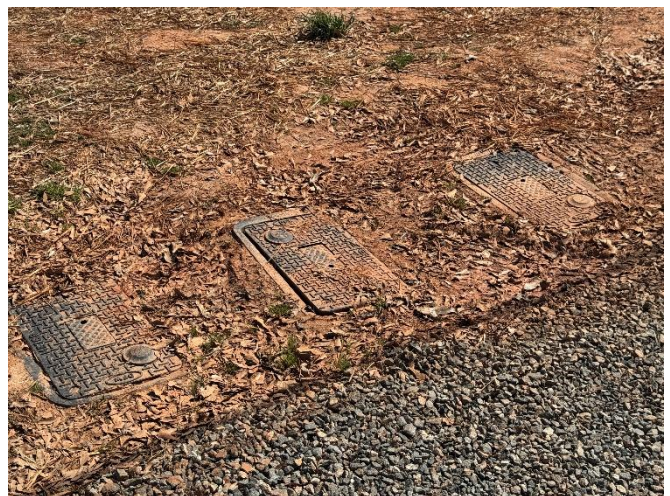
Picture 30: View of 3 water meters serving the building.

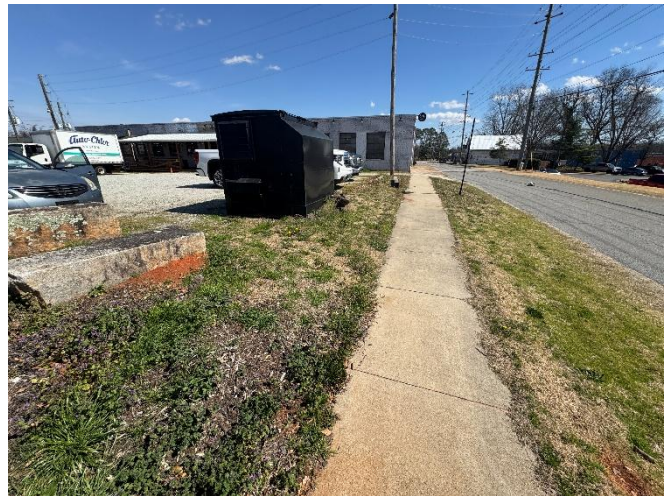
*Picture 34: View of the concrete sidewalks along XXX Street.*

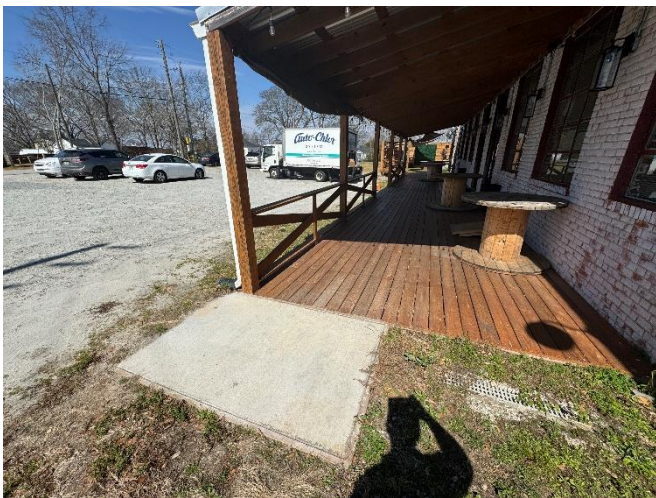
Picture 39: View of a concrete pad serving the porch.

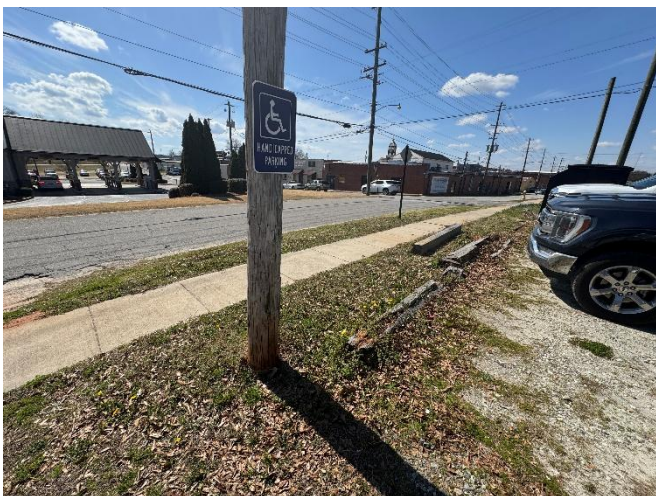
Picture 41: View of an ADA parking spot.

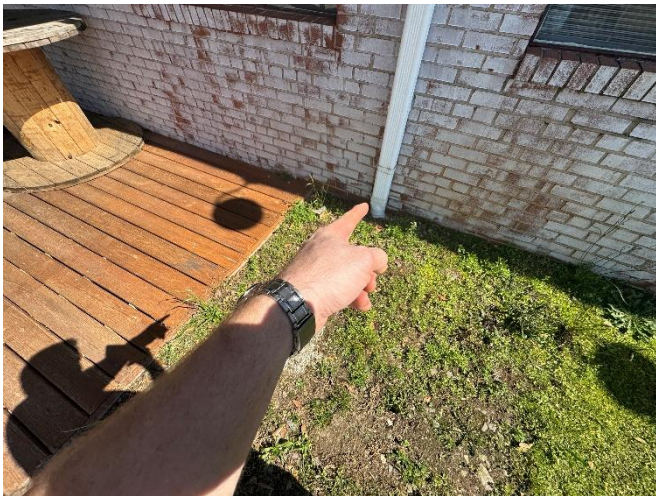
Picture 45: View of a downspout serving the below grade drainage piping.

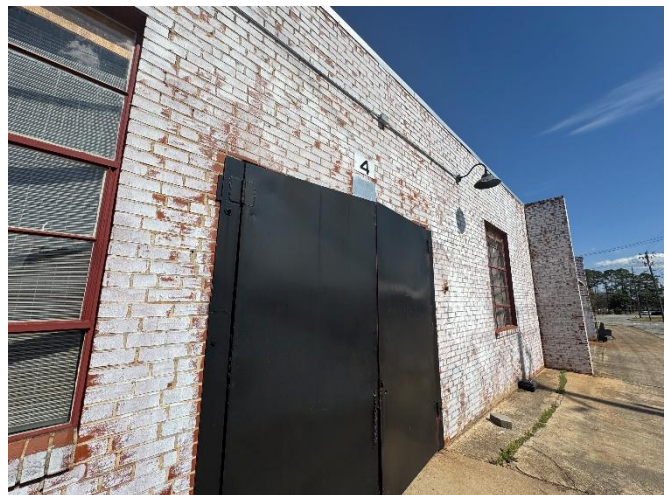
Picture 48: View of a steel egress door.

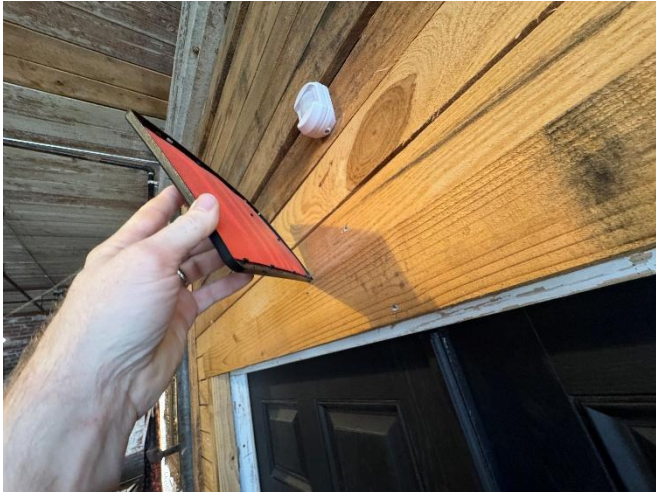
Picture 57: View of a non-illuminated exit sign.

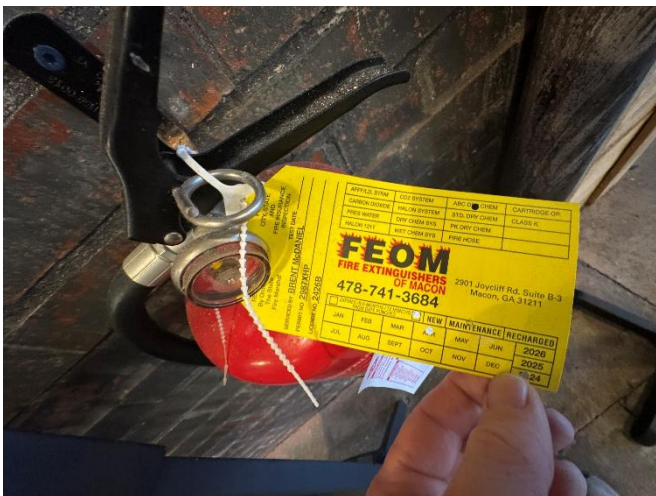
Picture 59: Closeup of a valid fire extinguisher inspection tag.

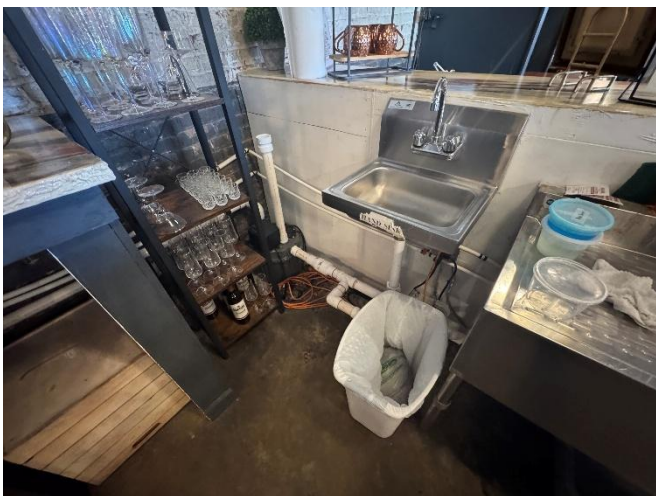
Picture 67: View of the drain pump serving the bar area.

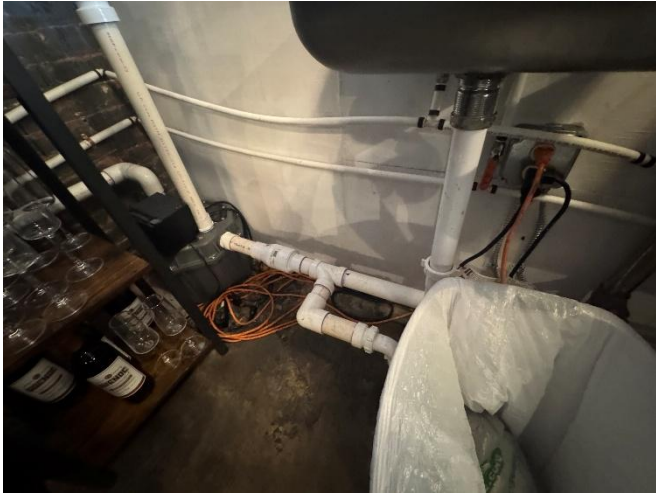
Picture 69: Closeup of the drain pump and piping.

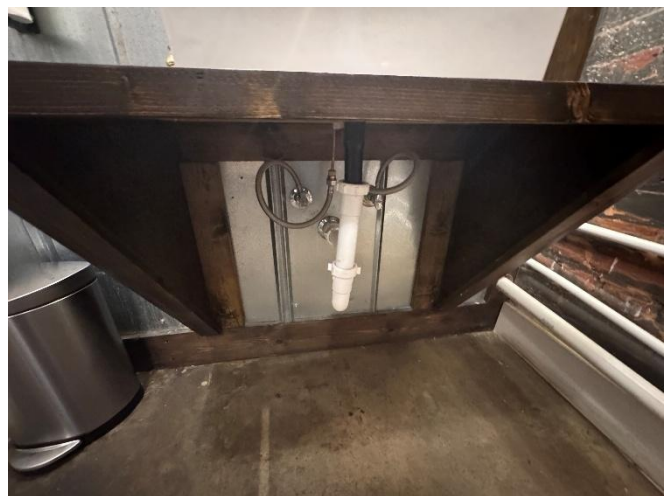
Picture 3076: Closeup of the sink piping.

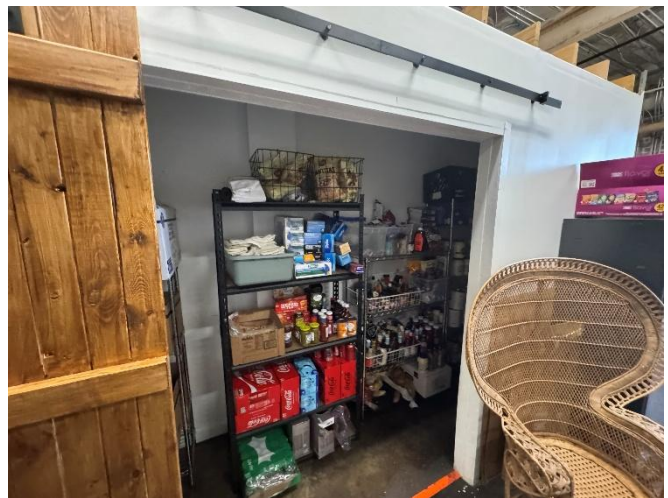
Picture 84: View of the storage closet.

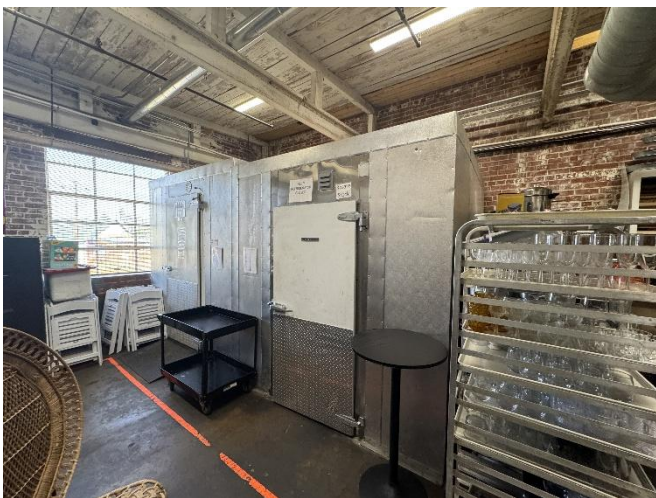
Picture 85: View of the walk-in cooler.

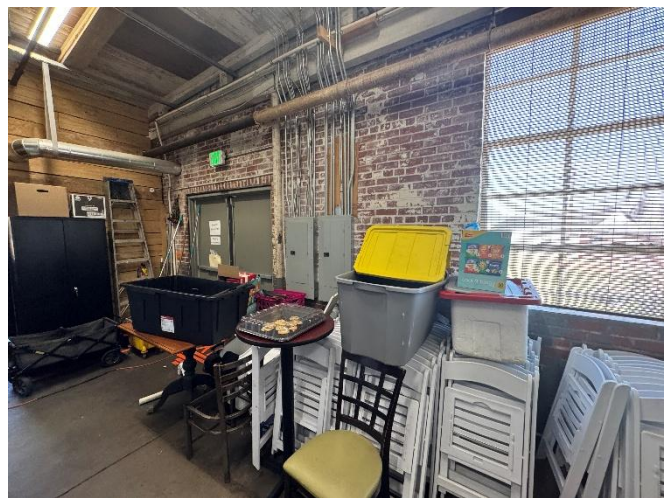
Picture 86: Overview of the electrical panels.

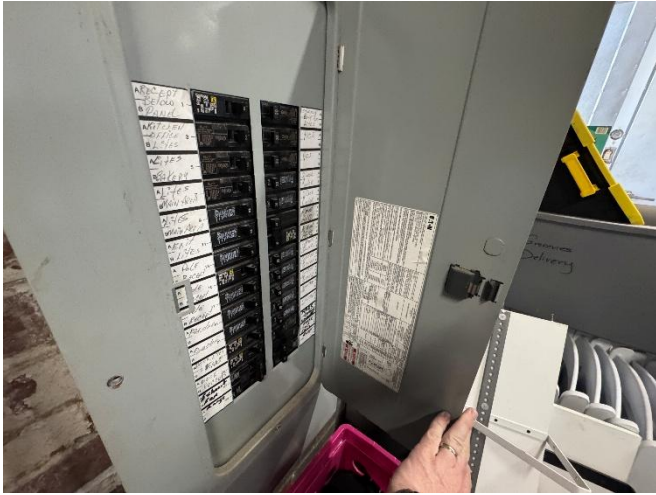
Picture 87: Closeup of panel 1.

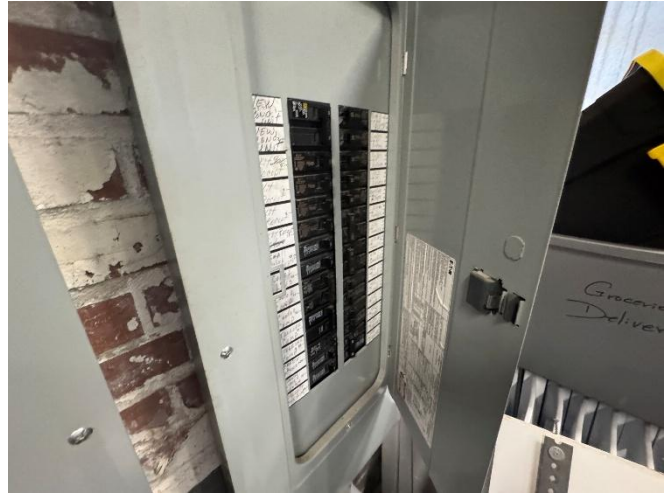
Picture 88: Closeup of panel 2.

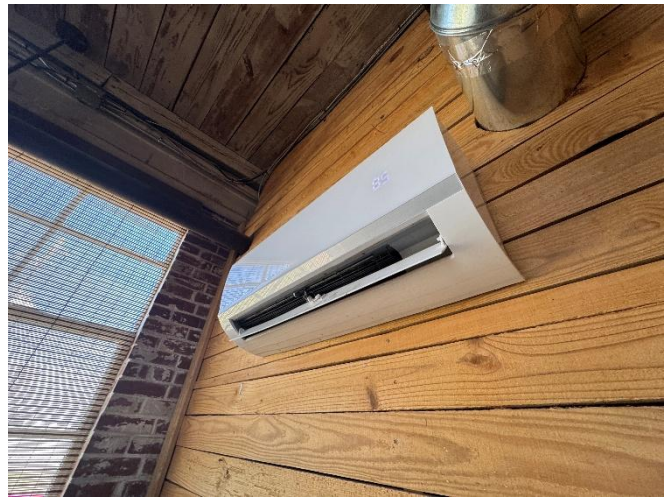
Picture 90: View of a ductless wall unit.

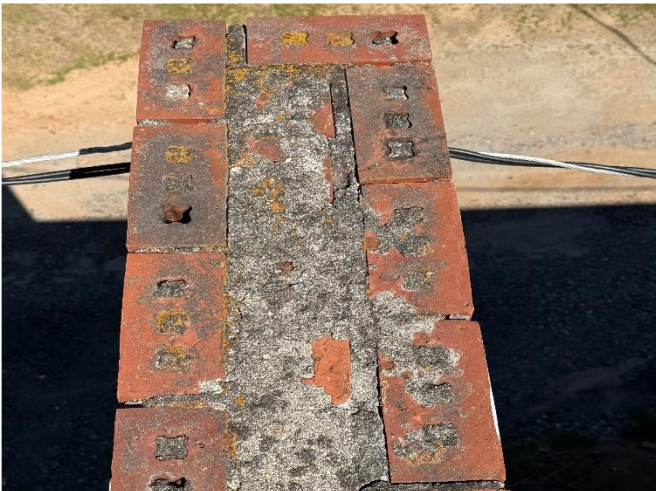
*Picture 97: Top of brick wing walls*

- \* The single-ply membrane roof is fairly new and in good overall condition.
- \* I would suggest trying to find out what contractor installed the roof and obtain a copy of the contract for warranty/records purposes.
- \* The roof was clear of debris at the time of inspection.
- \* The roof has one area of ponding water but should not pose an issue on this type of roof.
- \* There has been some caulking applied on multiple overlap seams that was most likely an attempt to repair leaking. This is not the proper type of repair on this roof system with this caulking.
- \* One roof scupper is impeded by the sign, and I would suggest trimming or moving the sign.
- \* I would suggest proper masonry sealing on the caps of the brick walls to prevent further degradation.

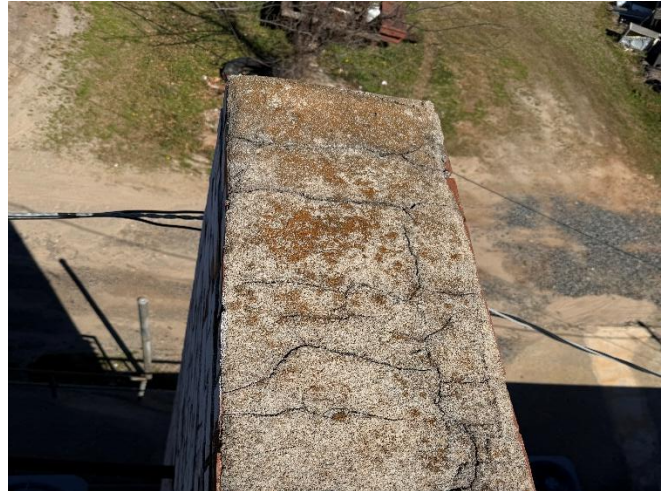
*Picture 98: Top of brick wing walls*

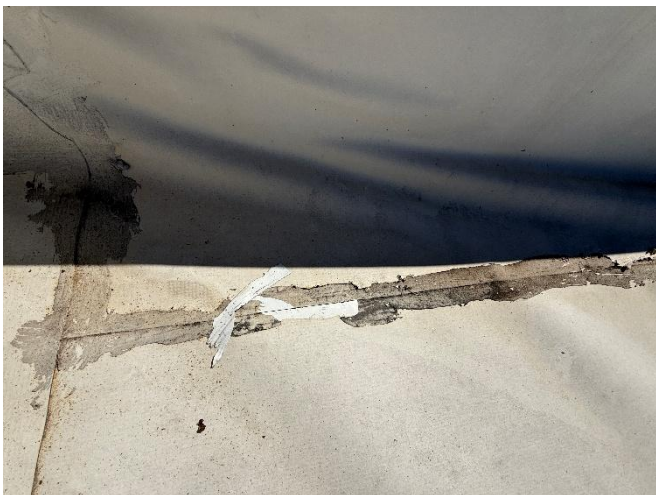
*Picture 99: Caulking on seams*

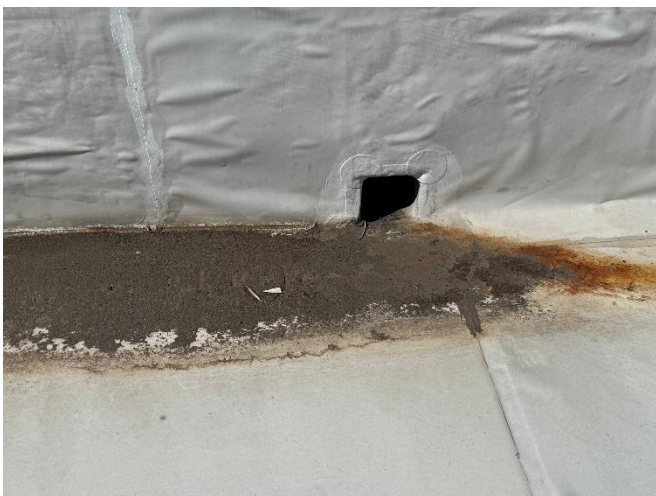
Picture 105: Scupper with impeded water flow
