## XXX Shopping Center

### XXX Crossing

**Abbreviated Property Condition Assessment**

Report Date: May 20, 2025

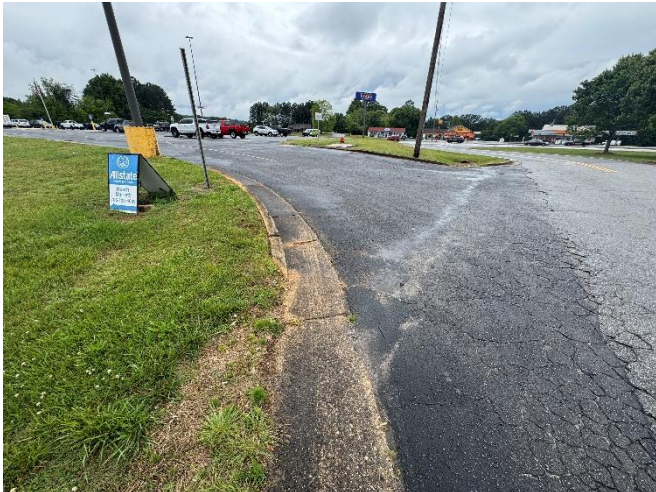
*Picture 1: Entrance to the parking lot from XXX Road.*

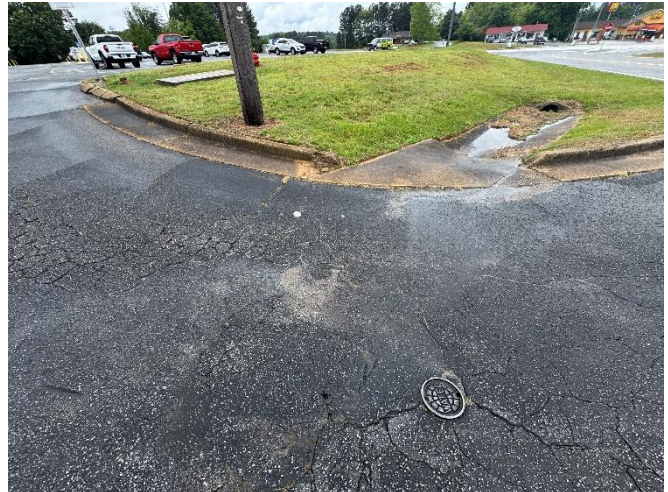
*Picture 2: Water valve noted at entrance off XXX Road.*

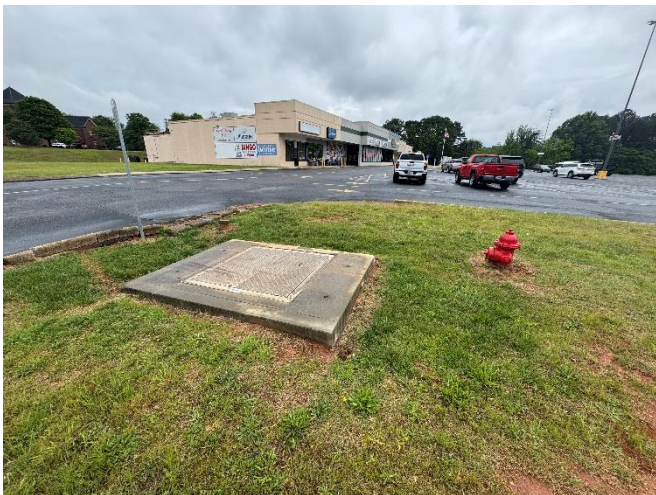
*Picture 3: Water vault and hydrant off XXX Road.*

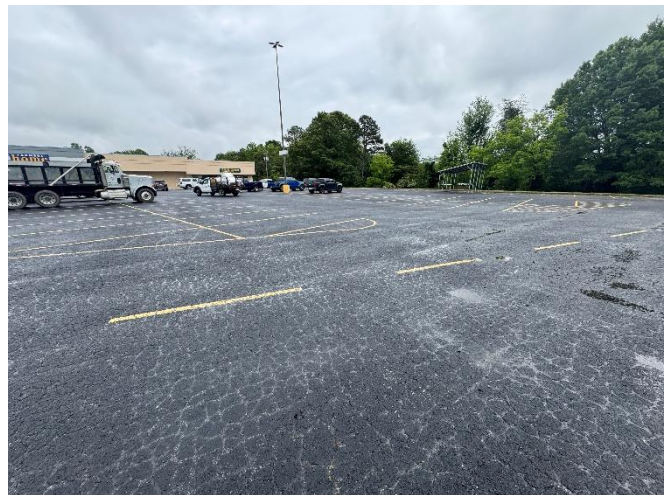
*Picture 4: Typical asphalt conditions – cracking observed throughout.*

***Recommendations: The asphalt parking and drive area was noted to have significant alligator cracking, yet we did not notice areas of significant subgrade failure which typically results in differential settlement, significant asphalt failures, and potholes. Given the conditions observed, we recommend an asphalt crack sealer and topcoat application throughout the parking and drive area as well as restriping. While no significant structural damage was noted in the parking/drive areas at the time of inspection, leaving the cracks unaddressed will create significant future repair costs. We have included an estimate to remedy these issues in our Immediate Repair Estimates section below.***

*Note, the above recommendation is to prolong the life of the existing asphalt pavement, yet a more permanent long-term repair would be to mill and overlay the entire parking lot. This includes removing the top layer of asphalt and installing a new wear layer which will last longer than crack treatment and top coating recommended above. The cost to mill and overlay the estimated 90,000 square feet of asphalt surface would be approximately \$445,500 (90,000 sf X \$4.95/SF).*

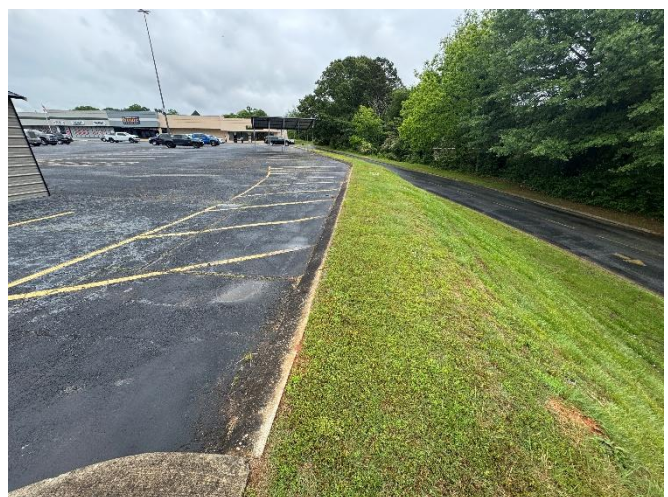
*Picture 6: Southern property area with entry drive to site.*

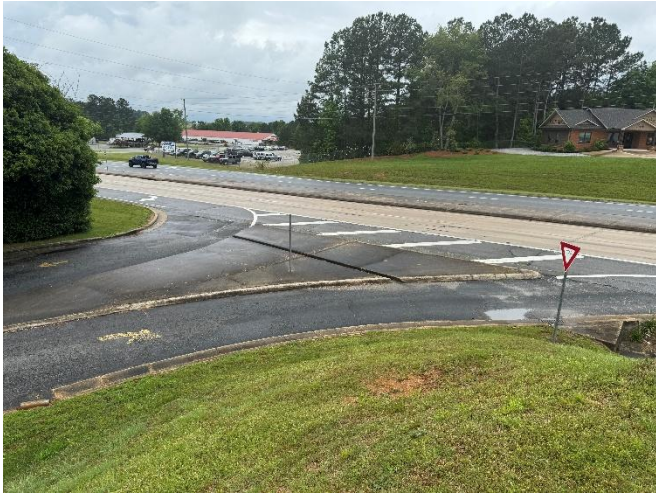
*Picture 7: Southern entry off U.S. Highway XXX.*

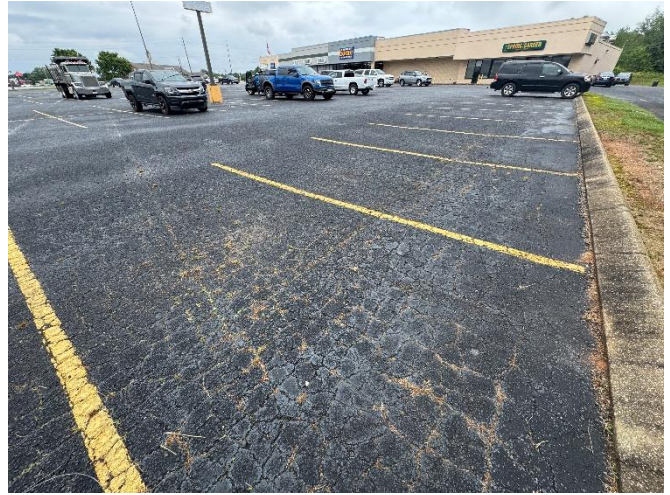
*Picture 8: Asphalt parking area conditions observed.*

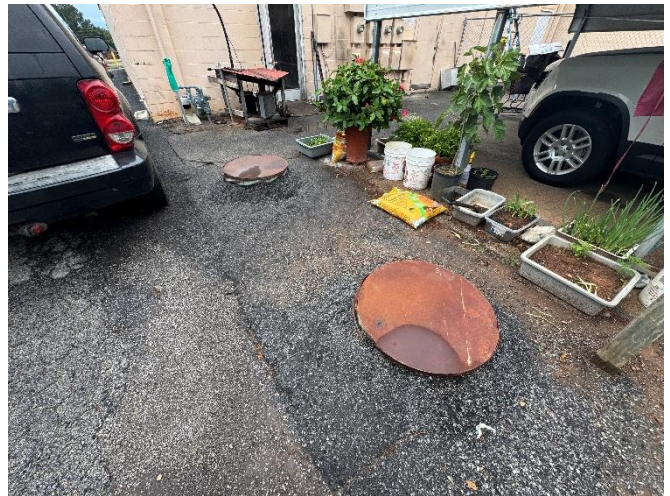
*Picture 10: Rear of XXX Restaurant – grease trap access.*

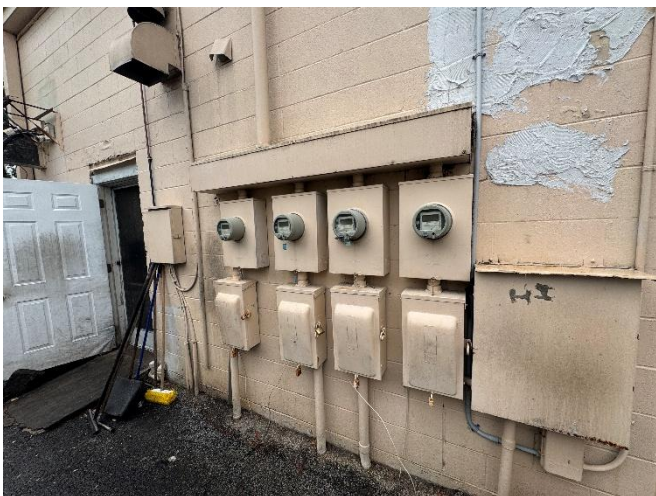
*Picture 11: Rear meter bank near XXX.*

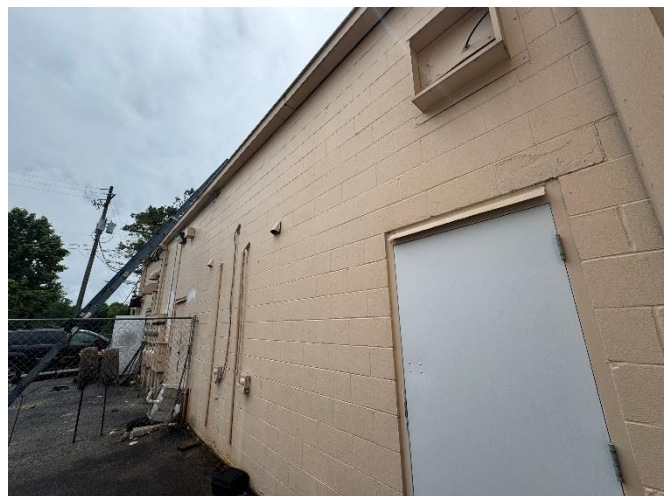
The building appears to be structurally sound and in fair condition. There was no evidence of unusual settlement or deflection of the foundation, wall or roof systems. While minor step cracking was observed at the rear CMU walls, the cracks did not appear to represent significant settlement of the exterior wall system.

*Picture 12: CMU block wall at rear elevation.*

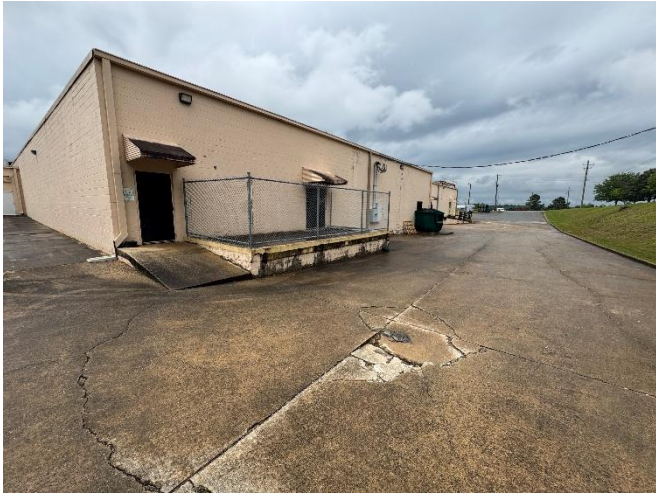
Picture 13: Rear loading area concrete pavement.

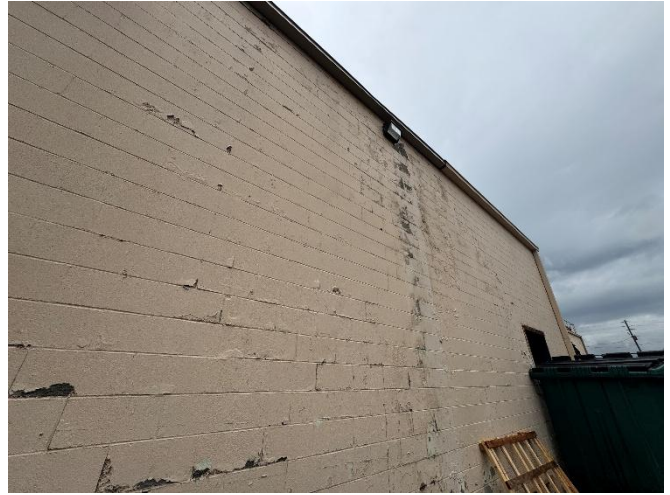
The CMU block exterior wall systems have water damage observed to the paint, which suggests that water has entered the CMU block and water pressure has caused bubbling and cracking/peeling of the exterior paint coating. Some areas of CMU block damage from water are evident as well, and the entirety of the CMU wall surfaces are in need of repair and repainting after the roof and gutter systems are corrected to prevent water damage to the rear CMU wall.

Picture 14: Water damage noted at rear CMU wall.

***Recommendations: Given that active roof leaks were not observed onsite during our site visit, we have not recommended a full roof replacement, as this report is to recommend Immediate Repair Concerns only. We have included a repair allowance to correct water ponding at the rear roof of the building, as well as replacement of gutter and downspouts to properly shed water away from the rear CMU walls and prevent further water damage. Additionally, we have included an allowance to repair and repaint all exterior CMU and EIFS veneer areas based on the conditions observed onsite.***

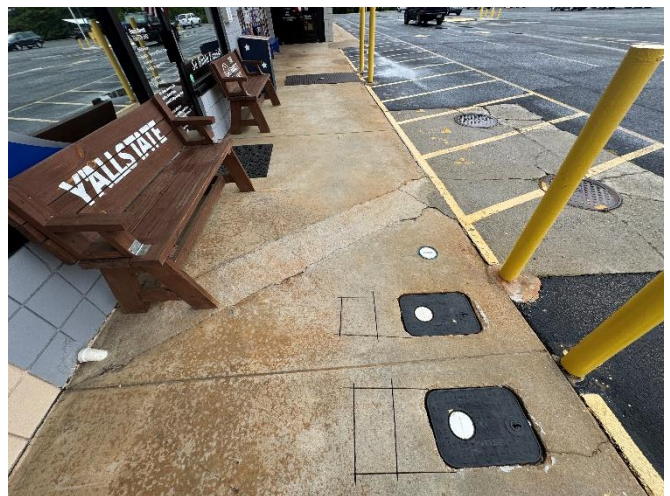
Picture 18: Individual water meters noted at front elevation.

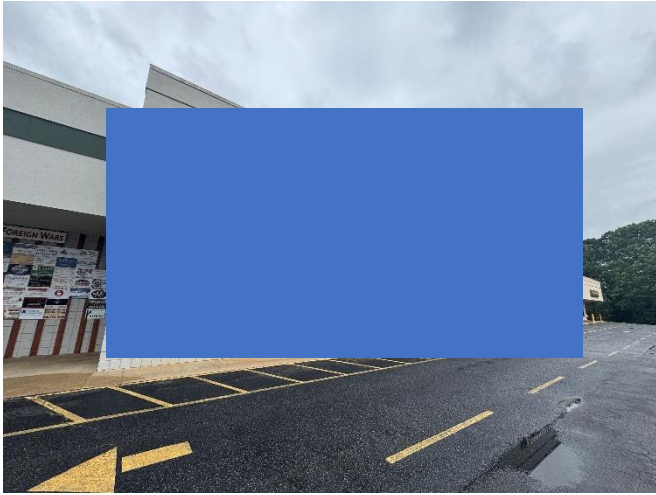
Picture 19: Front elevation at XXX and XXX Furniture.

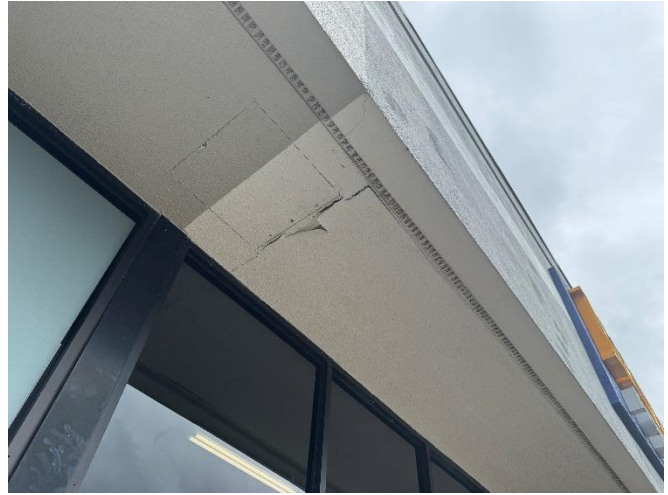
The front EIFS canopy veneer appeared to be in fair condition. Minor repairs and repainting are recommended to coincide with the rear CMU wall repairs and repainting. Aluminum storefront door and window systems, as well as the metal segmented roll-up door at the rear of the building appeared to be functional and in fair to good condition. No immediate repair concerns were noted.

Picture 20: Minor soffit damage noted at front elevation.

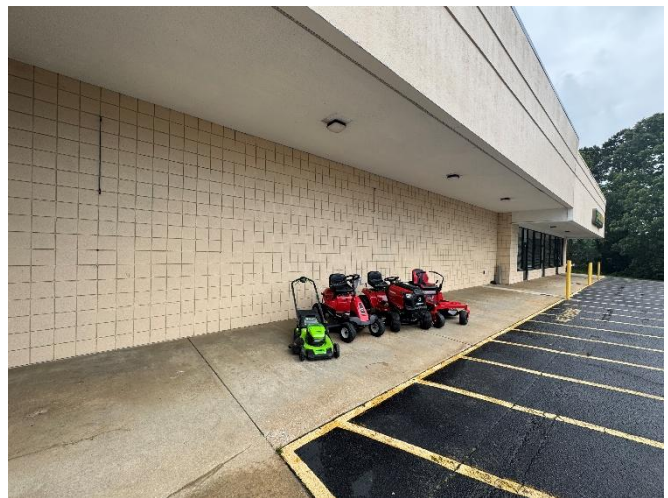
Picture 22: Canopy overhang area at XXX Furniture.

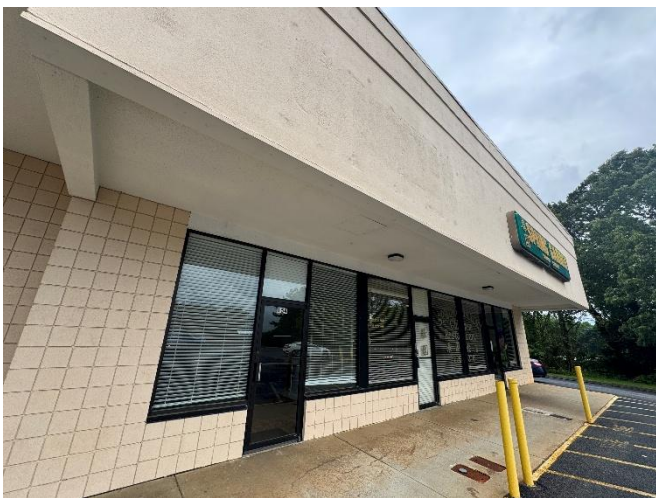
Picture 23: Front elevation at Suites 148 and 154.

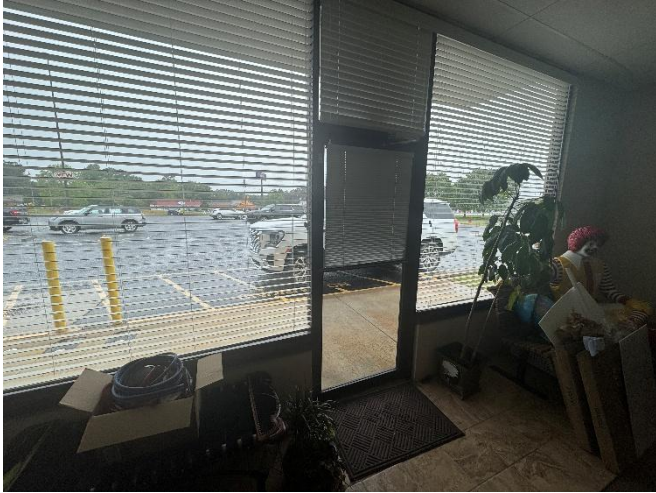
Picture 27: Interior of Suite 194 – Owner's storage suite.

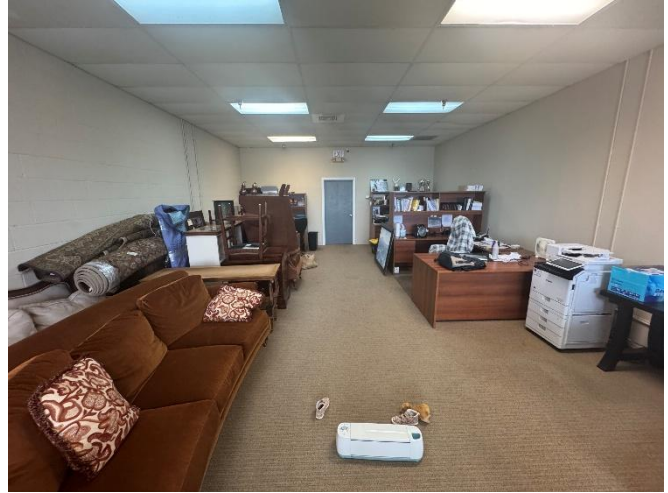
Picture 28: Interior of Suite 194.

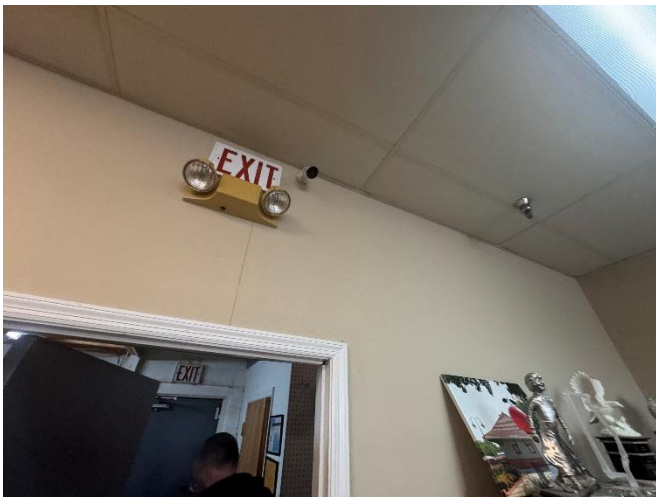
Picture 29: Exit signage at rear egress of Suite 194.

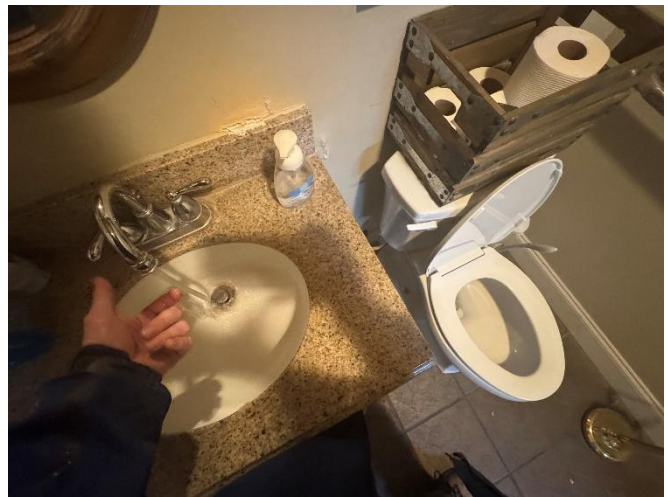
Picture 30: Bathroom at rear of Suite 194.

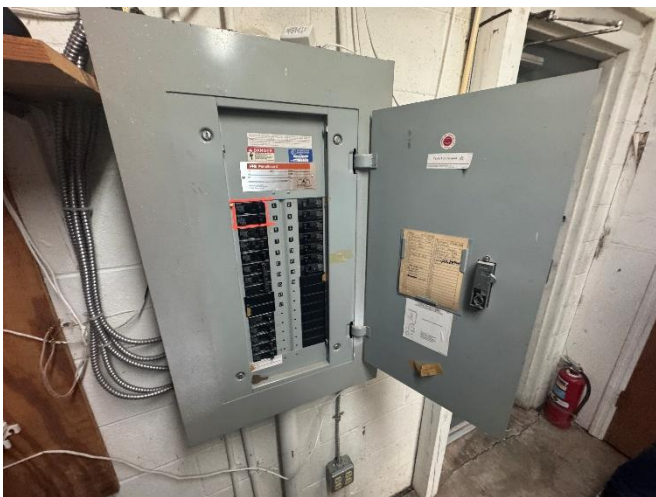
Picture 31: Typical electrical panel at rear of retail suites.

**ELECTRICAL:** *Our scope does not include thorough electrical system testing, yet the electrical systems observed onsite appeared in fair condition. Some panels are in need of updated panel surveys, and minor repairs which should be performed by a licensed electrician. Costs for such panel updates are below the threshold for inclusion in this report. Also note, future tenant needs could affect the electrical systems within the building, and additional electrical updates may become necessary in the future. No immediate lighting fixture updates appear necessary, yet some upgrades for more energy efficient LED lighting may be warranted in the future.*

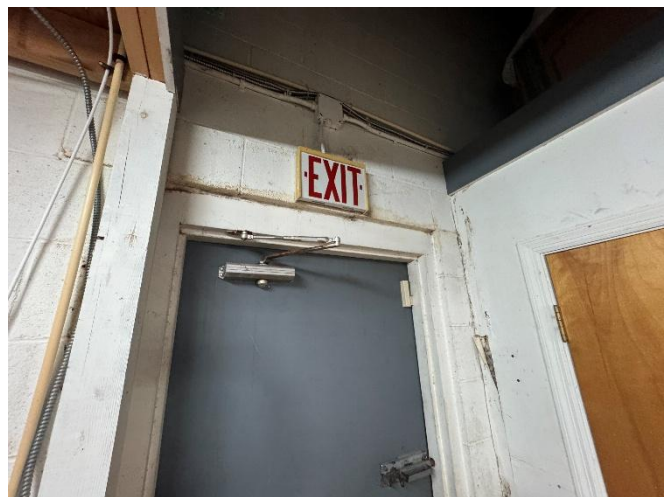
Picture 32: Rear egress doorway at Suite 194.

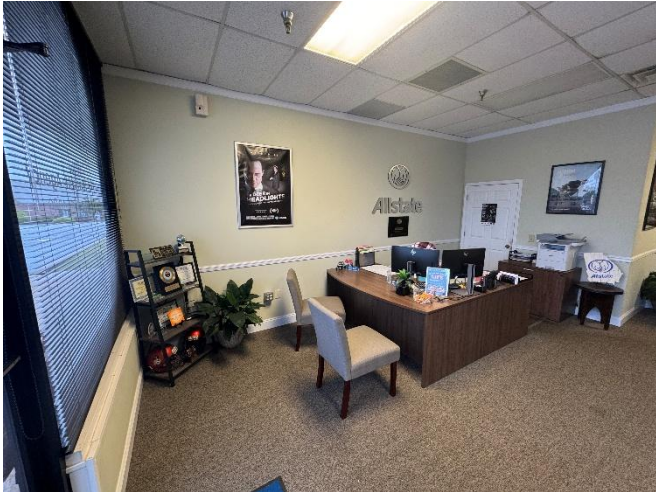
Picture 33: Suite 186 - XXX suite.

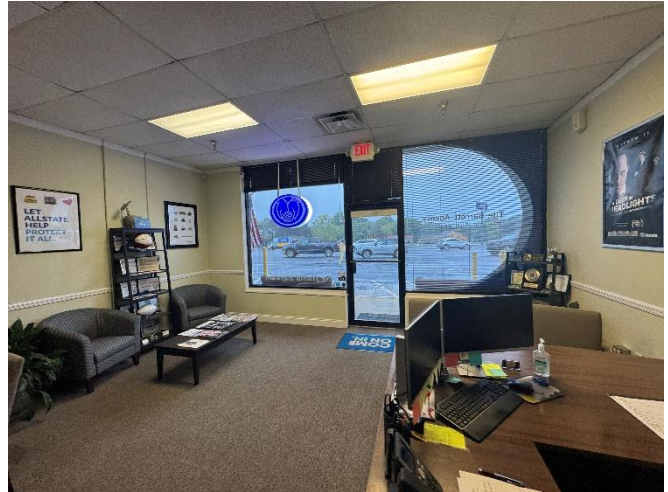
Picture 34: Typical interior finishes at Suite 186.

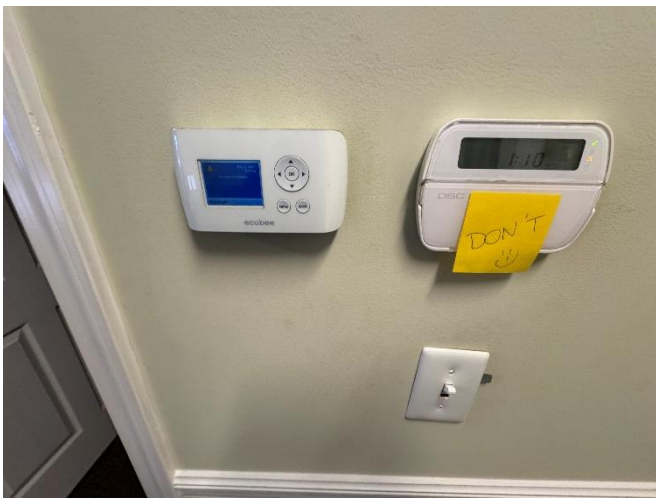
Picture 35: HVAC operational at Suite 186.

**HVAC:** *Based on random operation of the HVAC systems, immediate repairs do not appear necessary, yet we recommend reserving funds for HVAC replacements in the coming 1-2 years for systems which are observed to be over 15 years old. We anticipate approximately 30% of the units will need to be replaced annually, except for the 2 more recently replaced systems at the XXX Furniture. Based on this assumption, we will include an allowance in the Immediate Repair Table for 22.5 tons of cooling replacement (30% x 75 tons), and we would recommend similar budgets for Year 2 and Year 3, as well as typical ongoing maintenance of the HVAC systems in place. We also note that future tenant uses could affect the anticipated HVAC loads, and additional HVAC costs could be incurred during tenant turnover.*

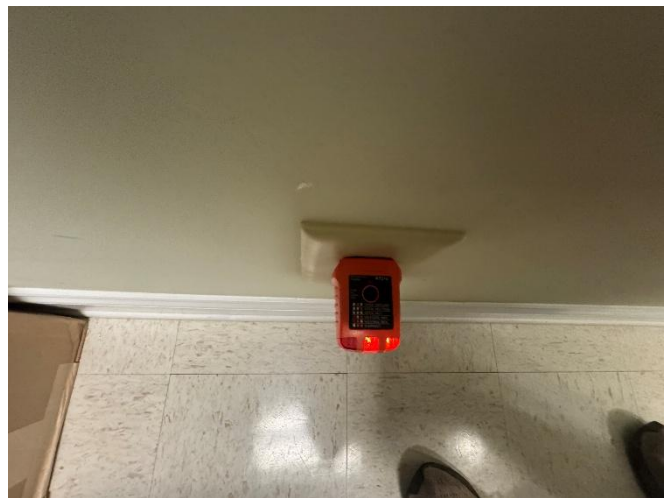
Picture 36: Electrical system polarity/ground checked – Suite 186.

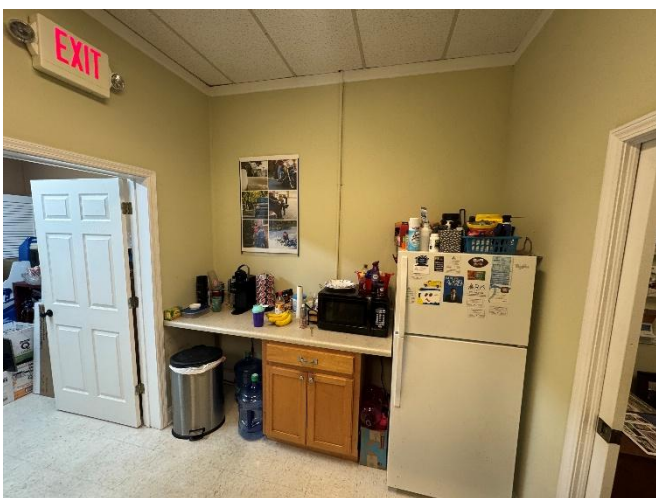
Picture 37: Rear breakroom area at Suite 186.

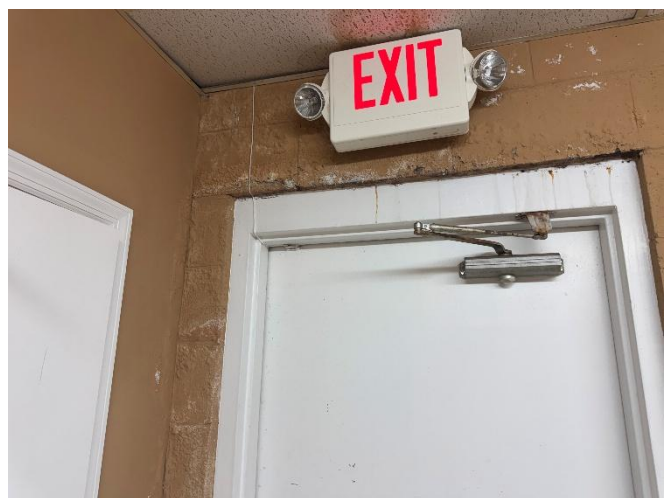
Picture 38: Rear egress doorway at Suite 186. Note peeling paint and water damage at the rear wall.

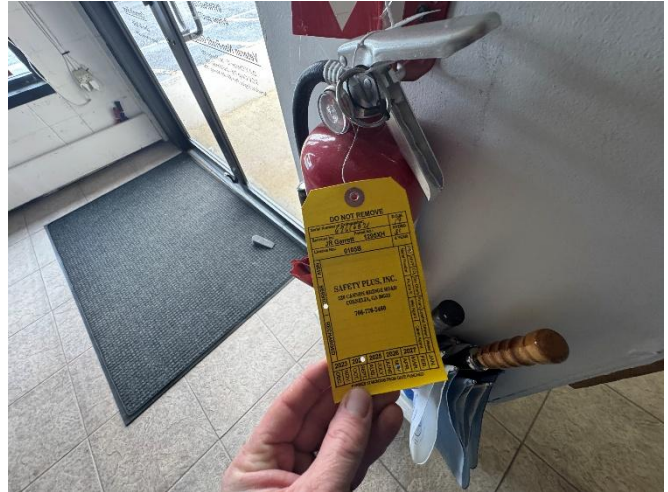
Picture 40: Fire Extinguisher annual service tag – needs inspection.

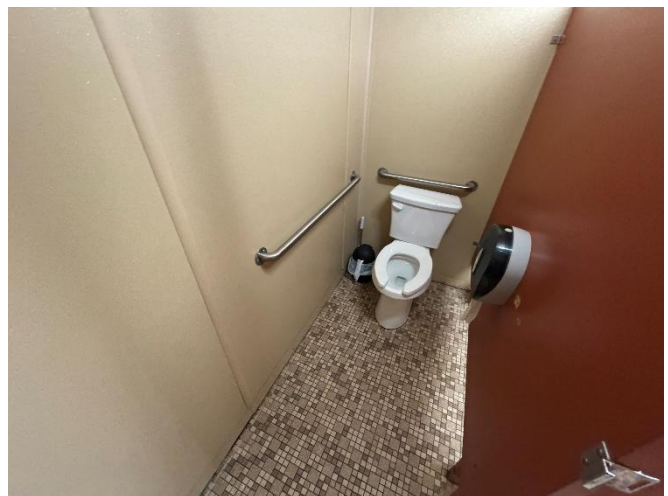
Picture 44: Grab bars in restroom at XXX space.

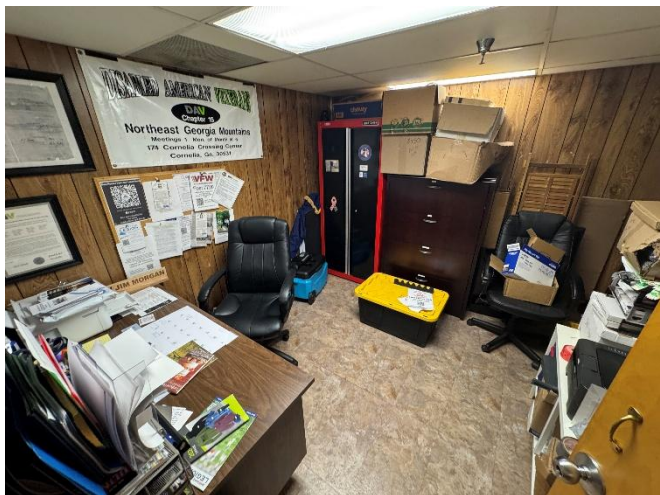
Picture 45: Mezzanine office area in XXX space.

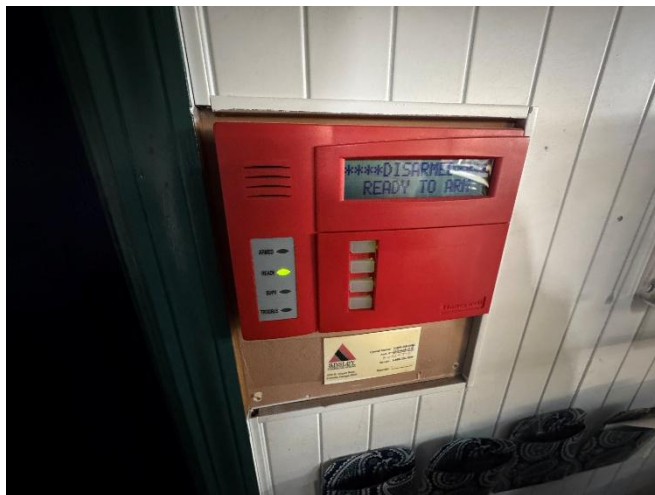
Picture 46: Fire Alarm display in XXX space.

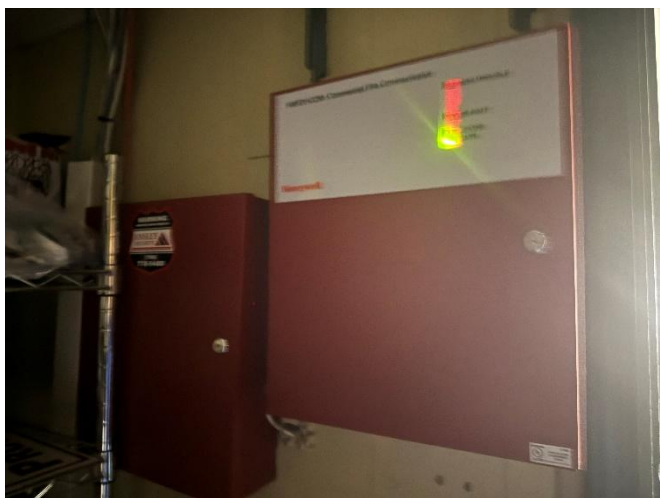
Picture 47: Fire Alarm panel in XXX space.

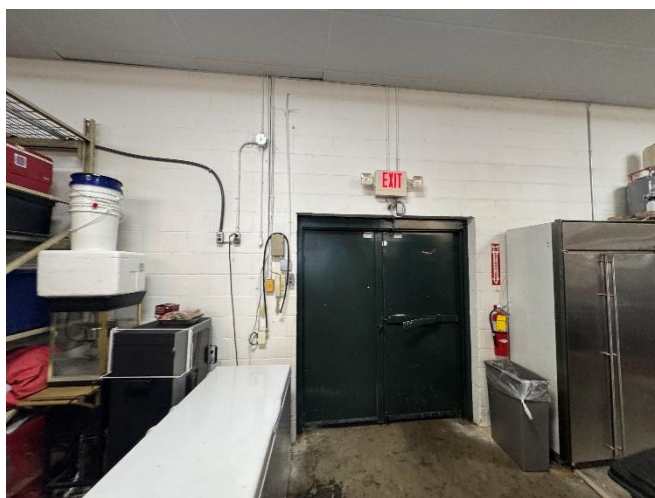
Picture 50: Rear egress doors at XXX space.

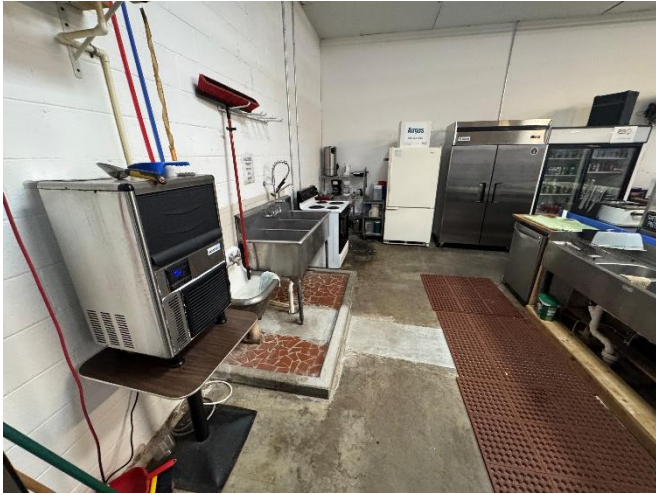
Picture 51: Warming kitchen at XXX space.

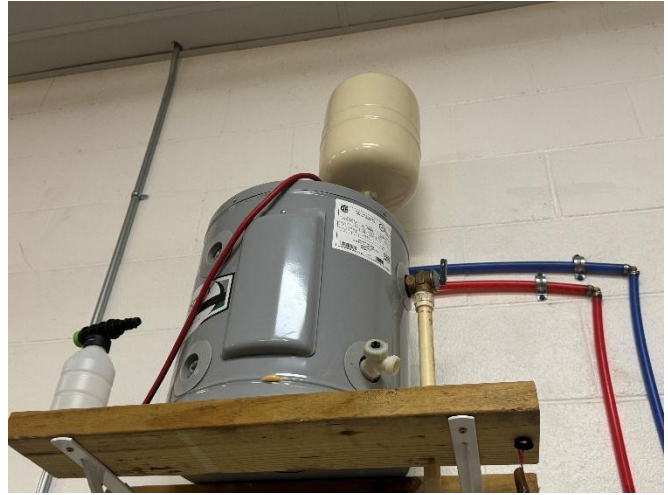
Picture 52: Small water heater at XXX warming kitchen.

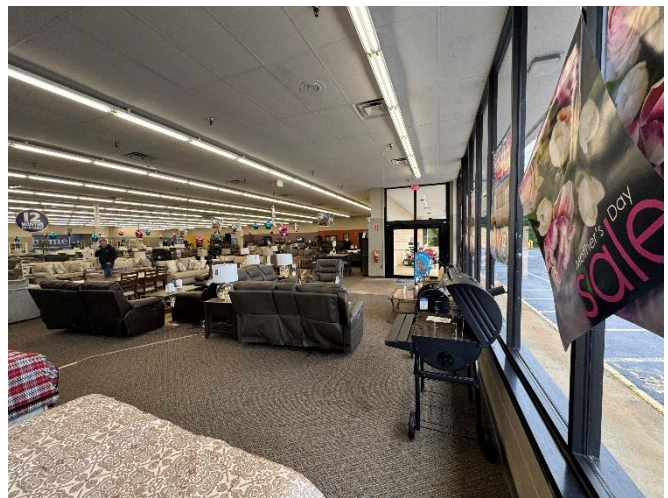
Picture 54: Suite 170 – XXX Furniture.

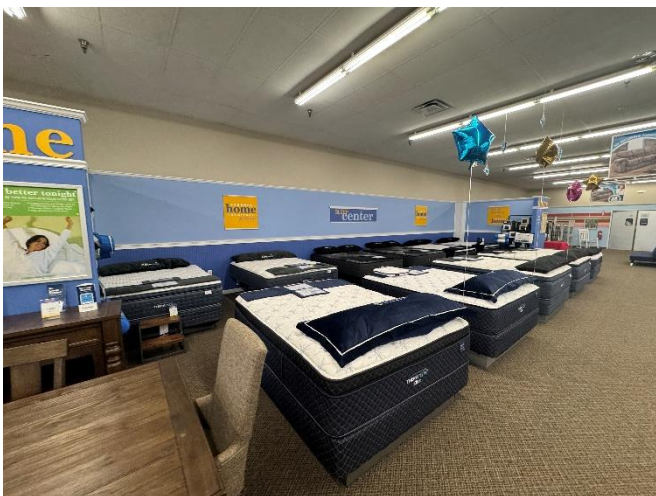
Picture 55: Suite 170 – typical retail area finishes.

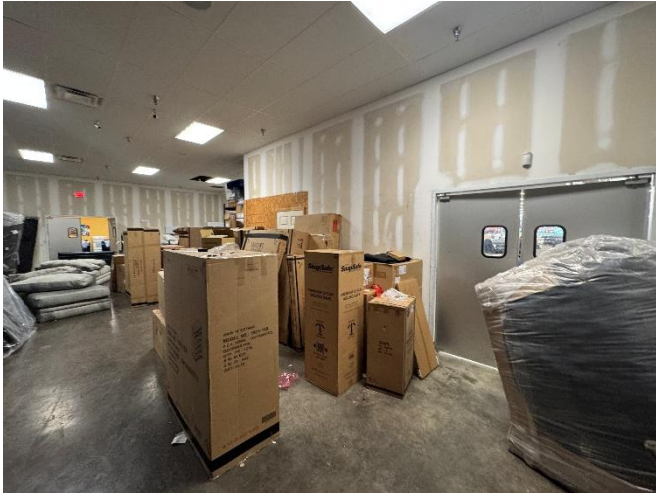
Picture 57: Rear stock storage area at XXX Furniture.

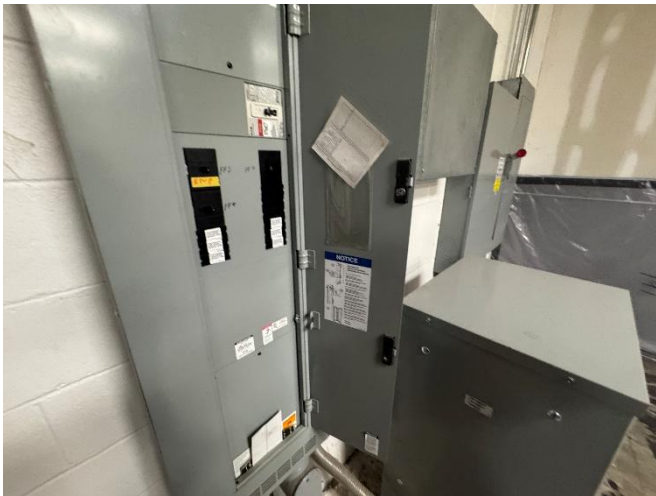
Picture 59: Electrical service panels at rear of XXX Furniture.

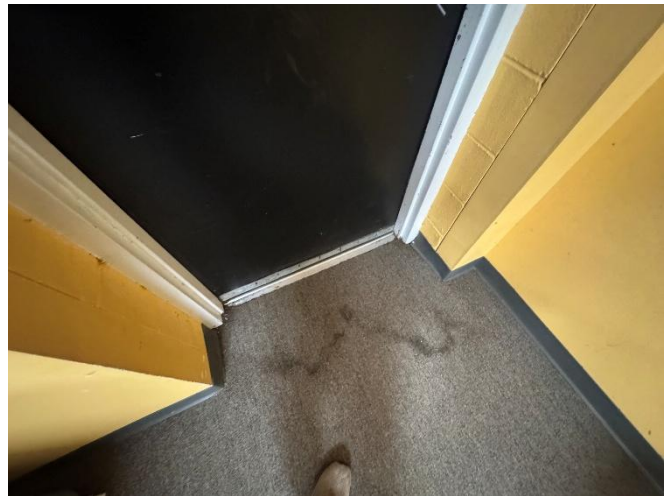
Picture 60: Water staining at rear egress door of XXX Furniture.

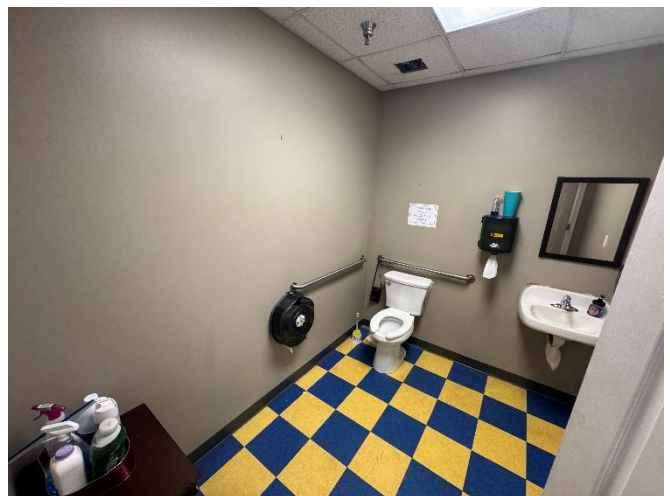
Picture 62: Typical bathroom at XXX Furniture suite.

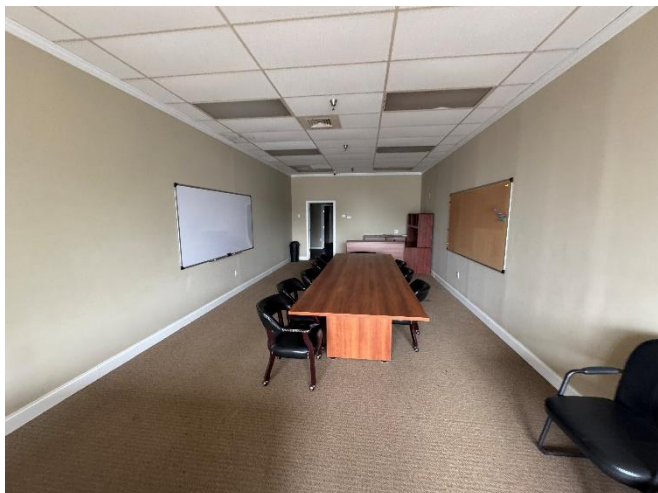
Picture 63: Vacant Suite 154.

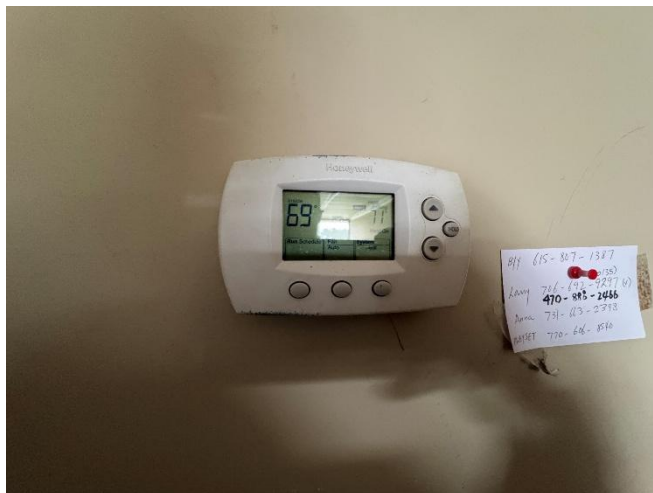
Picture 64: Power off at vacant Suite 154 – HVAC not operational.

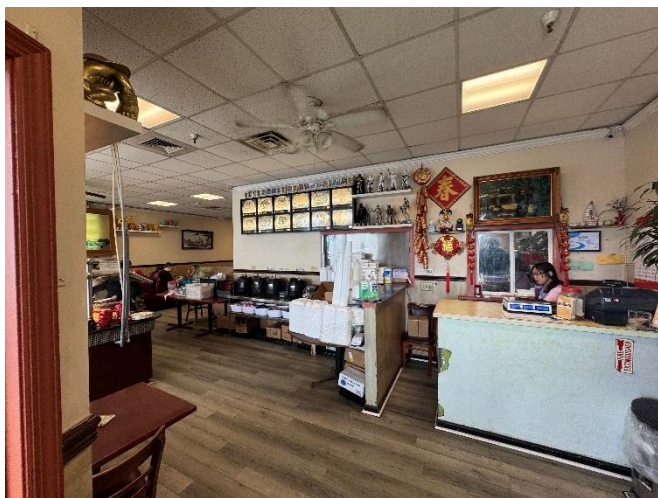
Picture 67: Interior of Suite 148 – XXX Restaurant.

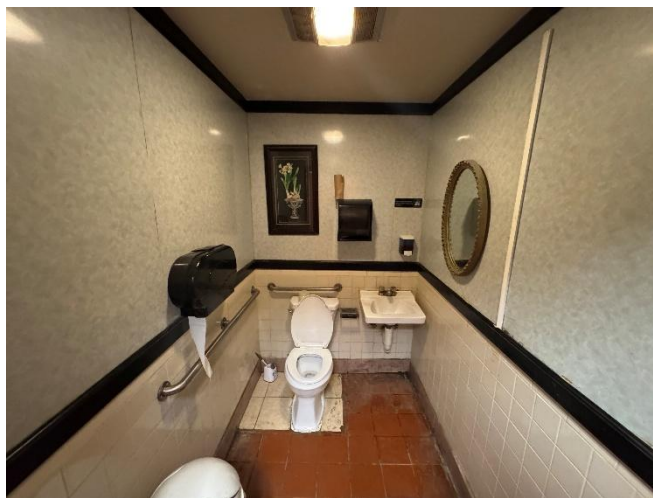
Picture 68: Bathroom at XXX tenant space.

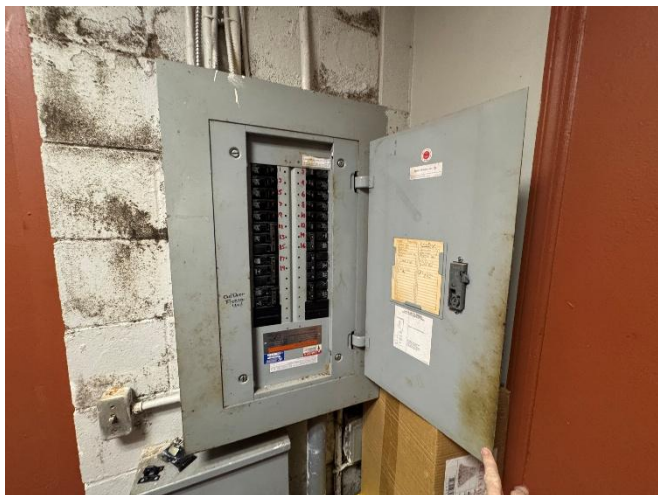
*Picture 69: Electrical panel at rear of XXX Restaurant.*

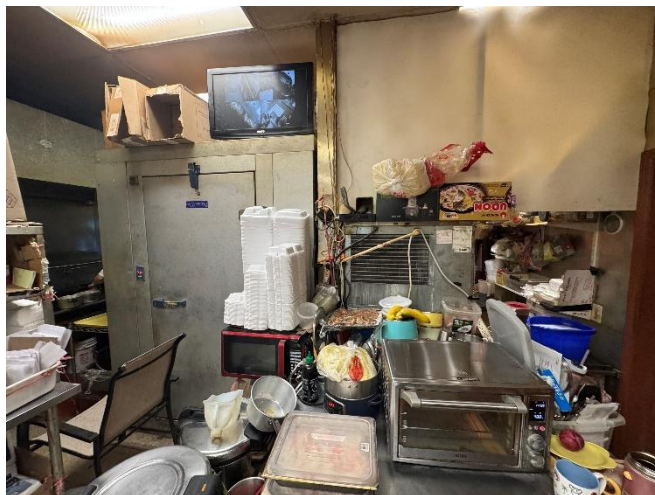
*Picture 70: Typical kitchen area observed at XXX.*

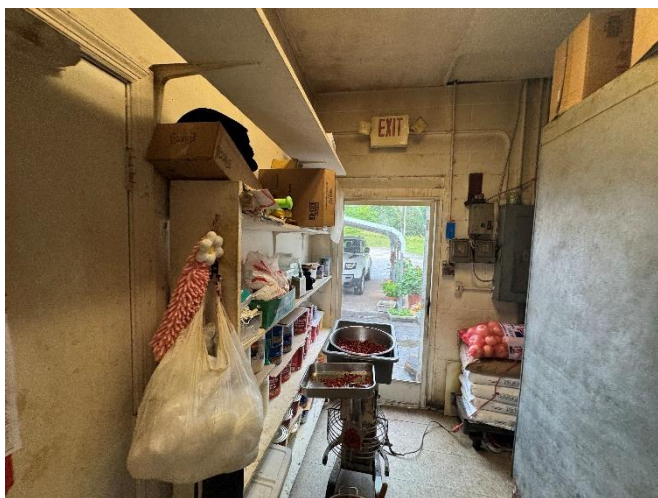
*Picture 71: Rear egress corridor at XXX.*

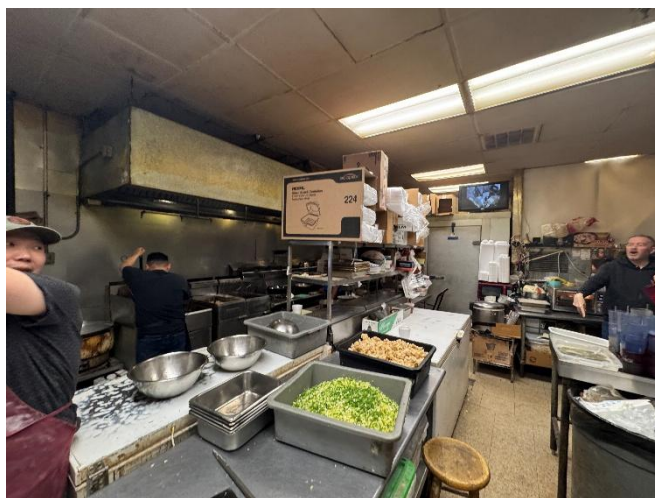
*Picture 72: Kitchen area at XXX.*
