# Commercial Building

**Full ASTM Property Condition Assessment**

Report Date: March 19, 2025

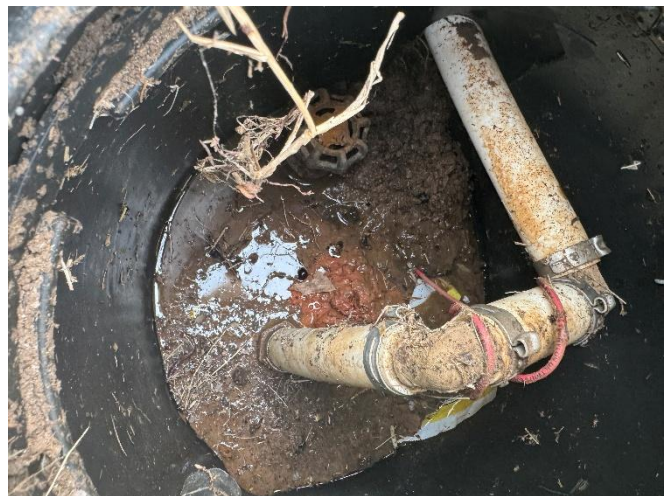
Picture 4: View of standing water in the valve box.

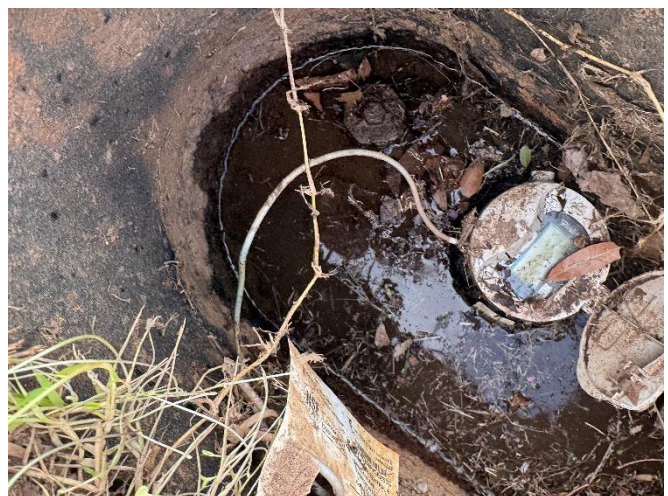
Picture 6: View of standing water in the water meter box.

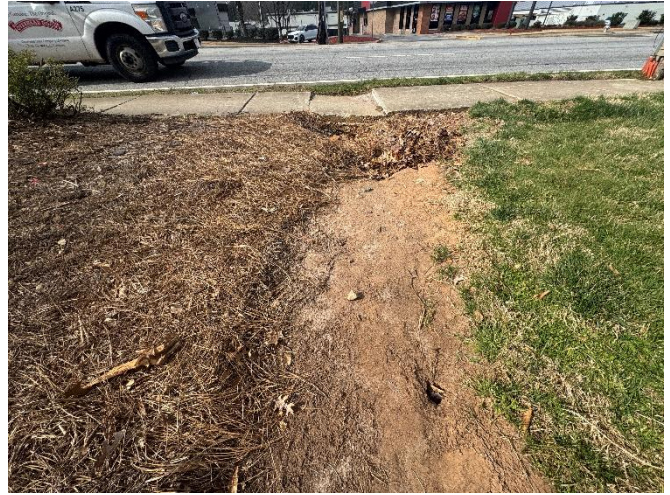
- The stormwater drainage system is in fair condition. The gutter downspouts discharge directly at the base of the building. In some instances, there is minimal to negative slope at the discharge points, and paved surfaces should be modified to allow for positive drainage at least 5 feet away from the base of the building. Pricing to remedy this issue will be discussed within the paving section below as it can be addressed during the recommended pavement repair work.

*Picture 8: View of drainage issues.*

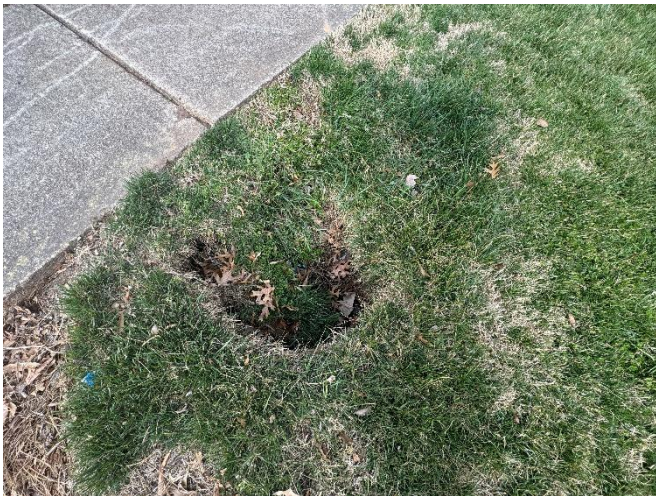
*Picture 9: View of erosion issues at the front of the site.*

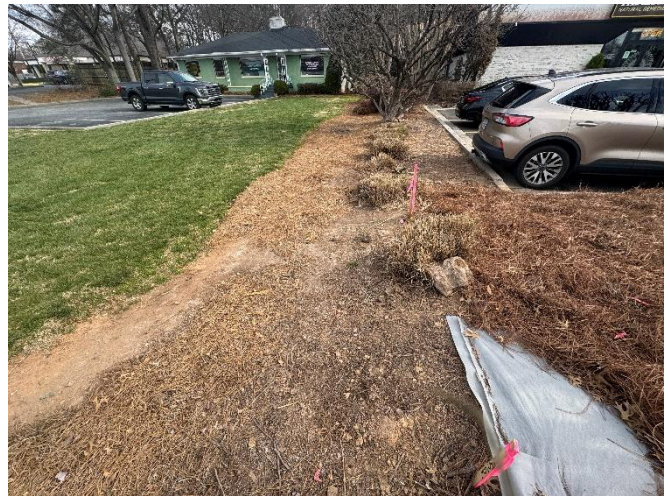
*Picture 10: Additional view of the drainage issues.*

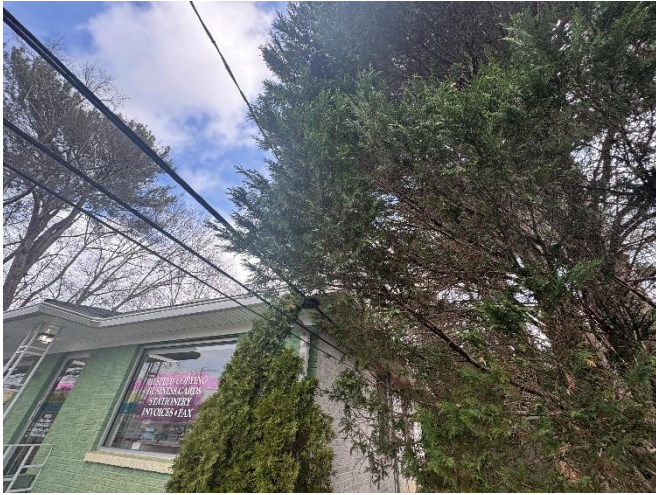
*Picture 13: View of the overgrowth at the main power feed.*

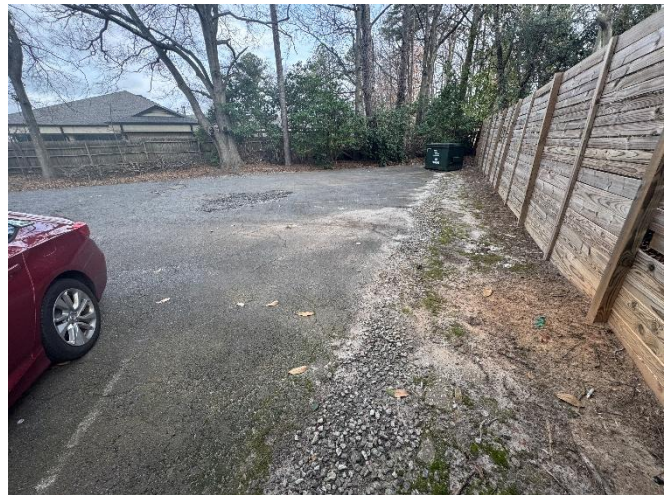
- The asphalt paved parking lot was in poor condition. Several areas of alligator cracking and paving damage were observed throughout the paved surfaces due to root damage and other subsurface issues. The extent of the pavement damage affects the usability and surface drainage capabilities of the surface.
- Pricing has been included within the Short-Term Repair Section of this report to mill & overlay the entire parking lot, which will result in a smooth, new wearing surface of asphalt. We have also included pricing for installing new parking lot striping.
- We have also reflected pricing within the 10-Year Replacement Reserve Table to reseal and re-stripe the parking lot every 5 years.
- The concrete curbing appeared to be in good condition. Pricing has not been included for this item.
- ADA parking issues will be discussed within the ADA Section of this report.

*Picture 22: View of the asphalt paving at the back elevation.*

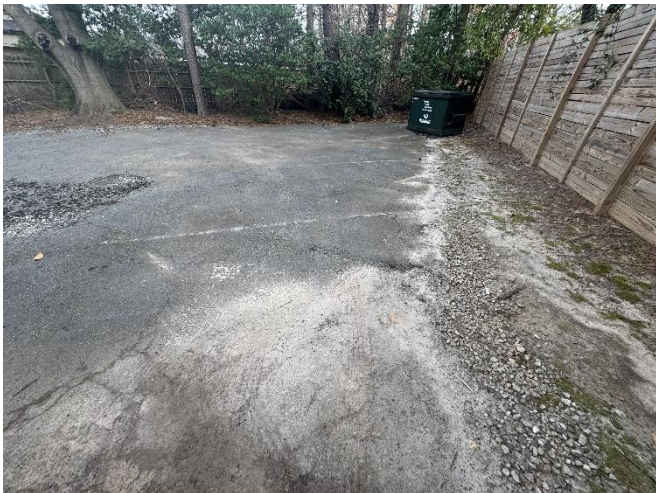
*Picture 23: Closeup of the paving.*

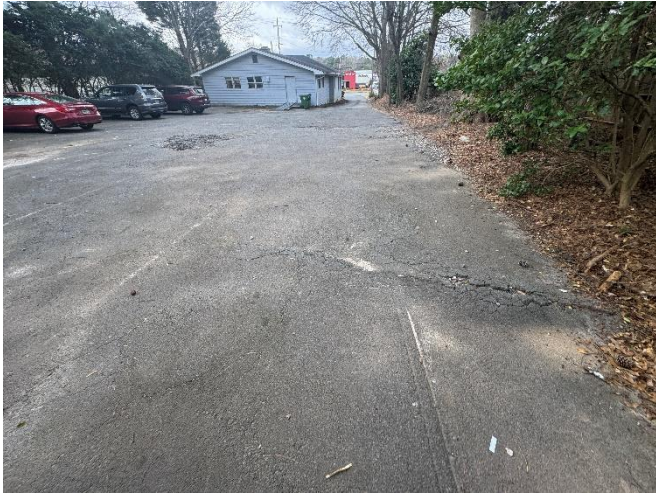
*Picture 25: Overview of the paving at the back elevation.*

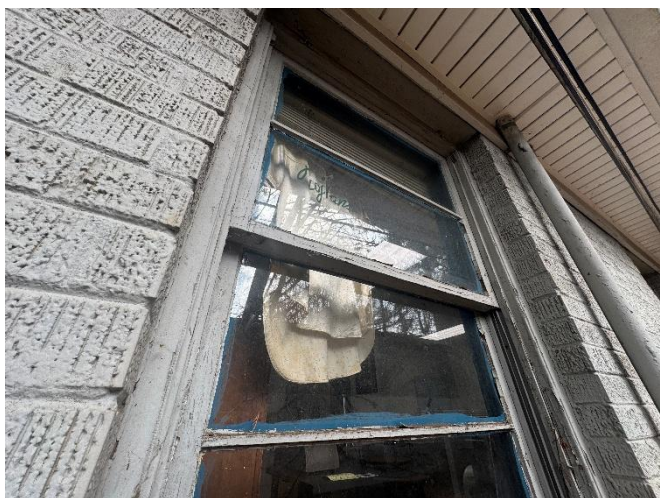
Picture 45: View of a window.

| Item | Quantity | Unit | Unit Cost | Budget<br>\$ Immediate | Budget<br>\$ Short Term |
|---|---|---|---|---|---|
| Window Replacements (Original Structure) | 8 | EA | \$1,000 | \$0 | \$8,000 |

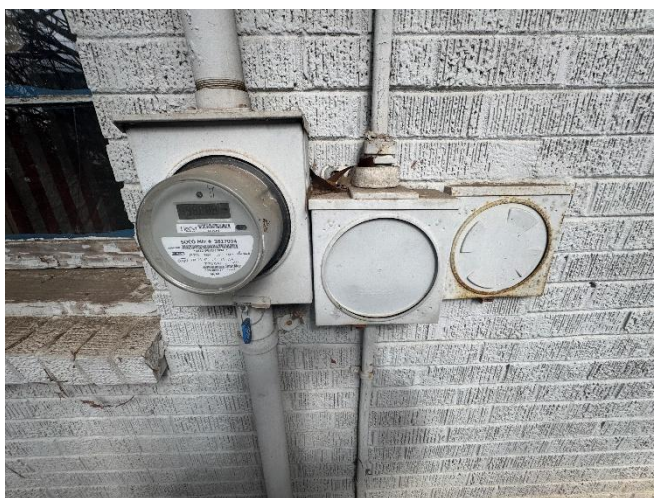
Picture 48: View of the electrical meter.

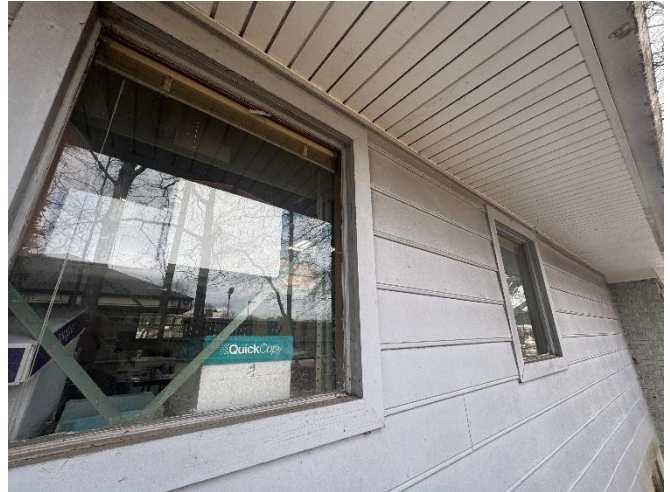
*Picture 62: View of the western elevation windows.*

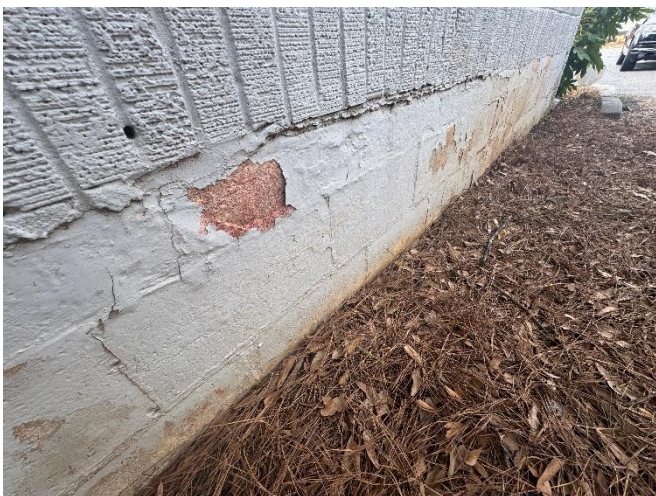
*Picture 65: View of the faded paint at the CMU stem walls.*

| Item | Quantity | Unit | Unit Cost | Budget<br>\$ Immediate | Budget<br>\$ Short Term |
|---|---|---|---|---|---|
| Exterior Repair Allowance – Siding, Waterproofing, Paint | 1 | EA | \$25,000 | \$0 | \$25,000 |

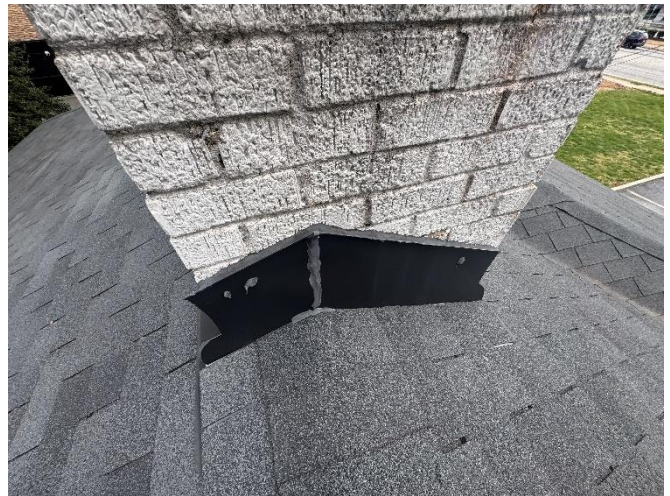
*Picture 70: Closeup of the chimney flashing.*

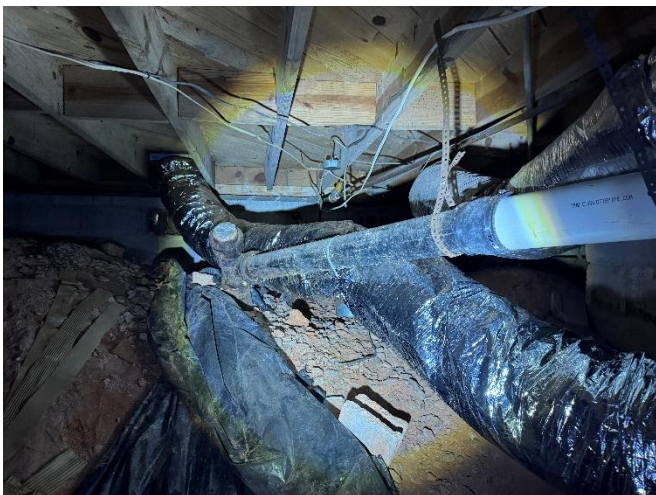
Picture 81: View of older drain piping (cast iron).

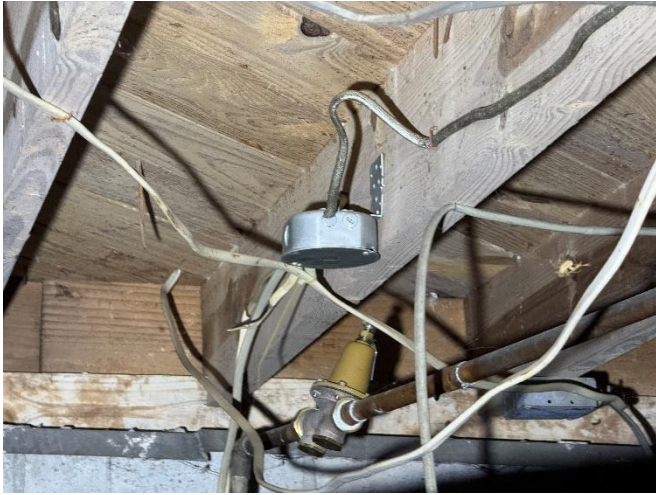
Picture 83: View of exposed wiring.

| Item | Quantity | Unit | Unit Cost | Budget<br>\$ Immediate | Budget<br>\$ Short Term |
|---|---|---|---|---|---|
| Electrical Upgrade/Repair Allowance | 1 | EA | \$17,000 | \$17,000 | \$0 |

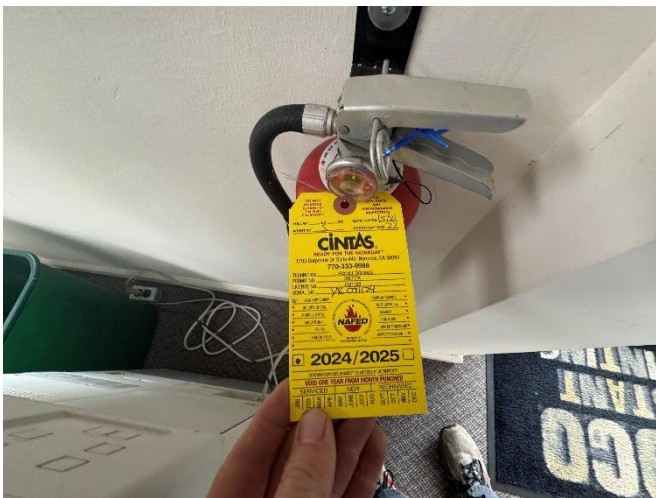
Picture 85: Closeup of a valid inspection tag.

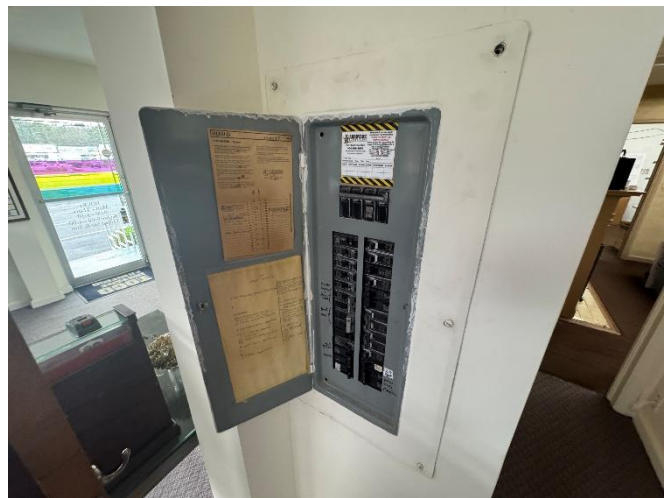
Picture 92: View of the MDP.

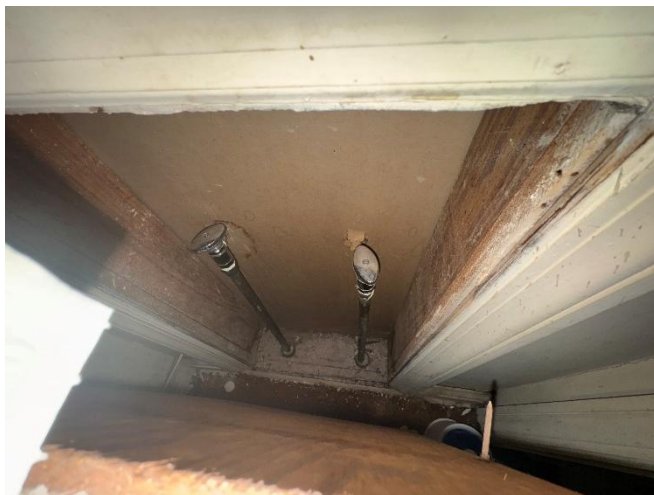
Picture 96: View of abandoned shut-off valves.

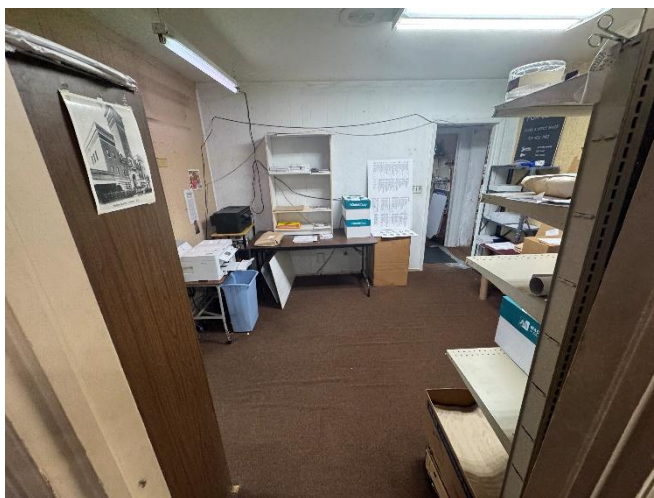
Picture 103: View of a non-grounded outlet .

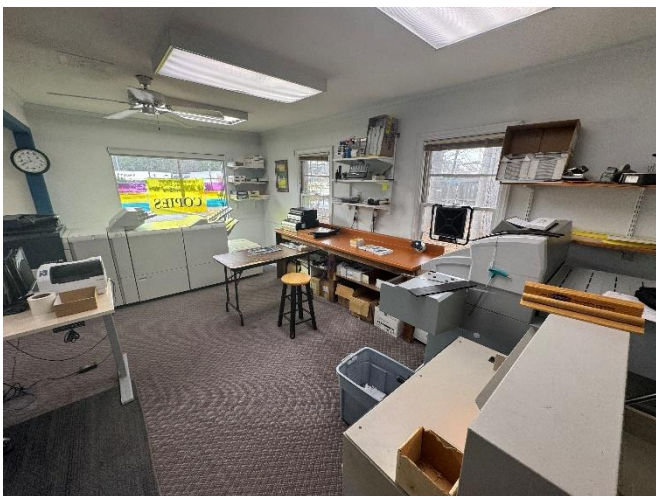
Picture 110: View of an outlet with an open ground.
